~~CONFIDENTIAL~~  
EPRI TR-104721  
Project 2229-01  
ESEERCO Project EP89-31  
Final Report  
December 1994

# **Evaluation of Fuel Rod Leakage Mechanisms—Summary Report**

## **Joint EPRI/ESEERCO/Westinghouse Studies**

Prepared by  
Westinghouse Electric Corporation  
Pittsburgh, Pennsylvania

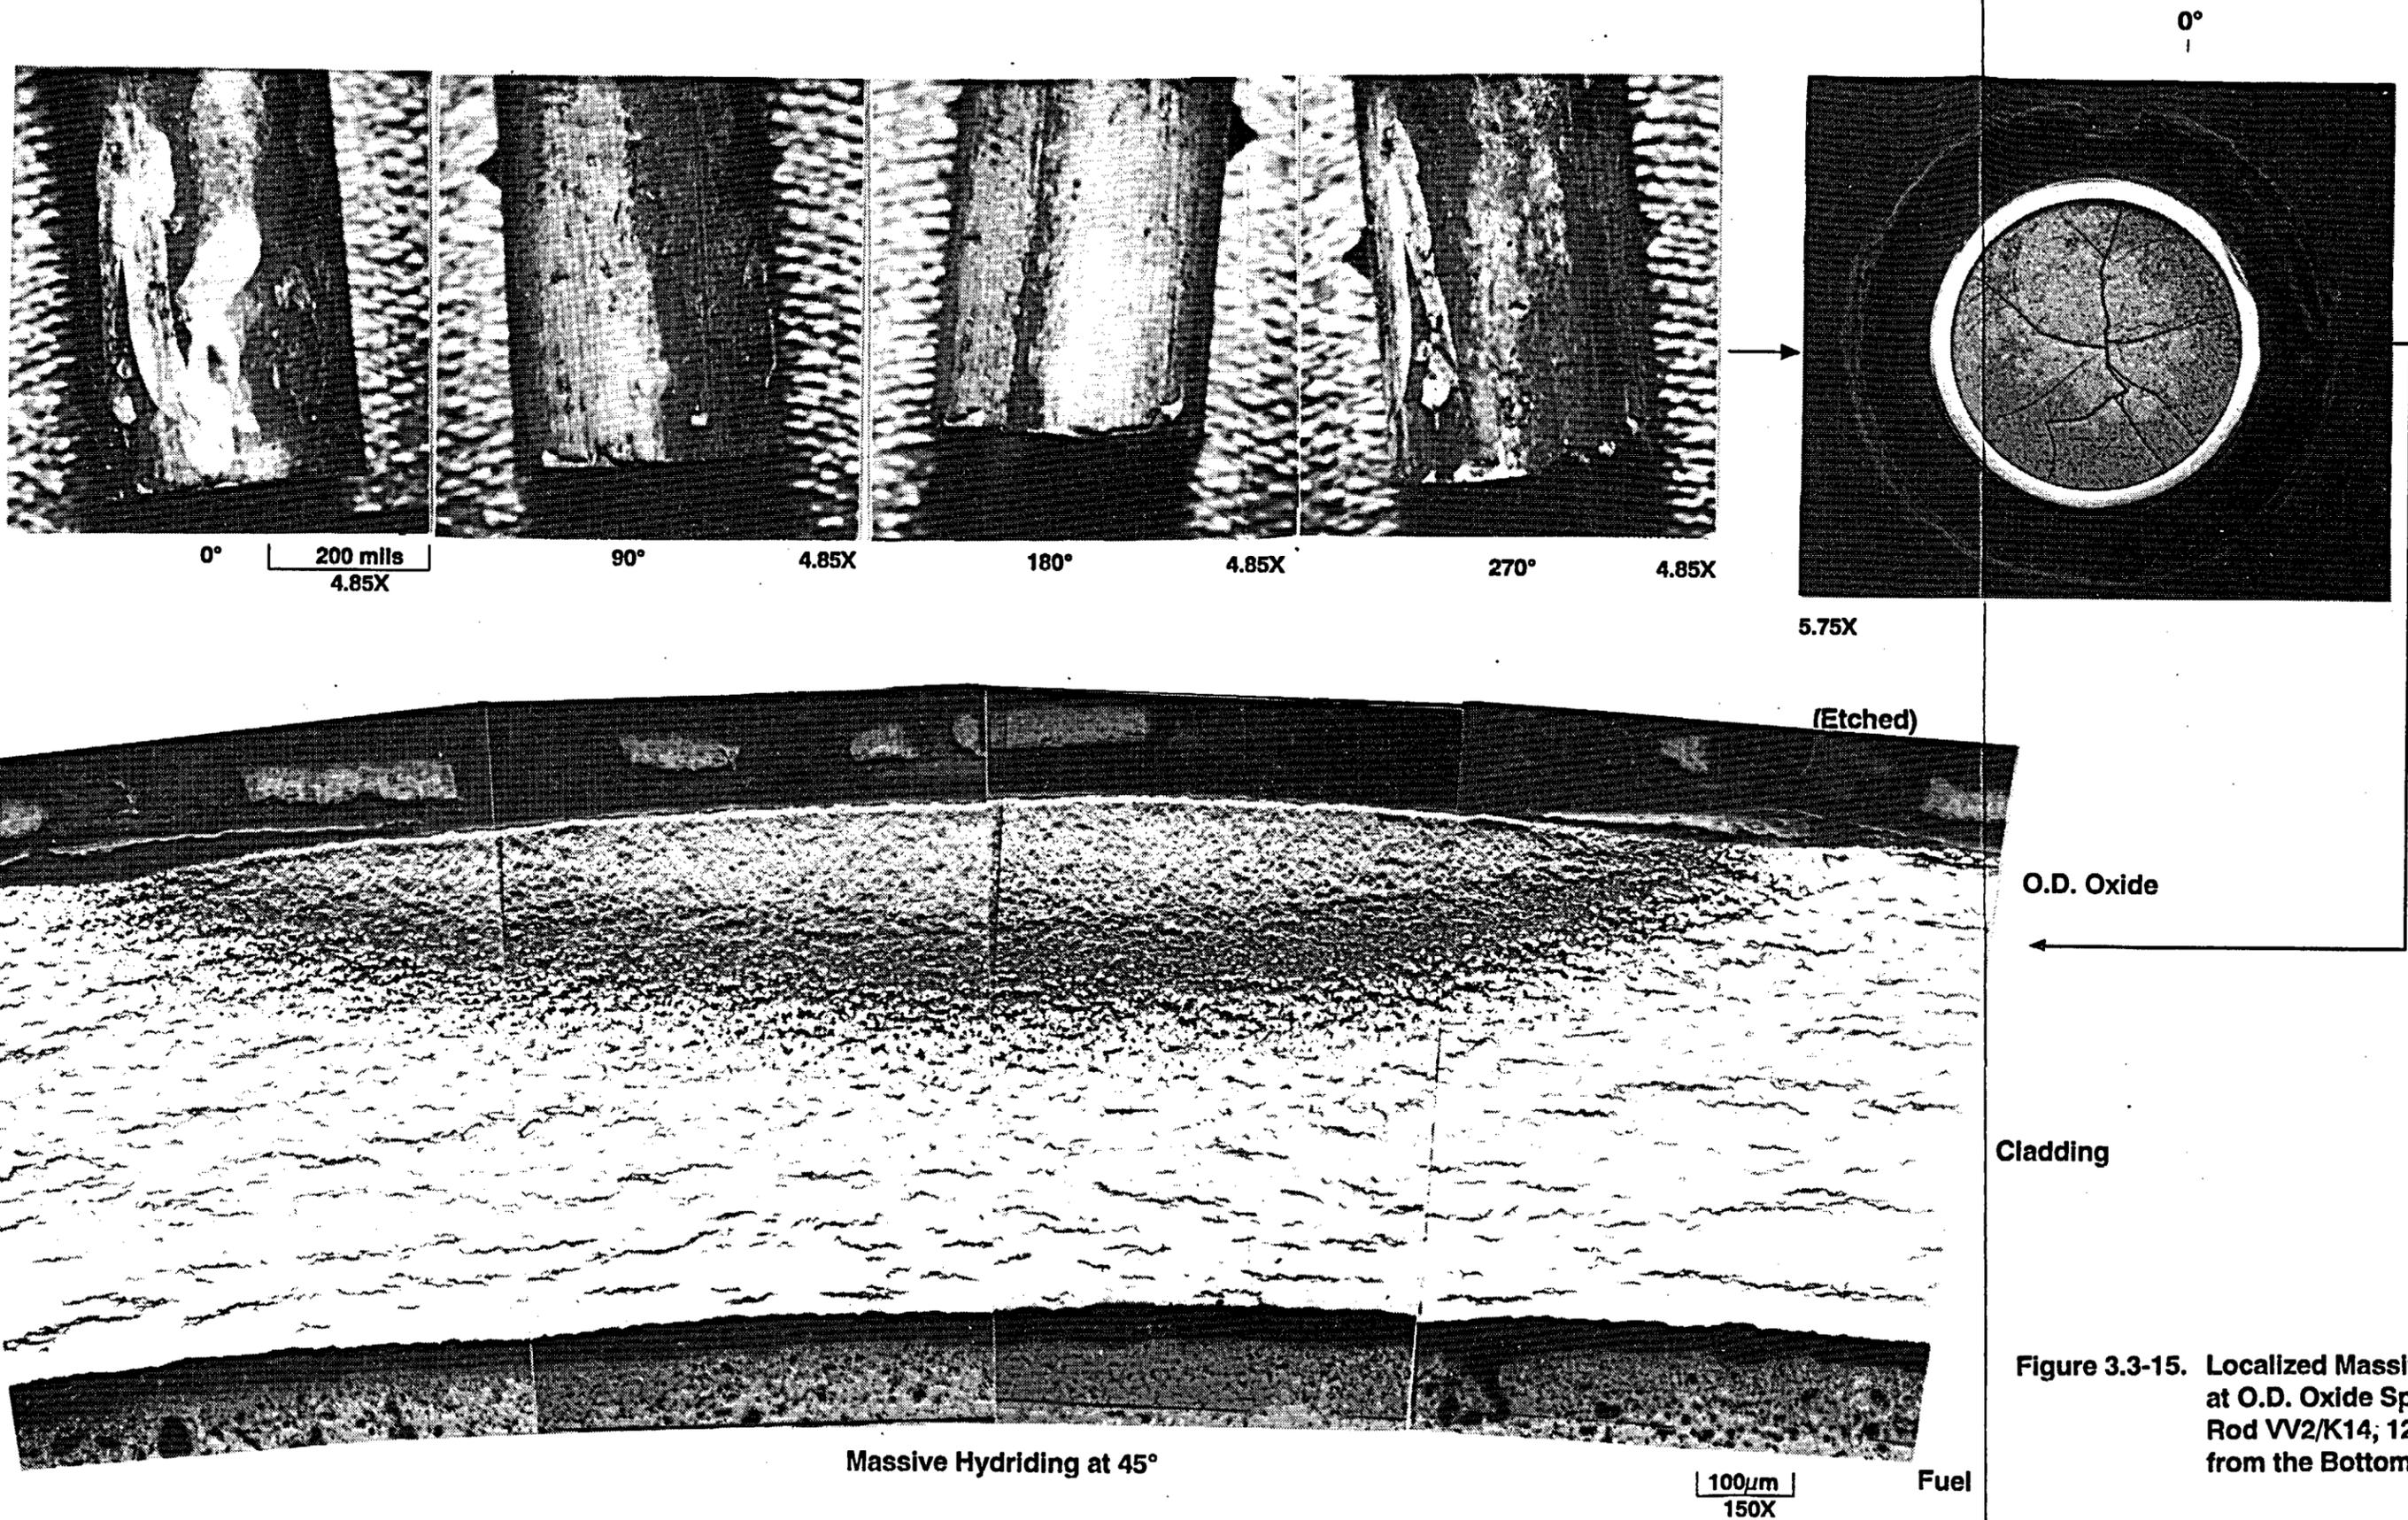
Figure 3.3-15. Localized Massive Hydriding at O.D. Oxide Spalled Area, Rod VV2/K14; 127 Inches from the Bottom
