W3F1-2003-0090

SUBJECT: Response to Request for Information Related to Review of Refuel 11
Steam Generator Tube Inservice Inspection Report SR-03-001-00
Waterford Steam Electric Station, Unit 3
Docket No. 50-382
License No. NPF-38

**List of SG 31 and SG 32
Flaws Found During RFO 11 Inspection**

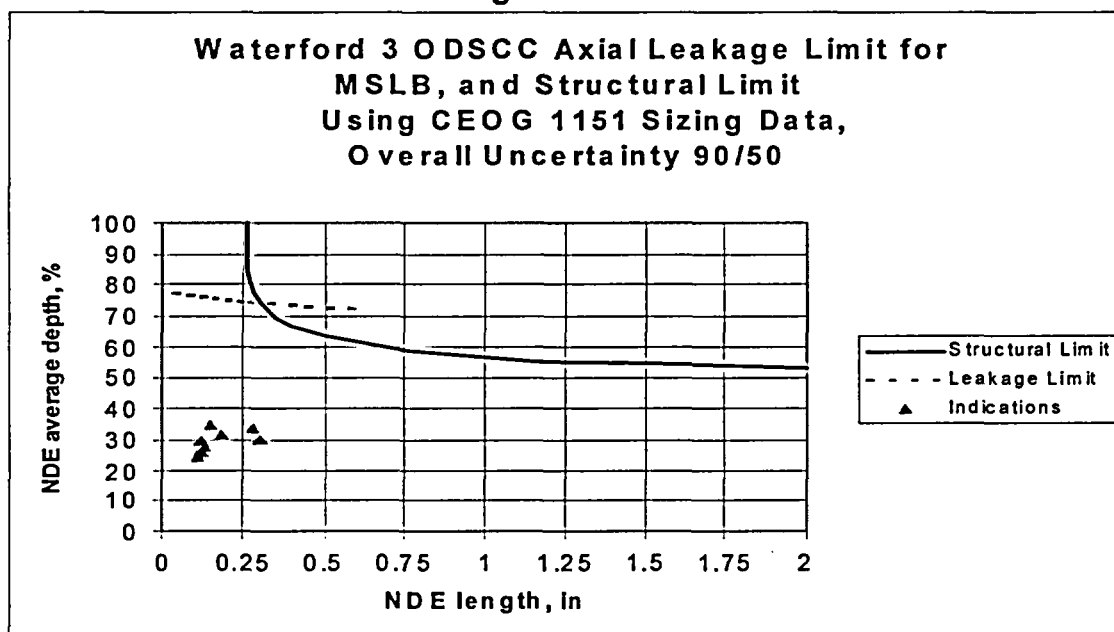
The sized indications are shown relative to the structural and leakage limits in Figure 5.1

Assessed Indications		OD Axials			
NDE length, inch	Ave. Depth, %	SG	Row	Col	Supt
0.13	27.9	31	63	17	TSH
0.3	30	31	46	58	04H+.5
0.28	33.8	31	64	66	03H+.7
0.18	31.9	31	90	154	TSH
0.12	26.2	31	4	162	TSH
0.12	29.4	31	4	164	TSH
0.15	34.9	31	9	169	TSH
0.11	24.8	31	7	171	TSH

All indications fall well below the structural and leakage limits which assure that the structural and leakage limits are satisfied with significant margin.

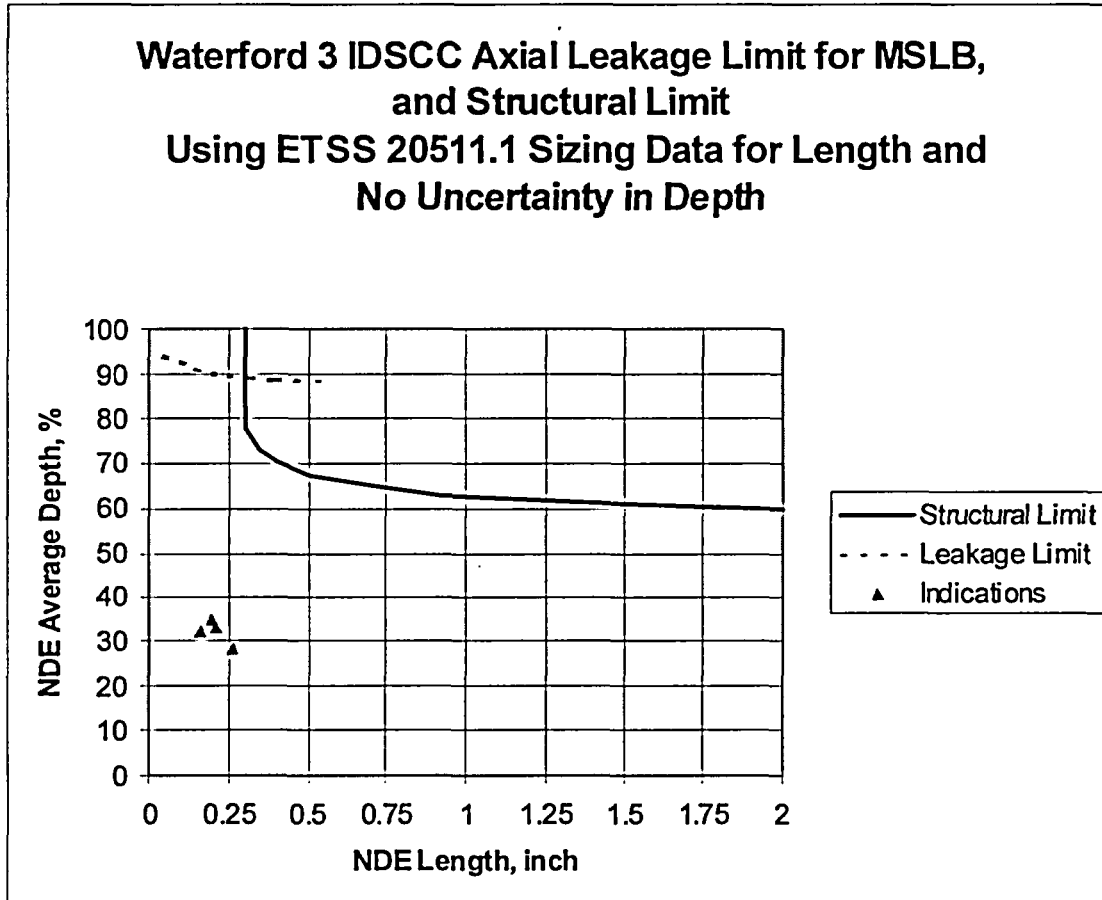
Figure 5.2

The sized indications are shown relative to the structural and leakage limits in Figure 5.2.

Assessed Indications		Axial				
ID	NDE length, inch	Ave. Depth, %	SG	Row	Col	Supt
	0.16	32.1	31	68	64	TSH-1.4
	0.26	28.1	31	66 <i>(typo, should be 68)</i>	88	TSH-1.3
	0.21	33	31	32	110	TSH-1.5
	0.2	34.7	32	70	102	TSH-1.3

All indications fall well below the structural and leakage limits which assure that the structural and leakage limits are satisfied with significant margin.

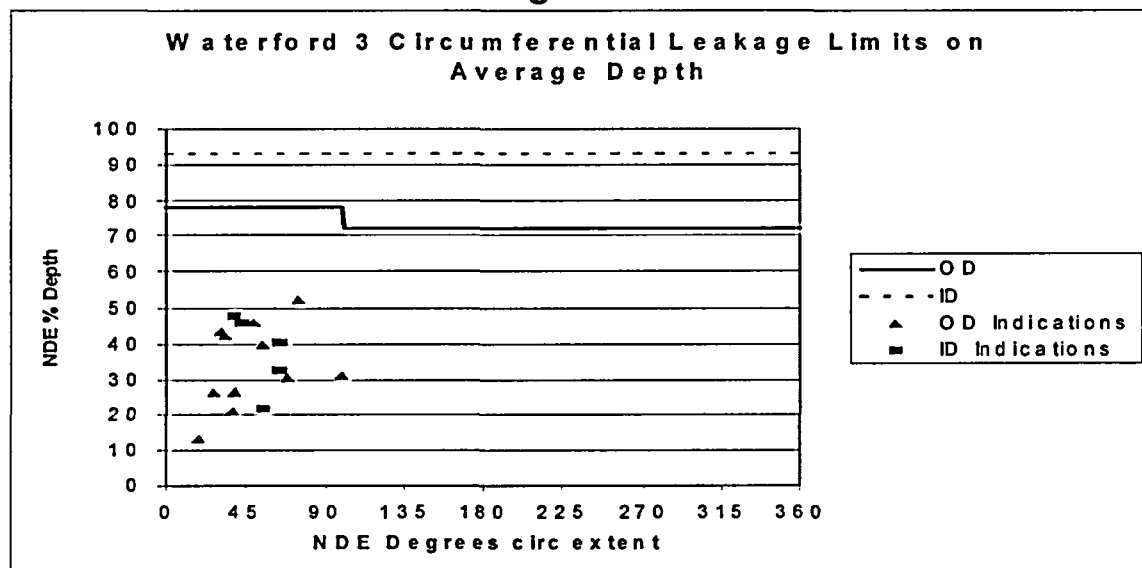
The tube integrity criteria on burst pressure is defined in terms of percent degraded area of the tube cross section. This limit is specified as a plus point measured PDA = 62% for OD circumferential indications and 77% for ID circumferential indications. The maximum PDA measured is less than 11%. The leakage criterion is defined in terms of average depth. The indications are compared to the leakage criteria in Figure 5.3

NDE length	Ave. Depth	PDA,%	SG	Row	Col	Supt
18.3	13.1	0.67%	31	34	24	TSH
31	43.3	3.73%	31	64	28	TSH
33.4	42.2	3.92%	31	71	29	TSH
37.1	21.2	2.18%	31	19	37	TSH
99	31.2	8.58%	31	1	47	TSH
74.4	52.1	10.77%	31	123	91	TSH
49.5	45.9	6.31%	31	27	135	TSH
27.1	26.1	1.96%	31	121	137	TSH
38.3	26.4	2.81%	31	86	158	TSH
54.8	39.7	6.04%	32	119	139	TSH
68	30.4	5.74%	32	82	160	TSH

NDE length	Ave. Depth	PDA,%	SG	Row	Col	Supt
54.1	21.8	3.28%	31	19	33	TSH-6.3
42.5	46	5.43%	31	34	52	TSH-0.1
63.8	32.6	5.78%	31	37	133	TSH-2.5
63.4	40.2	7.08%	31	68	64	TSH-6.9
38.8	47.7	5.14%	32	70	74	TSH

All indications fall well below the structural and leakage limits which assure that the structural and leakage limits are satisfied with significant margin.
