United States Nuclear Regulatory Commission
Document Control Desk
Washington, D. C. 20555-0001Subject: Response to Questions Regarding the 2002 Steam Generator Tube Inspections
(TAC No. MB9541)

RESPONSE TO QUESTIONS ON LICENSEE'S RESPONSES
TO REQUEST FOR ADDITIONAL INFORMATION
DAVIS-BESSE NUCLEAR POWER STATION
2002 STEAM GENERATOR INSPECTION (TAC No. MB9541)

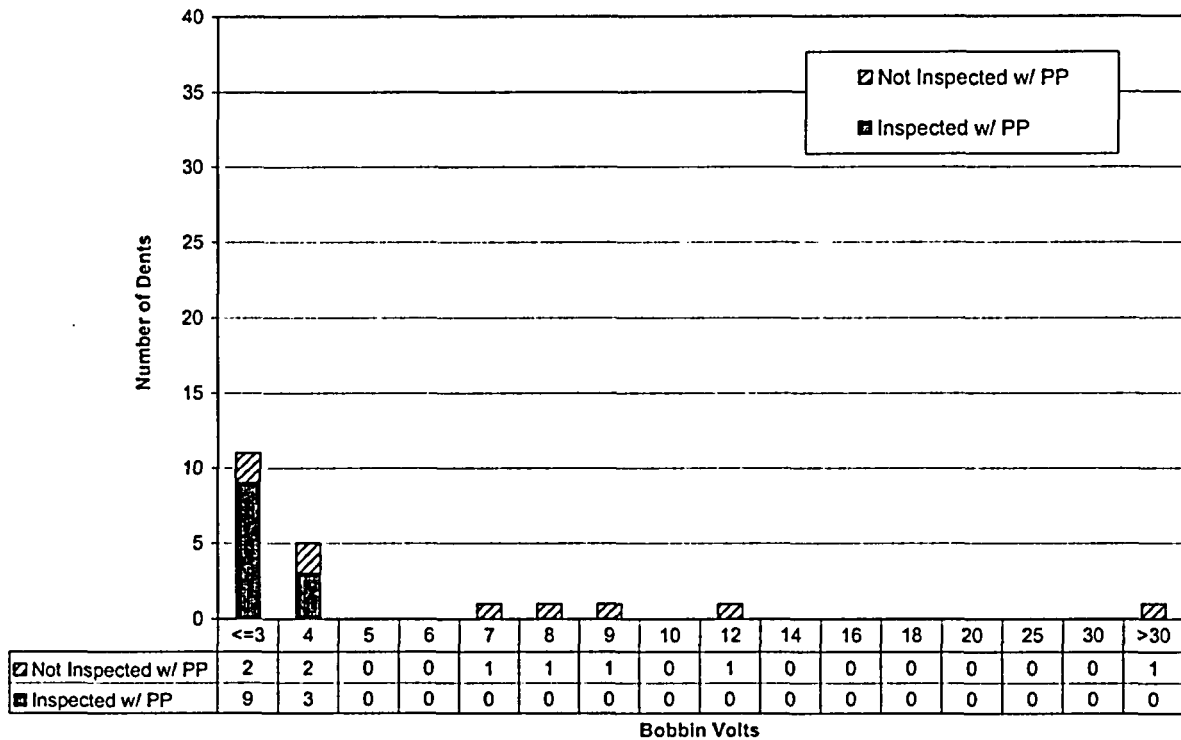
Voltage Distribution for Dents Between LTS and 14S
 DBNPS SG 2-A 02/02 13RFO

no expansion of the dent inspection scope was performed at 13RFO and the tube integrity analyses did not include any adjustments for the uninspected dent population. As demonstrated by the Figures, the inspected population provided a sufficient interrogation of dents such that if degradation existed in this region, the sample would have been sufficient to provide a high probability of detecting active degradation in the sample. At the next scheduled inspection of the OTSGs, the DBNPS is planning on inspecting 100% of all dents in all areas of the OTSGs, as well as preventive plugging of significant dents in the region at or above the 14th TSP in the periphery (damaged from auxiliary feedwater (AFW) header issues), where existing conditions (temperature, flow, loads) could accelerate tube degradation at the dented area.
