United States Nuclear Regulatory Commission
Document Control Desk
Washington, D. C. 20555-0001Subject: Response to Questions Regarding the 2002 Steam Generator Tube Inspections
(TAC No. MB9541)

RESPONSE TO QUESTIONS ON LICENSEE'S RESPONSES
TO REQUEST FOR ADDITIONAL INFORMATION
DAVIS-BESSE NUCLEAR POWER STATION
2002 STEAM GENERATOR INSPECTION (TAC No. MB9541)

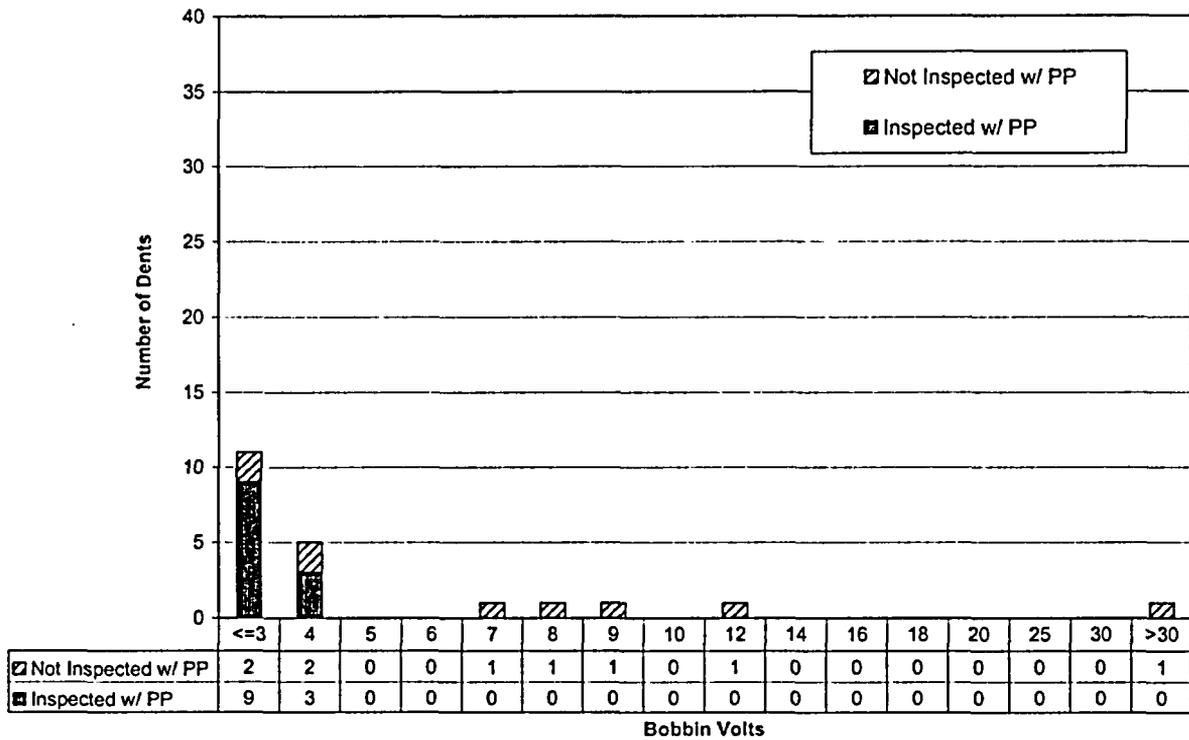
Voltage Distribution for Dents Between LTS and 14S
 DBNPS SG 2-A 02/02 13RFO

As previously stated, 100% of the dents located at or above the 14th TSP were inspected during 13RFO, and for dents below the 14th TSP, the DBNPS completed a 100% sample in three cycles with no indications of degradation present in any of the inspections. As requested, the figures provided below indicate the inspected versus uninspected population of dents in the region below the 14th TSP (not including dents at or in the LTS region) during the 13RFO inspection. Note that the 30 volt dent in A-61-109 was inspected in 12RFO with a +Point probe and no degradation was detected (dent present in history). Sampling in both OTSGs at the LTS sludge and dented region is accomplished under a separate inspection program.

no expansion of the dent inspection scope was performed at 13RFO and the tube integrity analyses did not include any adjustments for the uninspected dent population. As demonstrated by the Figures, the inspected population provided a sufficient interrogation of dents such that if degradation existed in this region, the sample would have been sufficient to provide a high probability of detecting active degradation in the sample. At the next scheduled inspection of the OTSGs, the DBNPS is planning on inspecting 100% of all dents in all areas of the OTSGs, as well as preventive plugging of significant dents in the region at or above the 14th TSP in the periphery (damaged from auxiliary feedwater (AFW) header issues), where existing conditions (temperature, flow, loads) could accelerate tube degradation at the dented area.
