December 23, 2003
RC-03-0254

Subject: VIRGIL C. SUMMER NUCLEAR STATION (VCSNS)
DOCKET NO. 50/395
OPERATING LICENSE NO. NPF-12
RESPONSE TO NRC BULLETIN 2002-02
REACTOR PRESSURE VESSEL HEAD AND VESSEL HEAD
PENETRATION NOZZLE INSPECTION PROGRAMS

**30-Day After Re-start from Refueling Outage 14
Response to NRC regarding February 11, 2003 Order
and
NRC SER issued from VCSNS Refueling Outage 13
(Bulletin 2002-02 "Reactor Pressure Vessel Head and Vessel Head
Penetration Nozzle Inspection Programs")
for
V. C. Summer Nuclear Station**

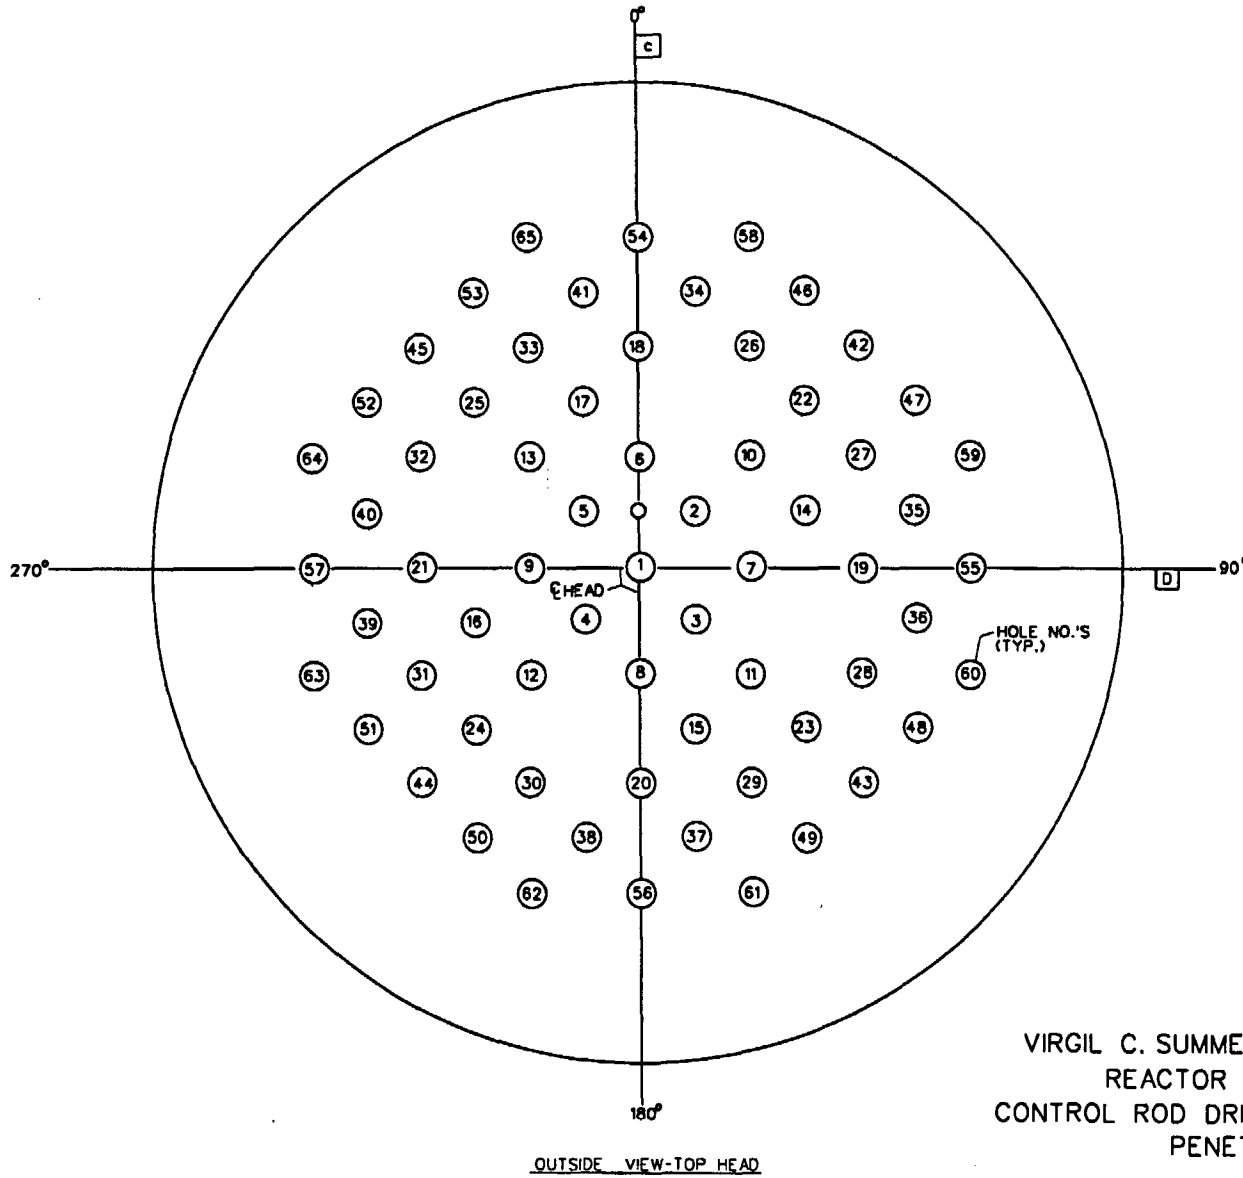
Conoseal penetrations are identified by housings 47, 49, 51, 59 and 55 on Attachment III. Leakage has been noted in the past, but not specifically on the conoseal for housing 47. However, the leakage from other conoseals could have run across the top of the insulation and entered through the insulation at a different location.
