CNWRA 2003-04

ANALYSIS OF RAIL CAR COMPONENTS EXPOSED TO A TUNNEL FIRE ENVIRONMENT

**U.S. Nuclear Regulatory Commission
Contract NRC-02-02-012**

November 2002

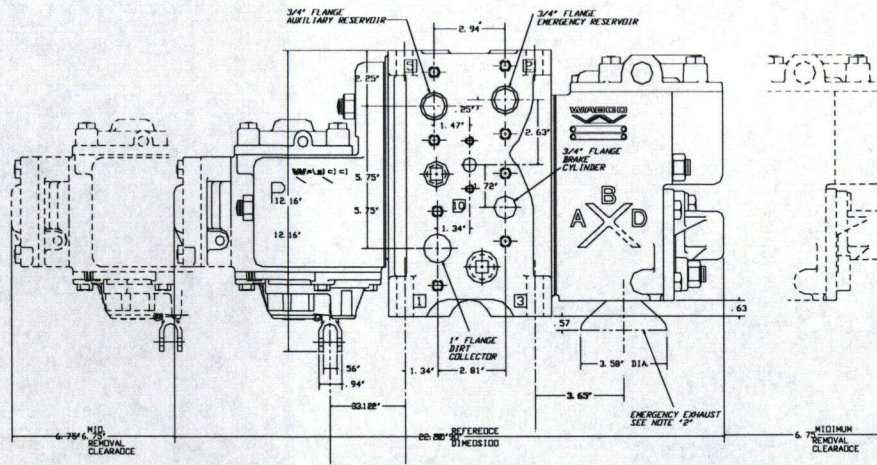
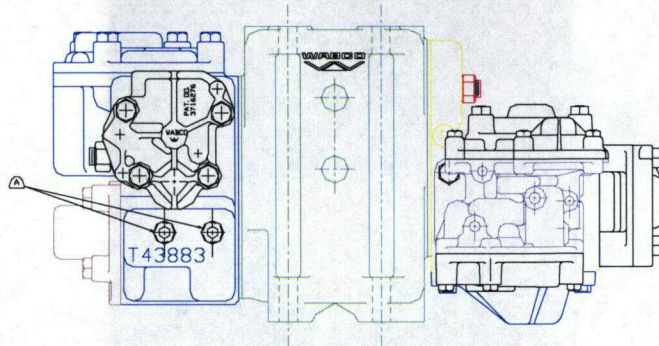
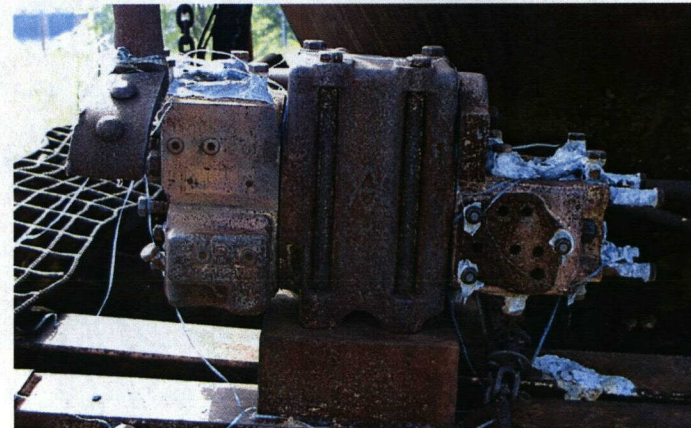
Remainder of ABDX-L Air Brake Valve from Car 52—This air brake valve exhibited evidence of prolonged fire exposure. The valve includes several die-cast aluminum covers, which had completely melted as a result of the fire. The valve was found approximately 10 m [33 ft] uphill from the spill site, and approximately 1 m [3.3 ft] from the tunnel floor. A similar valve assembly was found at the midpoint of Car 51, approximately 20 m [66 ft] uphill from the fire source. Although the exact model type was not determined, the valve cover was clearly from the same family of products and was composed of the same aluminum alloy.

Figure 3-1. The ABDX-L Control Valve (Clockwise from Top: Valve Body Schematic, Photograph of Damaged Valve on Car 52, Corresponding Outline of the Valve Body)

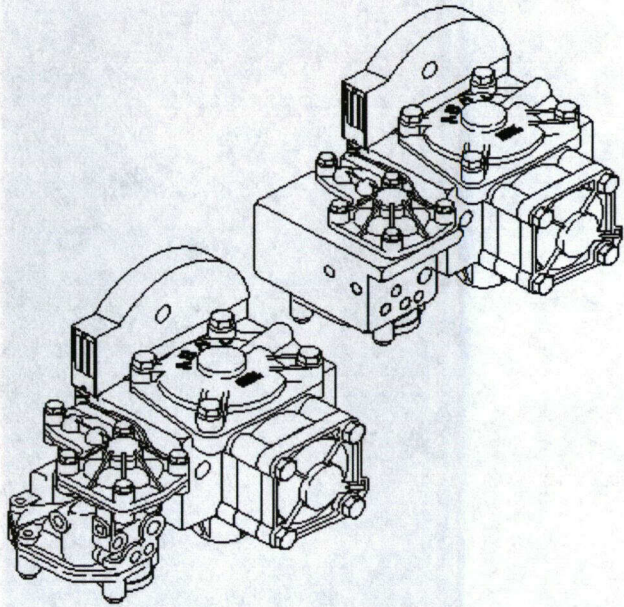
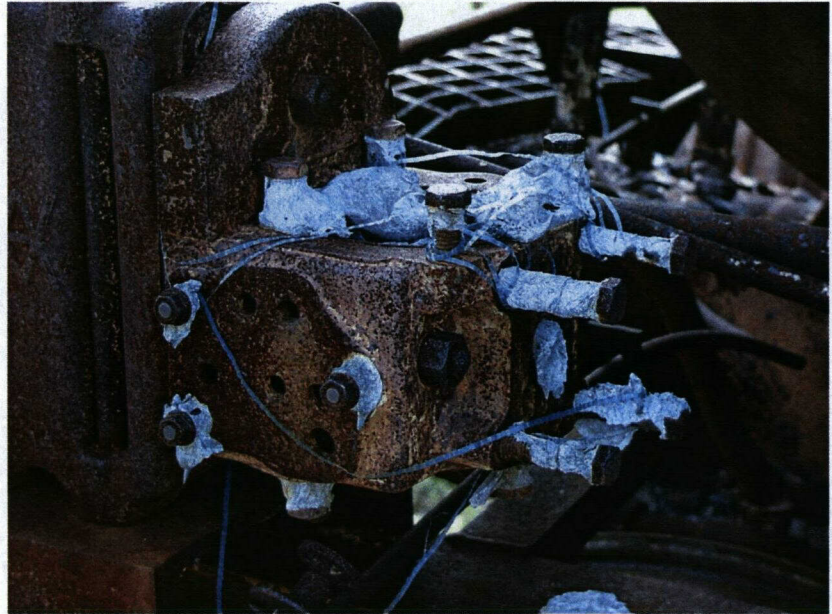
Figure 3-2. ABDX-L Service Portion Outline and Photograph

The standard ABDX-L-style valve consists of a normal service valve and an emergency valve. For this analysis, the damage observed on the service portion of the valve was analyzed (see Figure 3-2).

The primary area of interest in the analysis was the aluminum alloy cover over the release valve in the service portion of the valve assembly shown in Figure 3-2. The location of the cover is marked by the four bolts remaining on one side of the valve, and the associated aluminum residue.

Complete Melting—The aluminum section reached its liquidus temperature. This is a good assumption considering the condition of the covers in Figure 3-2.

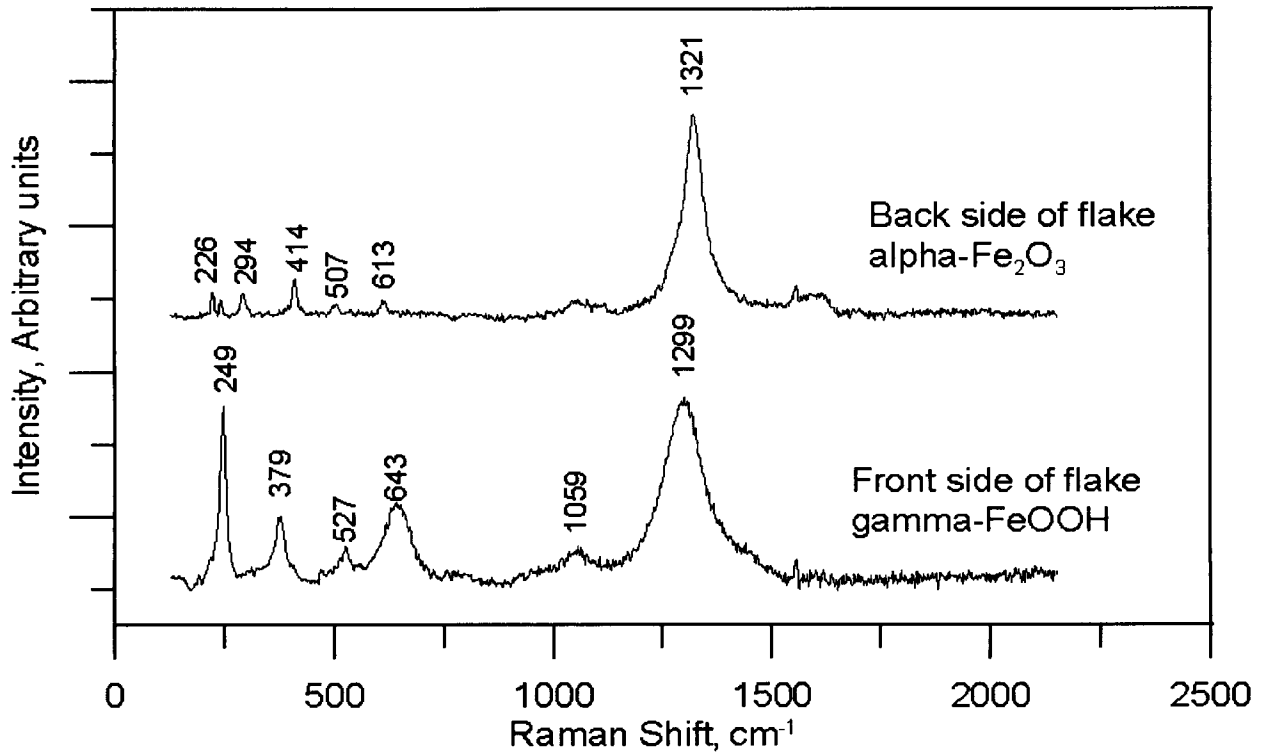
Both Raman spectroscopy (Figure 4-4) and x-ray diffraction (Figures 4-5 and 4-6) of the scale obtained from Car 51 indicate the presence of lepidocrocite ($\gamma\text{-FeOOH}$), hematite ($\alpha\text{-Fe}_2\text{O}_3$) and possibly magnetite (Fe_3O_4). It should be noted that magnetite can easily be oxidized in air to hematite. The presence of $\gamma\text{-FeOOH}$, which covered large sections of the scales, indicates that the specimens were exposed to either a humid environment or water. Formation of $\gamma\text{-FeOOH}$ may have occurred as a result of water contact after rupture of the water main, fire fighting efforts, or subsequent storage of the train cars involved in the derailment.

Figure 4-4. Raman Spectra for Scales Recovered from Car 51

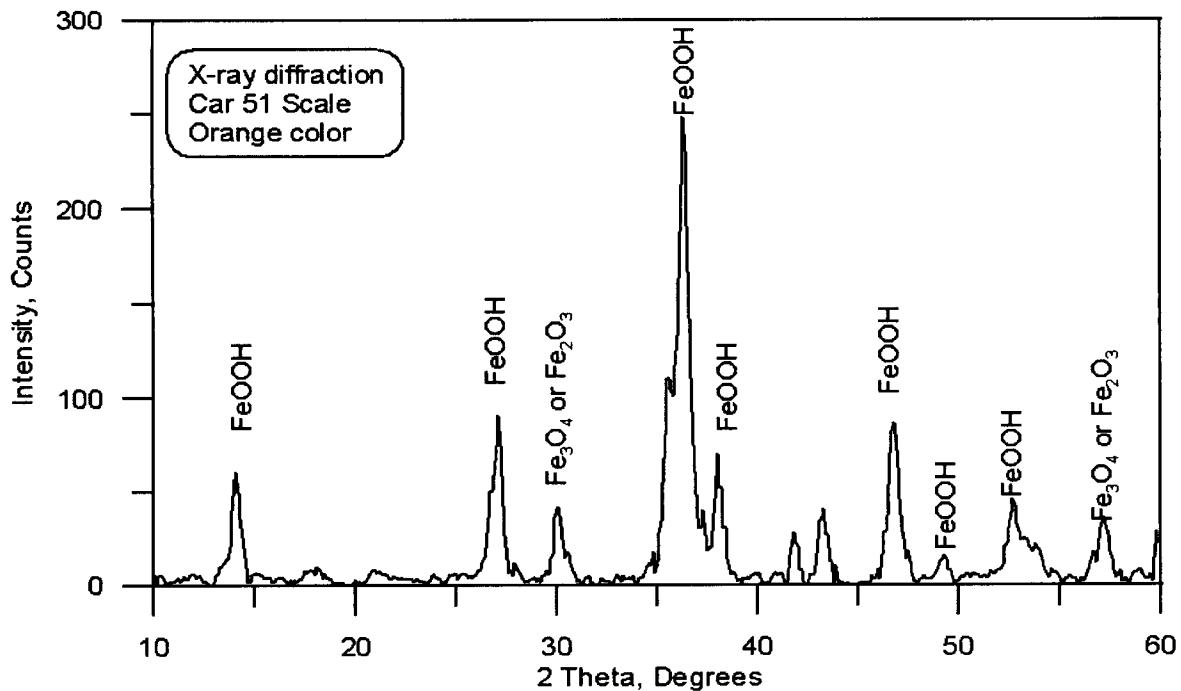
Figure 4-5. X-Ray Diffraction of Orange Colored Oxide Scales from Car 51

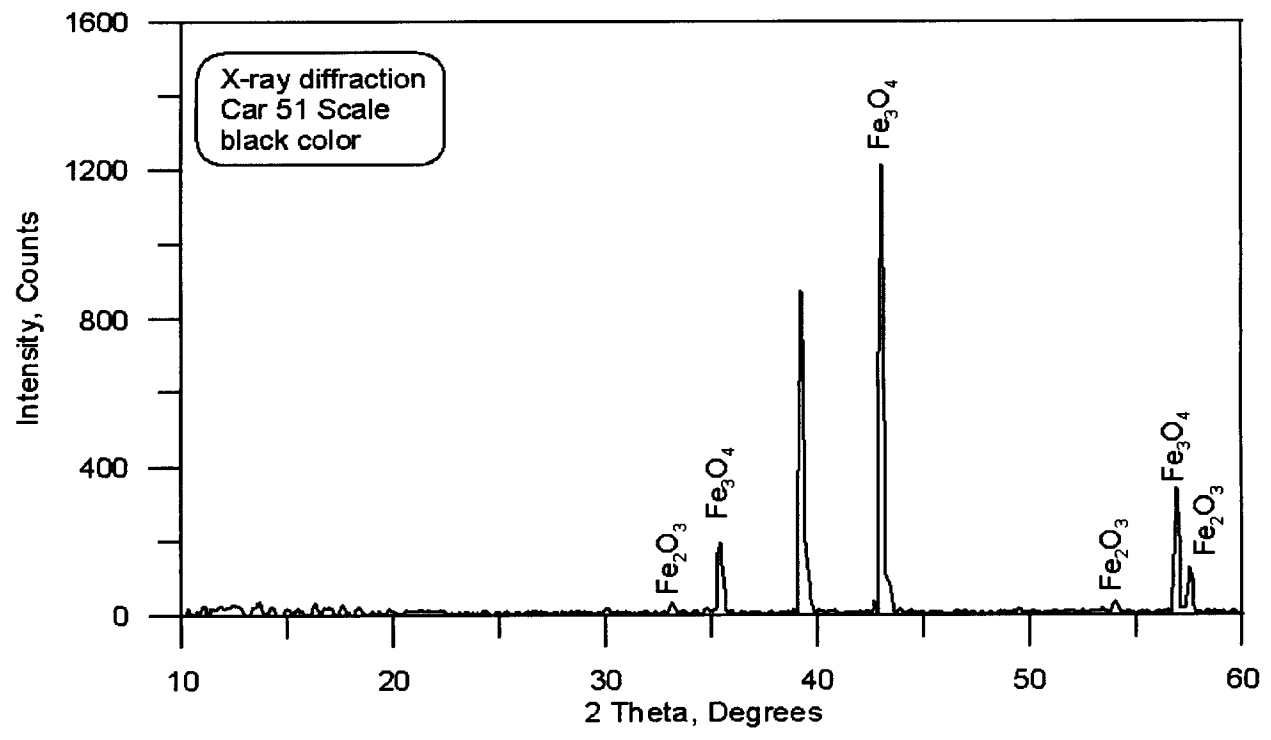
Figure 4-6. X-Ray Diffraction of Black Colored Oxide Scales from Car 51

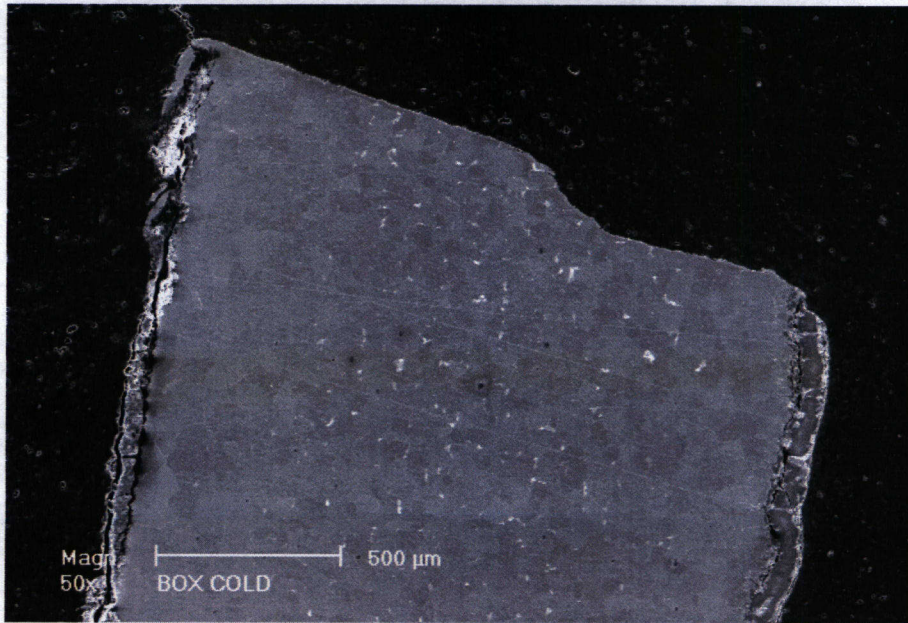
Specimens from the roof section of Car 50 were analyzed for oxide scale thickness as well as the thickness of the remaining steel section. The first specimen was cut from the opposite end of the roof panel section that may not have been directly exposed to the fire (Figure 4-7). The second specimen was cut from the edge of the roof panel section that was directly exposed to flames from the paper inside the box car (Figures 4-8 and 4-9). From the cross section of the roof shown in Figure 4-7, the remaining metal thickness was determined to be 1,761 μm [0.069 in]. Near the edge of the roof, the metal thickness varies from 829 μm [0.033 in] at the edge (Figure 4-9), to 1,464 μm [0.058 in] at a distance approximately 3 cm [1.2 in] from the exposed edge (Figure 4-8). Although it is apparent that the metal thickness of the roof section shown in Figure 4-7 has been reduced by oxidation, the metal thickness of this section was used as a basis to determine metal loss. Assuming that metal loss occurred at equal rates on both sides of the specimen shown in Figures 4-8 and 4-9, the metal loss from each side varied from 148 to 466 μm [0.006 to 0.018 in]. Based on the calculated reduction in metal thickness as a function of time and temperature shown in Figure 4-2, temperatures in the range of 927 to 1,077 $^{\circ}\text{C}$ [1,700 to 1,970 $^{\circ}\text{F}$] for approximately 10 hours would be required to have the reduced metal thickness assuming spalling of the oxide does appreciably increase the oxidation rate.

Figure 4-7. Cross section of Car 50 Roof Approximately 40 cm [16 in] from the Opposite End of the Roof Panel Section that May Not Have Been Exposed to the Fire. Thickness of the Metal was Approximately 1,761 μm [0.069 in].

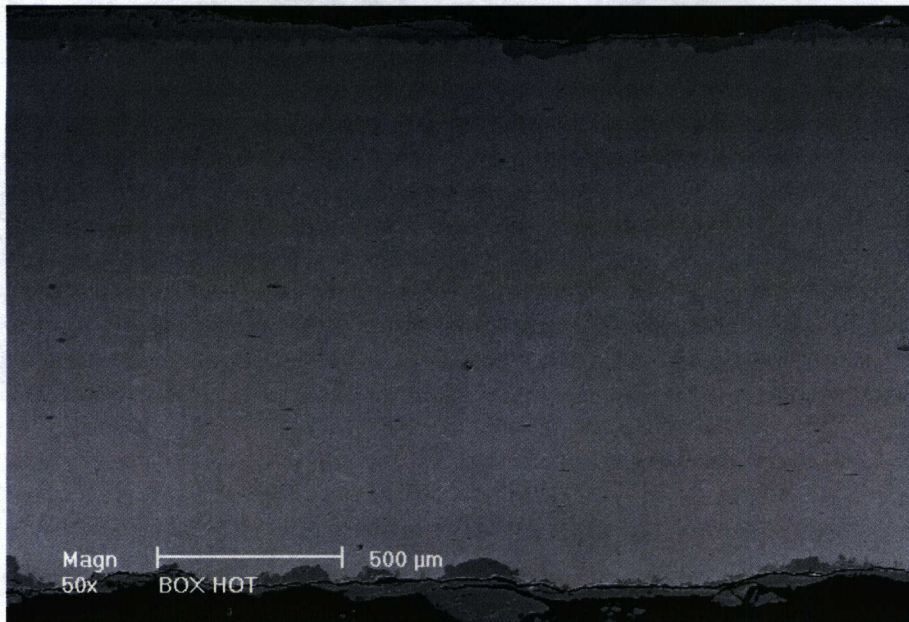
Figure 4-8. Cross Section of Car 50 Roof Approximately 3 cm [1.2 in] from the Edge Directly Exposed to the Fire. Thickness of the Metal was Approximately 1,464 μm [0.057 in].

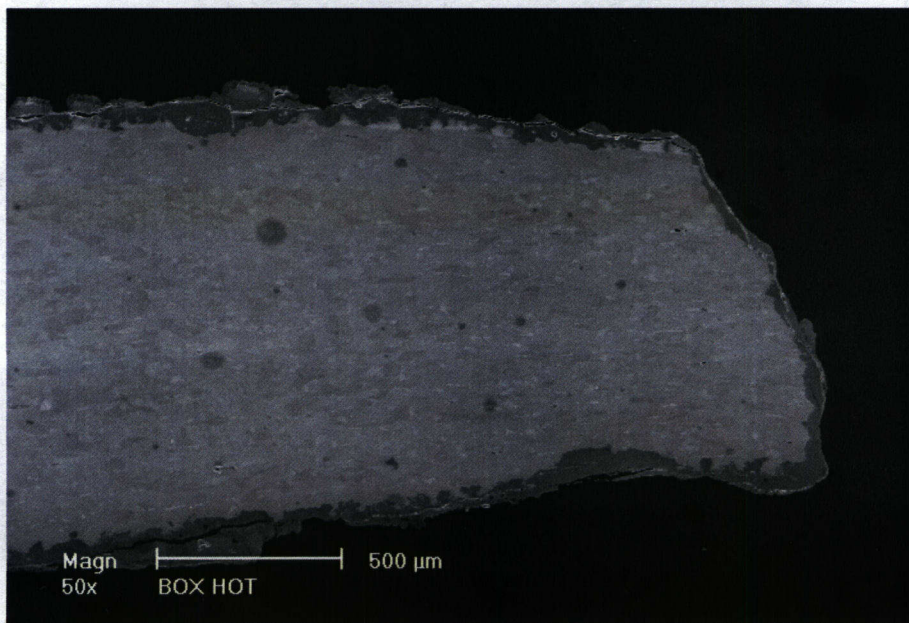
Figure 4-9. Cross Section of Car 50 Roof at Edge Directly Exposed to the Fire. Thickness of the Metal Ranged from 829 to 930 μm [0.033 to 0.037 in].

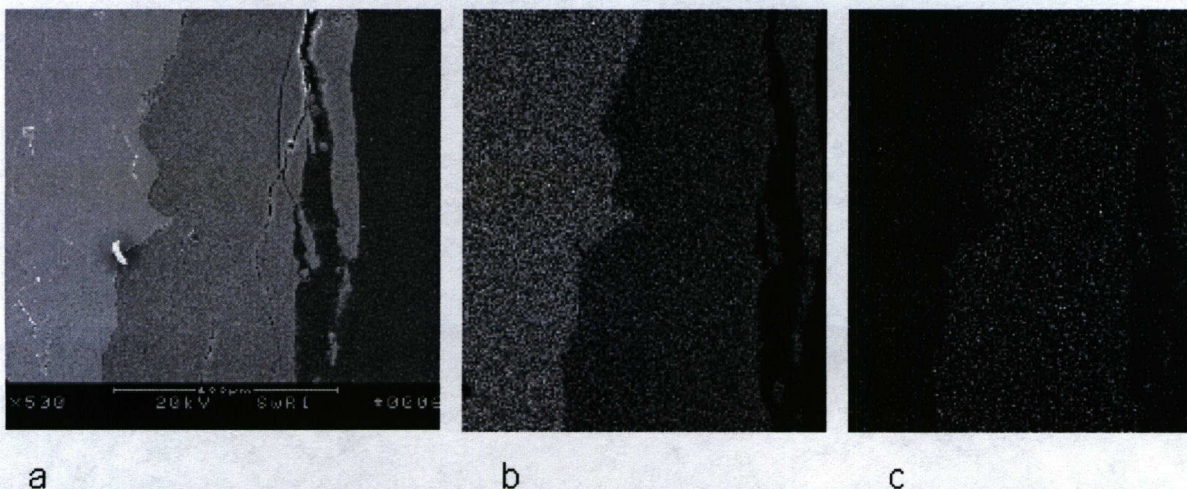
Figure 4-10(a) shows a closeup of the metal oxide scale of the Car 50 roof section near the edge exposed to the fire. Cracks and spalling of the oxide are apparent from the cross section. Figure 4-10(b) shows the scanning electron microscope-energy dispersive spectrometer element map for iron, and Figure 4-10(c) shows the element map for oxygen which confirms the scale is an iron oxide. Based on the analyses of the cross-sectioned specimen, the oxide scale on the roof section exposed to the fire ranged from 50 to 81 μm [0.0019 to 0.0032 in] in thickness. According to the calculations shown in Figure 4-3 temperatures in the range of 700 to 750 $^{\circ}\text{C}$ [1,292 to 1,382 $^{\circ}\text{F}$] for a period of upward of 10 hours would produce oxide scales similar to the thicknesses observed on the Car 50 roof section.

Figure 4-10. (a) Secondary Electron Image from Car 50 Roof at Edge Directly Exposed to the Fire, (b) Iron Image Map, (c) Oxygen Image Map

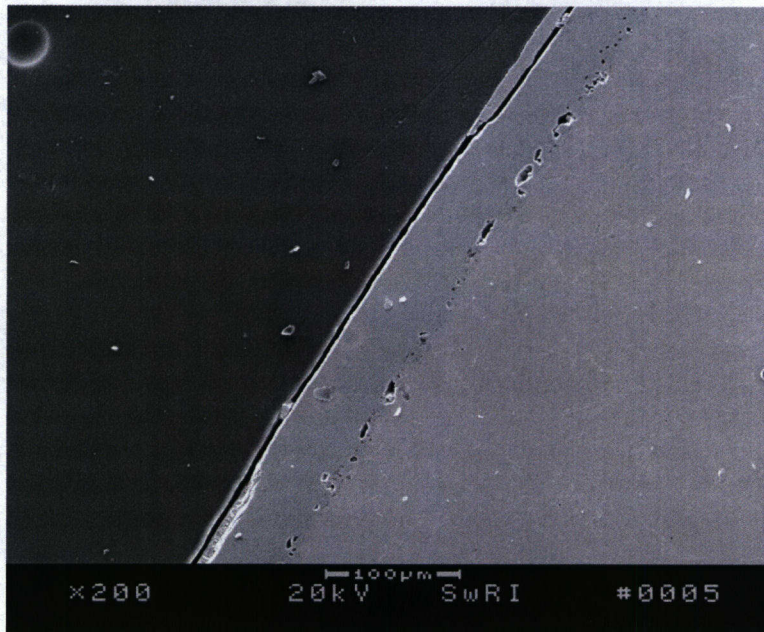
The cross section of the air brake bolt is shown in Figure 4-11. The oxide scale on the bolt shank was determined to be 53 μm [0.0021 in]. Little spalling or cracking of the oxide layer was observed suggesting the temperature was less than that achieved by the roof panel of Car 50. Based on the predicted metal oxide thickness shown in Figure 4-3, a 53 μm [0.0021 in] oxide scale could be expected in less than 8 hours at 727 $^{\circ}\text{C}$ [1,340 $^{\circ}\text{F}$]. At 677 $^{\circ}\text{C}$ [1,250 $^{\circ}\text{F}$], the oxide scale thickness would be approximately 45 μm [0.0017 in] after 16 hours.

Figure 4-11. Scanning Electron Microscope Secondary Electron Image of Car 52 Air Brake Valve Bolt Showing Metal and Oxide Layer

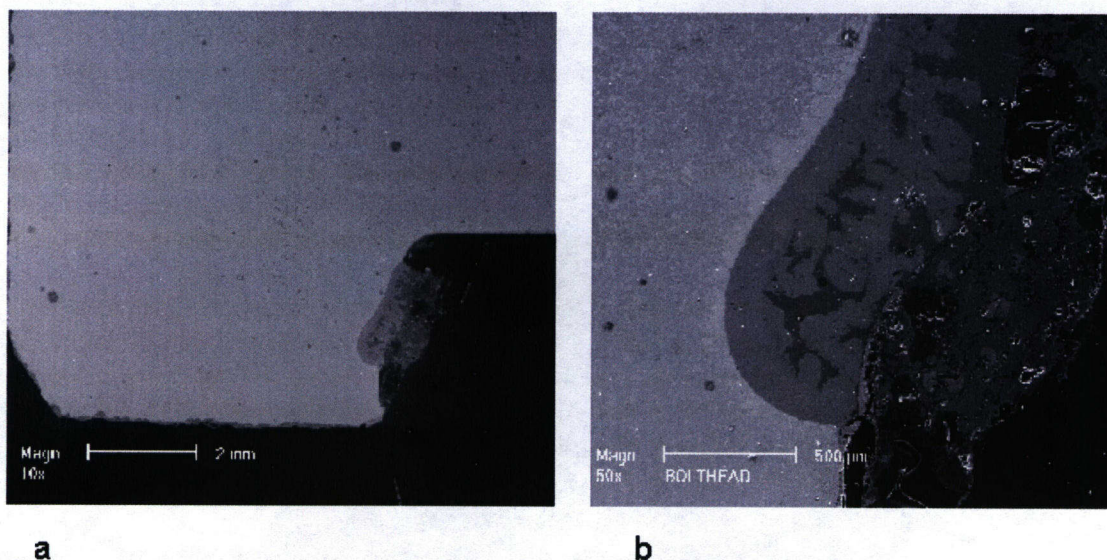
Figure 4-12(a) shows a cross section of one of the air brake assembly bolts. During the analysis of the specimen, several regions were found where an aluminum–iron phase had formed. A higher magnification of such a region is shown in Figure 4-12(b). Using an energy dispersive spectrometer, the composition of the bolt was determined to be 98.4 atomic percent iron with no measurable concentration of aluminum. In the mixed aluminum–iron region, the composition was found to be 66 atomic percent aluminum, 4 atomic percent silicon, and 30 atomic percent iron. The liquidus temperature for a 66 atomic percent Aluminum and 34 atomic percent iron binary is 1,180 °C [2,156 °F] and the solidus temperature is 1,165 °C [2,129 °F] (ASM International, 1992). The aluminum–iron binary phase diagram does not contain low melting point eutectic compositions. The addition of 4 atomic percent silicon is not expected to significantly alter the solidus or liquidus temperatures based on examination of the iron–silicon and aluminum–silicon binary systems.

Figure 4-12. (a) Scanning Electron Microscope Secondary Electron Image of Car 52 Air Brake Valve Bolt Head Showing Iron and Aluminum and (b) Closeup of Iron with Aluminum

The aluminum–iron phase identified on the air brake valve bolt may have been formed as a result of diffusion of aluminum into the iron at elevated temperatures. Eq (4-2) describes simple diffusion

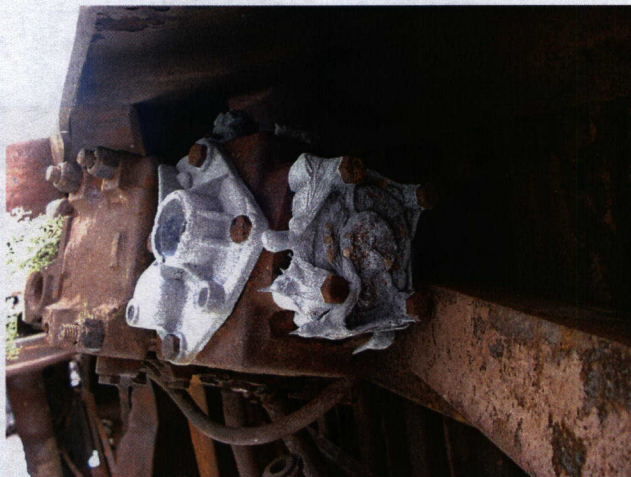
A second aluminum witness was found approximately 20 m [66 ft] uphill of the fire source. This piece is shown in Figure 6-1.

It is interesting to note that this piece did not melt completely, which would indicate the very specific conditions required to melt the valve assembly on Car 52 were likely not encountered at approximately 20 m [66 ft] away.

Figure 6-1. Air Brake Valve Found 20+ m [66 ft] from Fuel Spill Site (Note Only Partial Melting at This Location)

Closer analysis of the damage caused to the valve cover found at Car 52, indicates that a separation distance of approximately 20 m [66 ft] was sufficient to limit the exposure conditions in this area, as evidenced by the level of damage to the valve cover. Considering only partial melting in this area, temperatures at the surface of the aluminum were only slightly above 600 °C [1,112 °F] (enough to initiate melting) but were not maintained for any appreciable duration.
