Subject: Confirmatory Action Letter Response – Revision 1 to Root Cause Analysis  
Report Regarding Reactor Pressure Vessel Head Degradation

# Root Cause Analysis Report

Significant Degradation of the Reactor  
Pressure Vessel Head

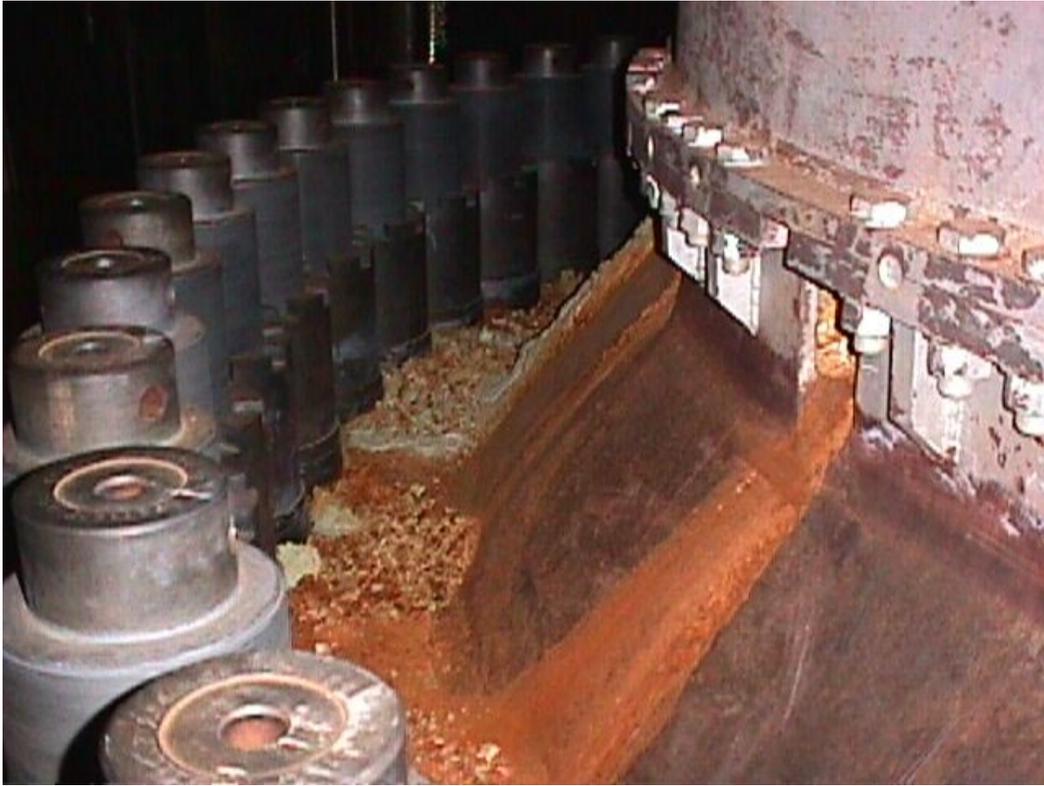
Figure 4. Boric Acid and Iron Oxide on Vessel Flange at 12RFO

The following is a summary of the non-destructive examination effort on the cracked nozzles and degraded RPV head. After removal of insulation from the RPV flange early in 13RFO, boric acid crystal deposits and iron oxide were found to have flowed out from several of the openings (mouse holes) in the lower service structure support skirt (Figure 20). Figure 4 shows deposits on the flange during the inspection in the twelfth refueling outage (12RFO).

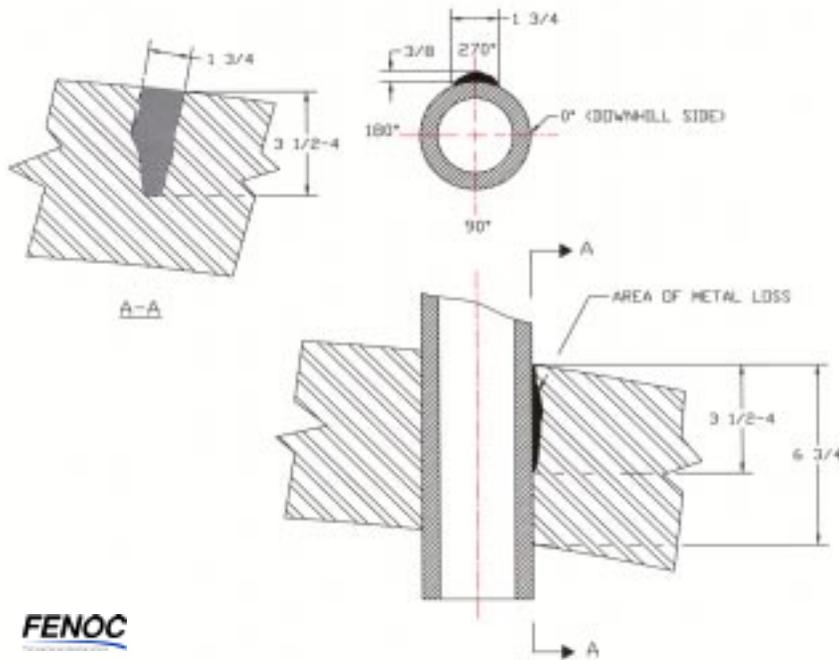
Figure 5 Nozzle 2 Corrosion Area Location, Size, and Profile.

Degradation was observed at nozzle 2 following the initiation of repair efforts. Figure 5 shows the observed area of corrosion. The overall corroded area, based on the video examination and approximate measurements from the impression, is 3-1/2 to 4 inches in length starting from the top of the RPV head, about 3/8 inch deep (at the deepest location approximately 1-3/4 inches from the top of the RPV head), and between 1-1/4 to 2 inches at it's widest location. The depth of corrosion decreased as the annulus opening was approached. This type of corrosion profile is similar to testing that has been performed by EPRI (reference 8.5.3) regarding location of the deepest corrosion and the fact that it could have been identified on the top of the RPV head.

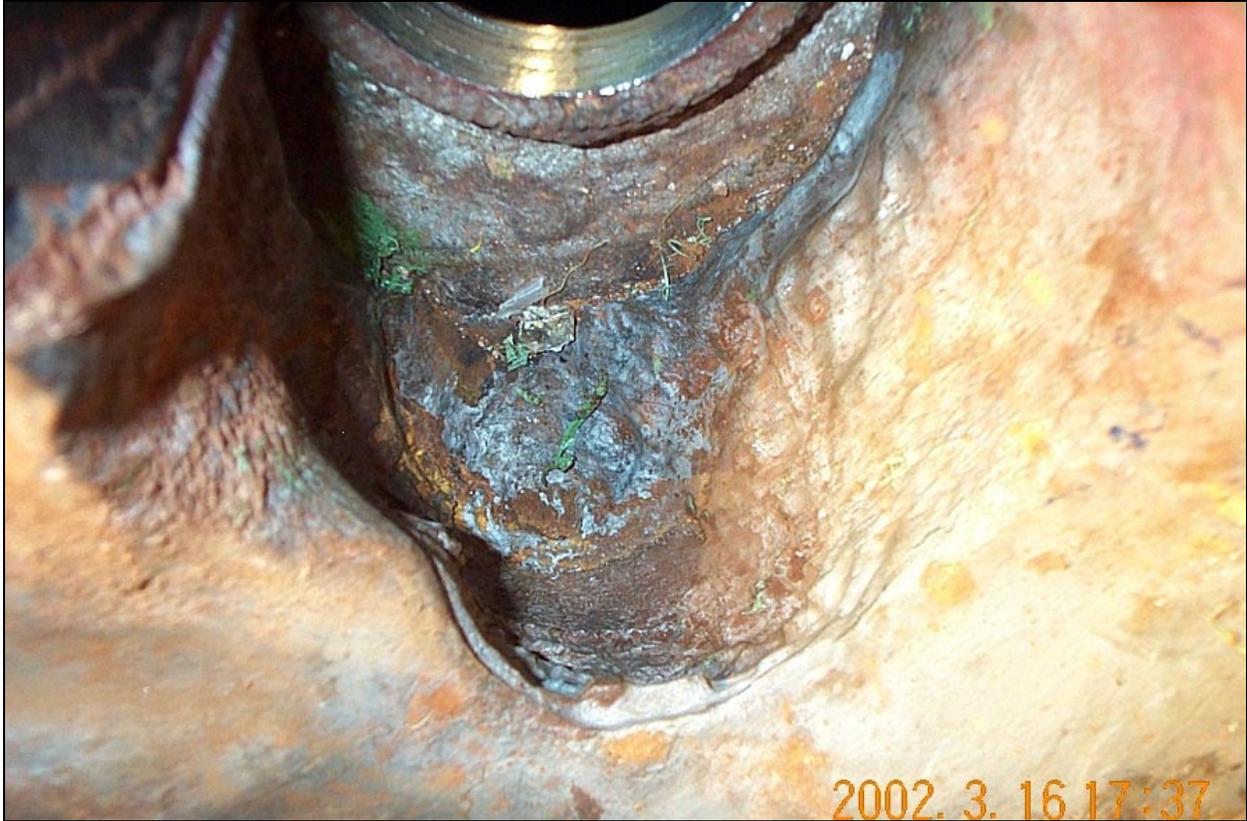
Figure 6. Cavity in Reactor Vessel Head Between Nozzle 3 and 11

After removing the lower part of nozzle 3, a cavity was discovered in the low-alloy steel RPV head material above the J-groove weld on the downhill side. Additionally, after removing the lower part of nozzle 2, a smaller area of corrosion of the low-alloy steel RPV head material was discovered between the bottom of the machined nozzle and the top of the J-groove weld (Figure 5). This area of corrosion was found to extend under the portion of the nozzle left in place after machining.

After pulling nozzle 3 and cleaning by hydrolasing, the top of the RPV head was inspected using a video camera on a long pole through the vacated nozzle 3 penetration. This inspection showed a large cavity in the low-alloy steel RPV head material between nozzles 3 and 11 (Figure 6). The area with missing material was reported as being about 6.6" long and approximately 4-5" at the widest point. Ultrasonic thickness measurements from the underside of the RPV head showed the thickness of the remaining material (cladding) to be an average of approximately 0.3", which is greater than the 3/16" nominal or 1/8" minimum specified clad thickness. The videotape inspections also showed a small area of corrosion where nozzle 2 penetrates the RPV top head surface. The small area of corrosion at the top of nozzle 2 was found to lie directly over the area of corrosion at the bottom of nozzle 2 as seen in Figure 5. The videotape inspection also showed evidence of a small leak path where nozzle 1 penetrates the RPV top head surface.

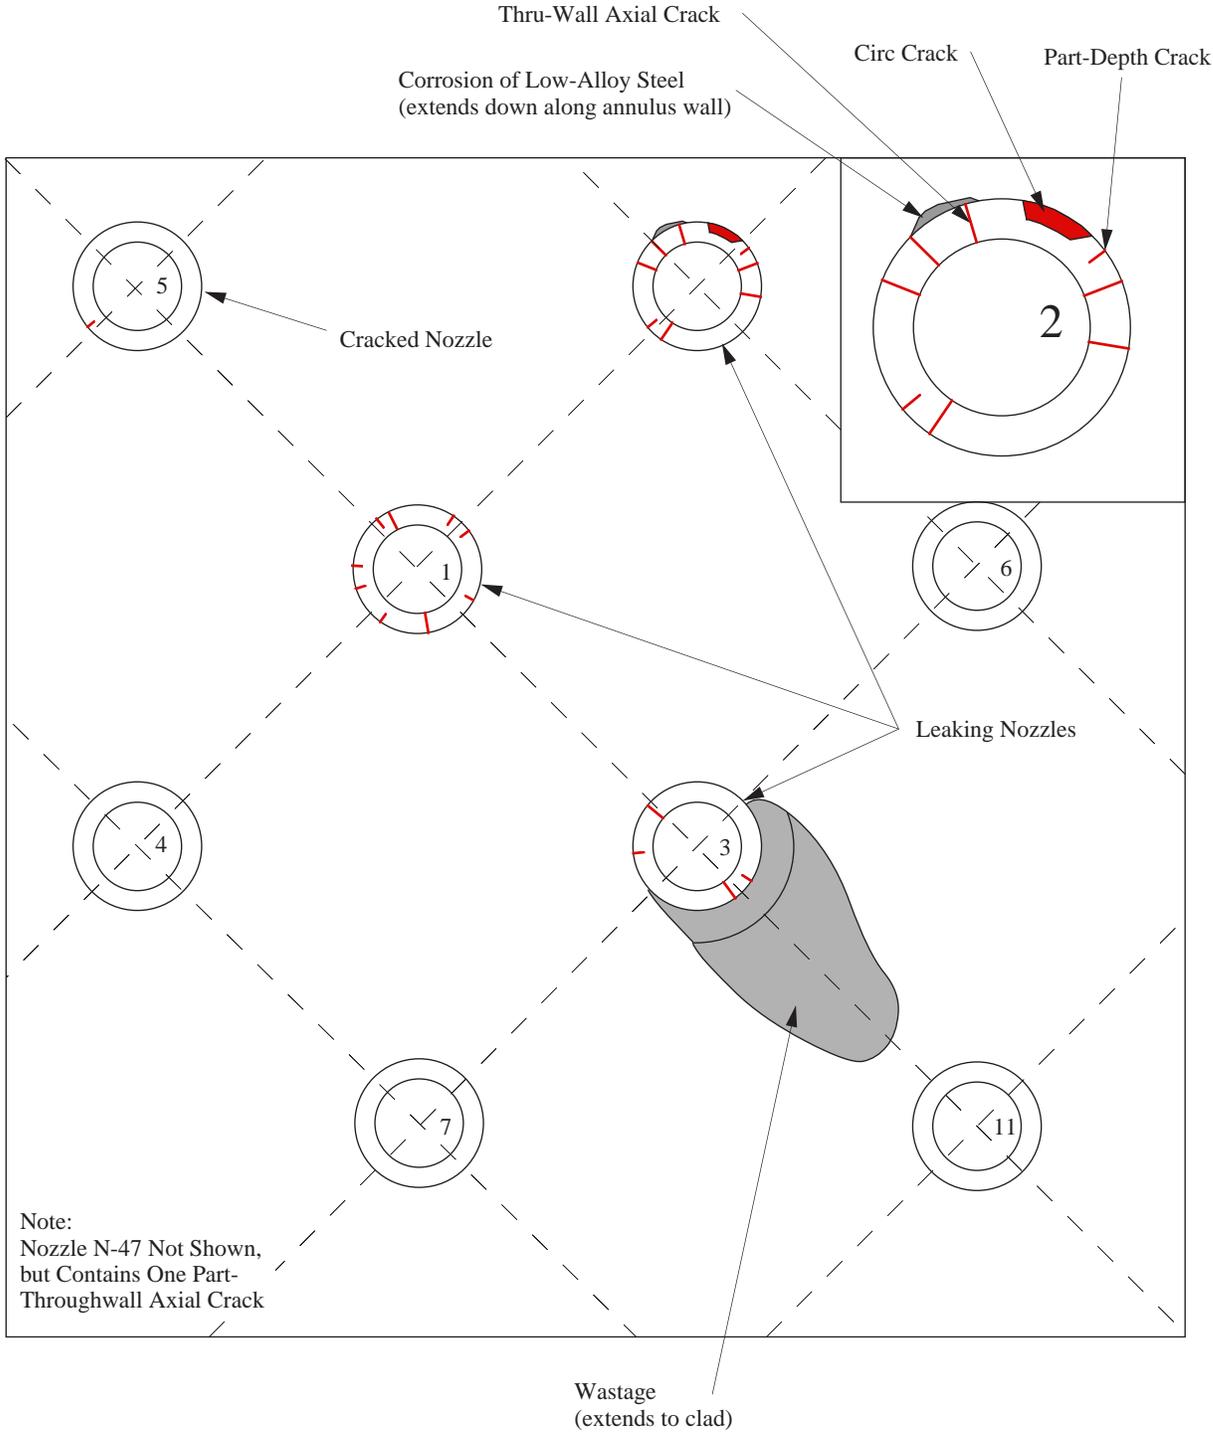
Figure 7. Locations of Cracks and Corrosion on Davis-Besse RPV Head at 13RFO

Figure 7 shows locations of cracks and corrosion on the Davis-Besse RPV top head surface. This figure is included to serve as a reference for the following descriptions of the degraded areas.

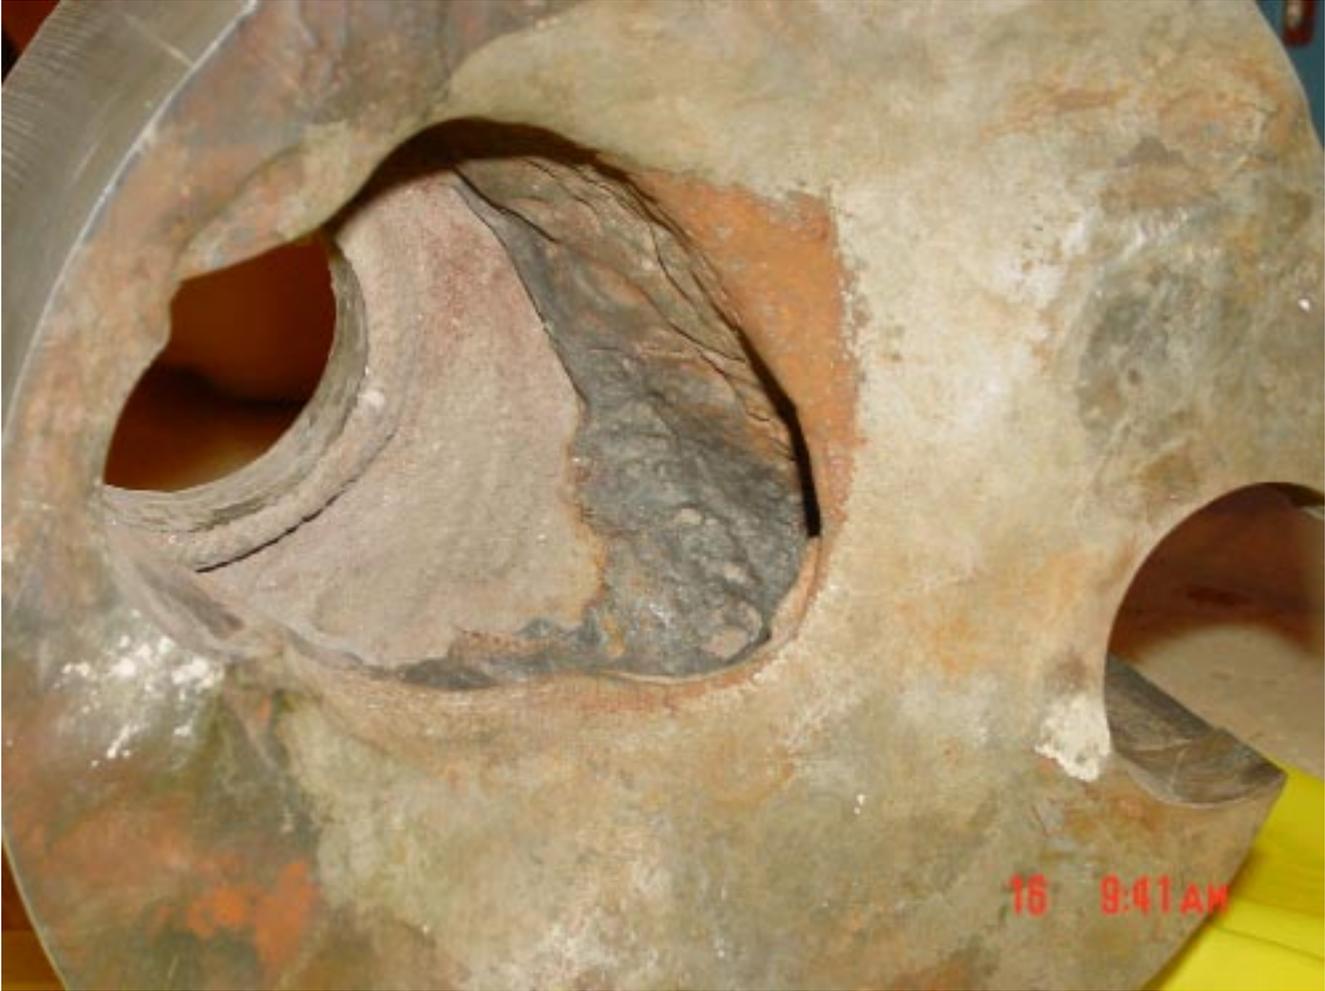
Figure 13. Corrosion and Possible Impingement at Nozzle N-3

Degradation observed at nozzle 3 is pictorially shown in Figure 13. The 180° (uphill toward nozzle 1) location is essentially intact, with little to no degradation. The 0° (downhill toward nozzle 11) location exhibits the worst degradation, with the low-alloy steel material corroded away, down to the stainless steel cladding, for approximately 6.6 inches in length and 4 to 5 inches at the widest part. Figure 14 shows cladding thickness measurements made by UT from the underside of the RPV head. (Note: There are several low readings outside the designated area of damage. These are attributed to inclusions or bad readings. These readings do not correspond with visual observations, and will be further verified following excavation of the damaged area.)

From the 270° location to the 0° location (counterclockwise looking down from the top of the RPV head), there is a large undercut area. From the 0° location to the 90° location (counterclockwise looking down from the top of the RPV head), the corrosion is less.

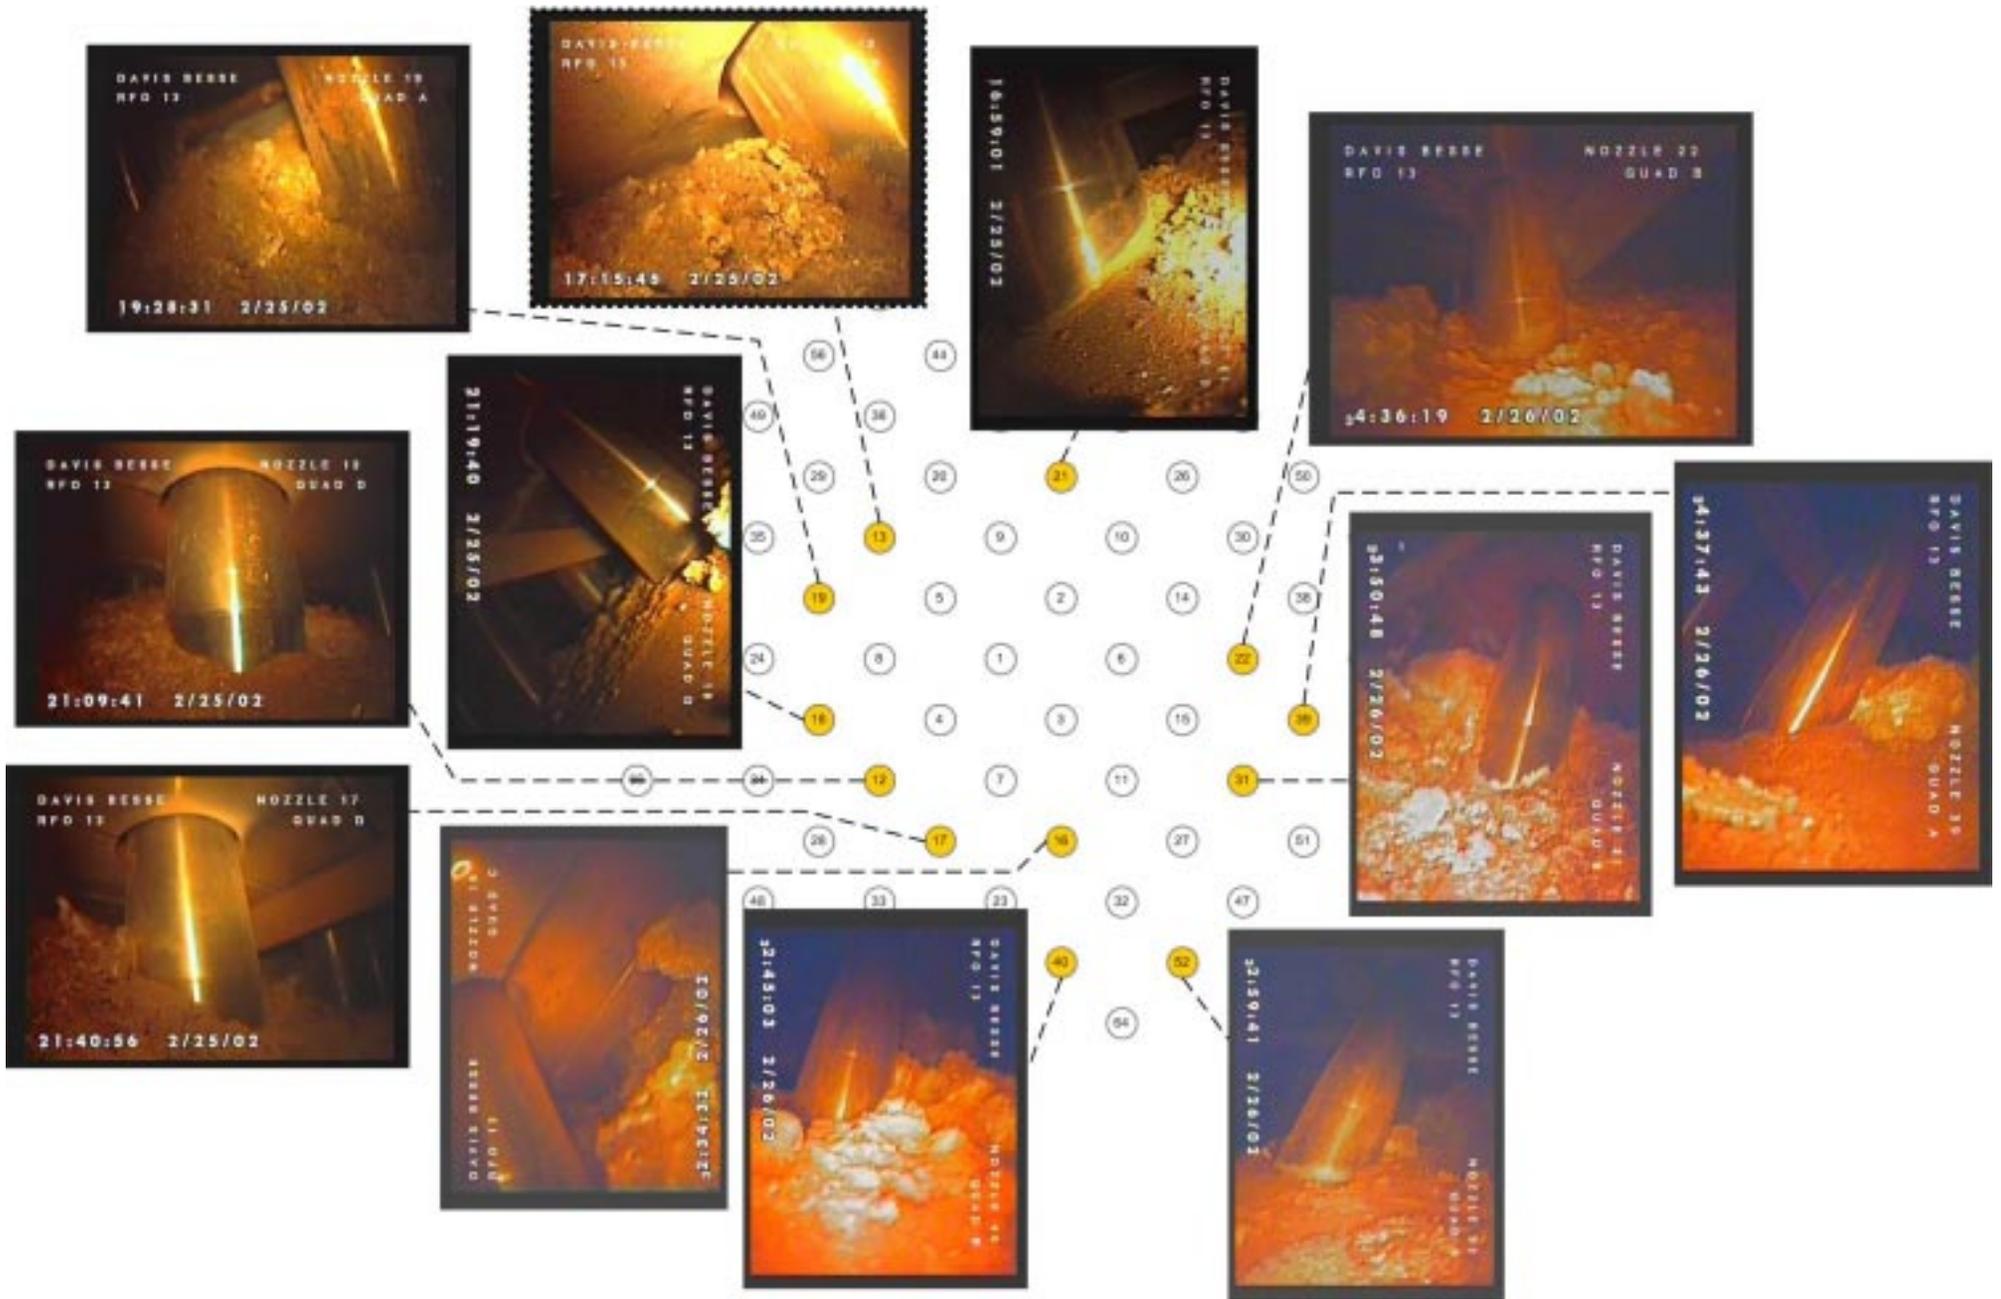
Figure 24. Boric Acid Deposits on Top of Head at Start of 13 RFO

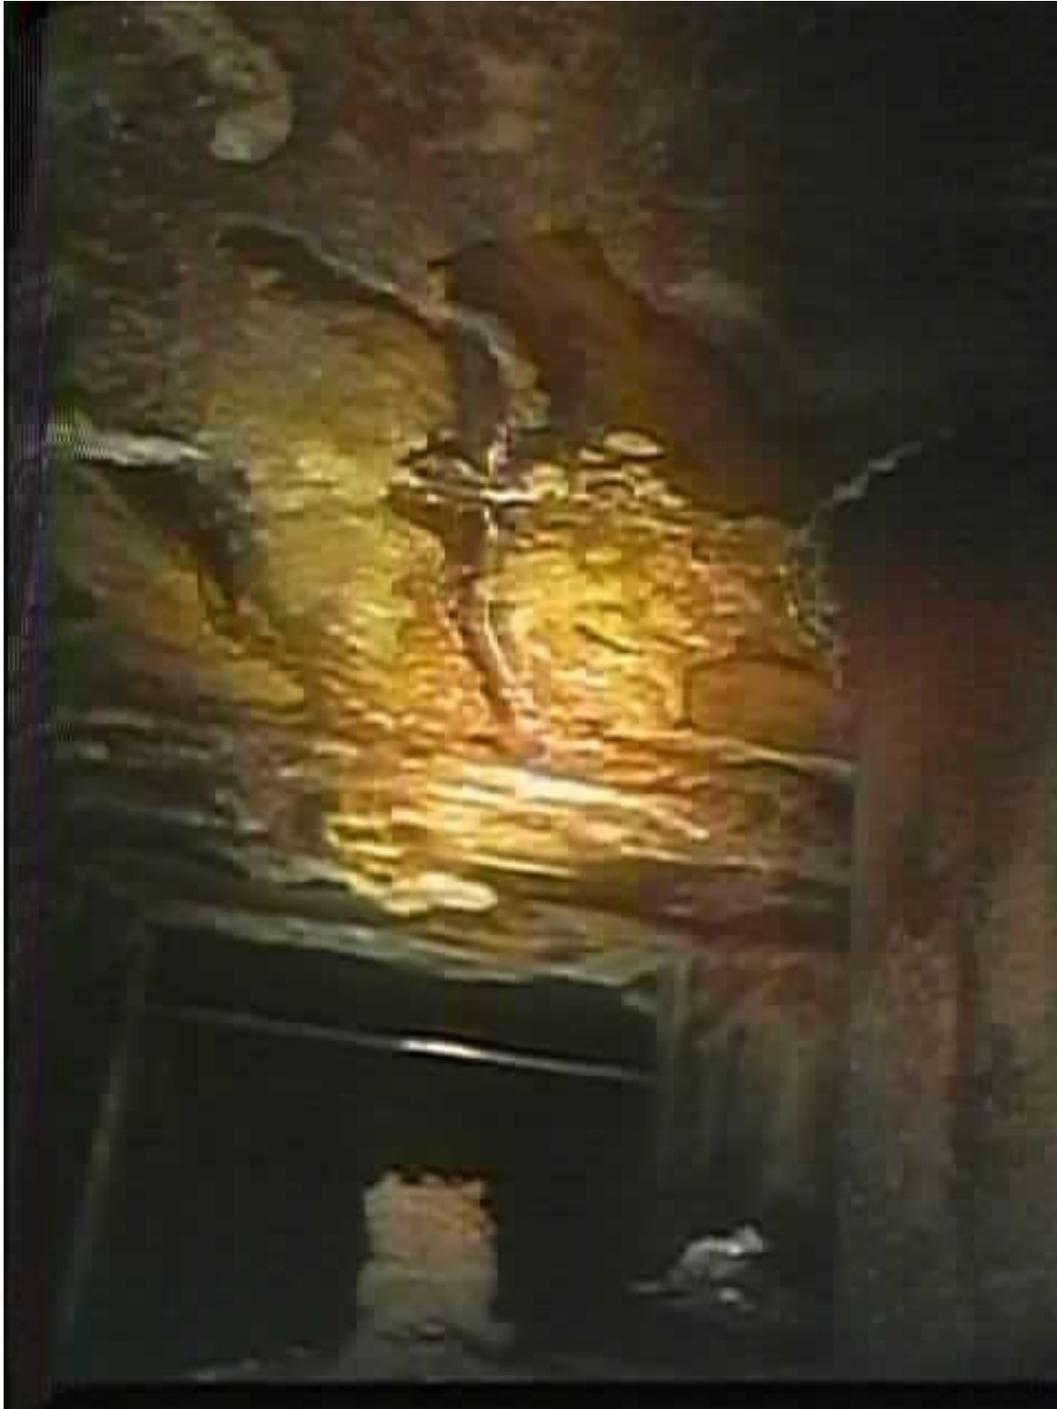
Figure 29. Flange Leakage with Stalactite Formation from Insulation and Stalagmite Formation on top of Reactor Vessel Head (8RFO)

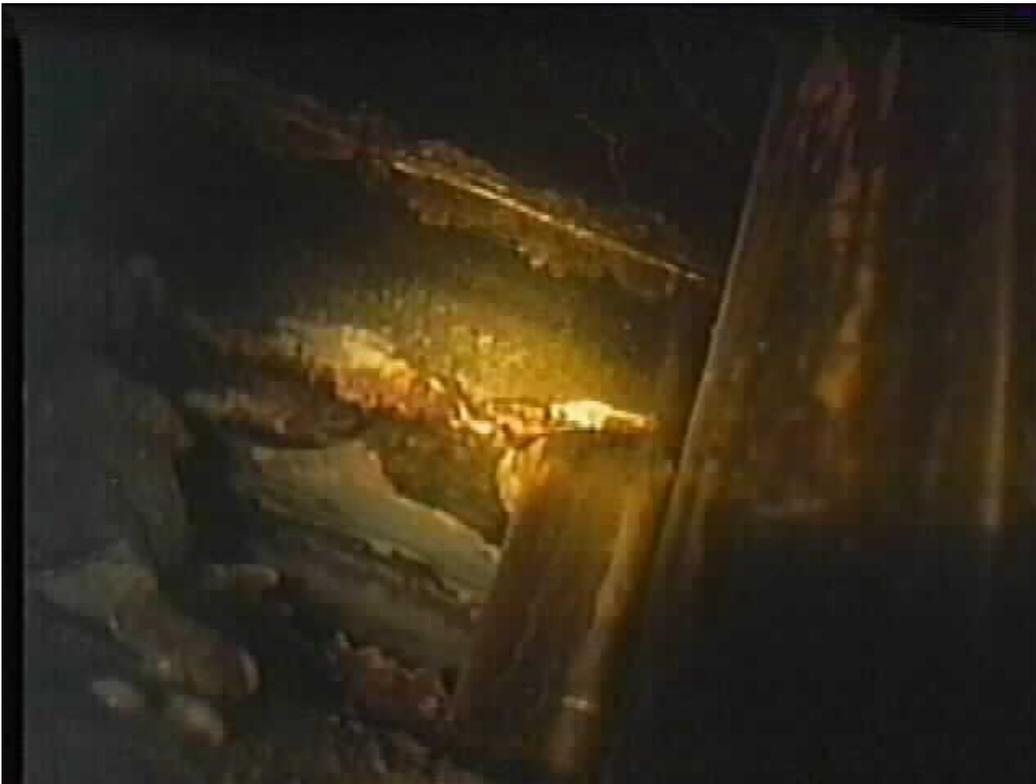
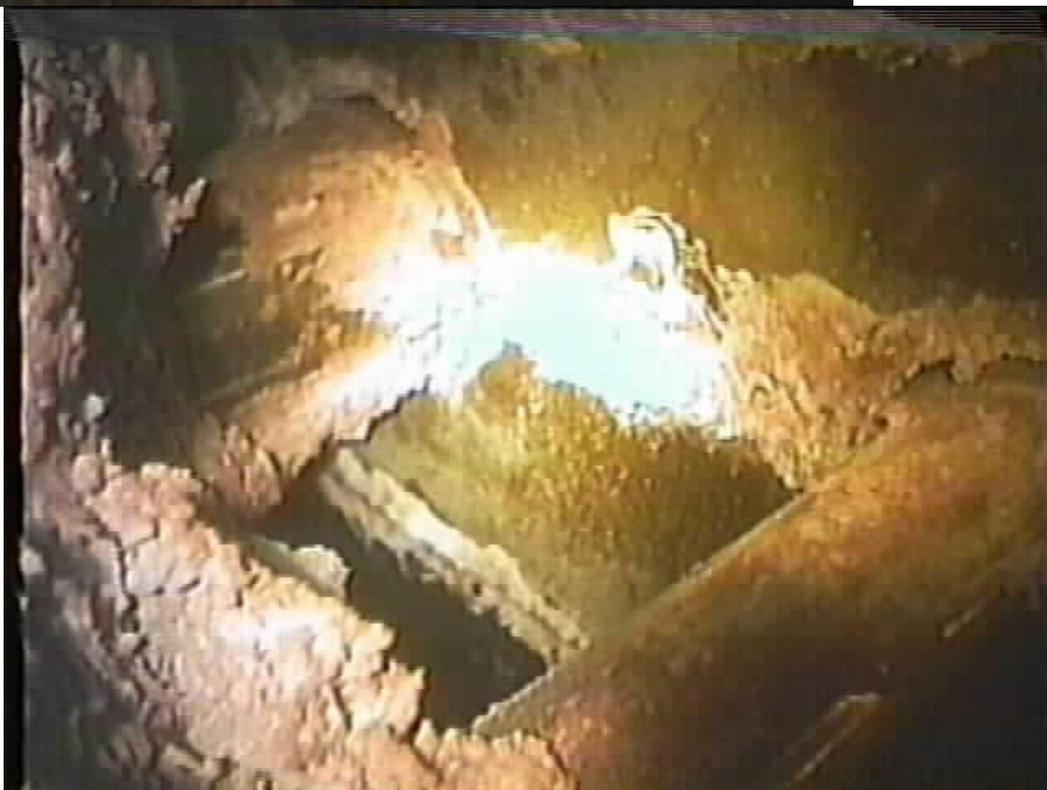
Figure 30. Flange Leakage Crusted On Side of Nozzles and Stalactites from Gaps in Insulation (8RFO)

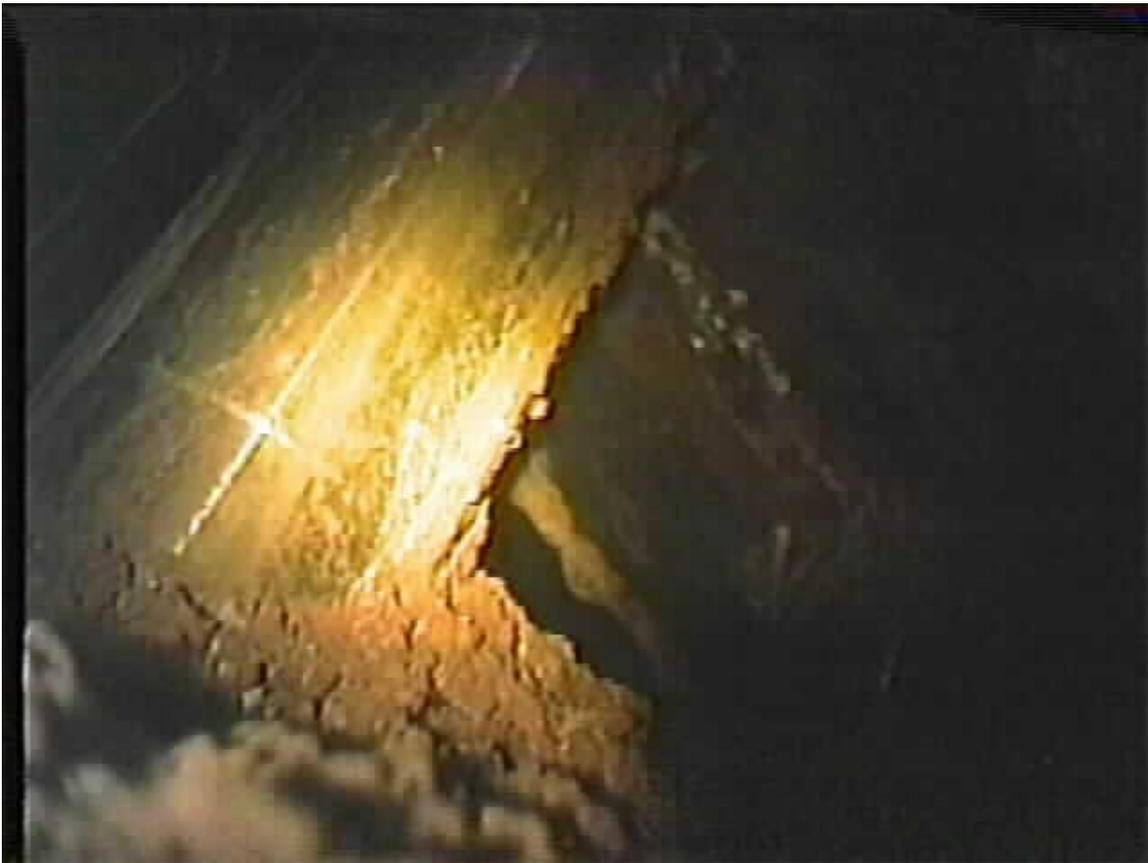
Figure 31. Reddish Brown Boron Deposits Crusted on Side of Nozzle (8RFO)

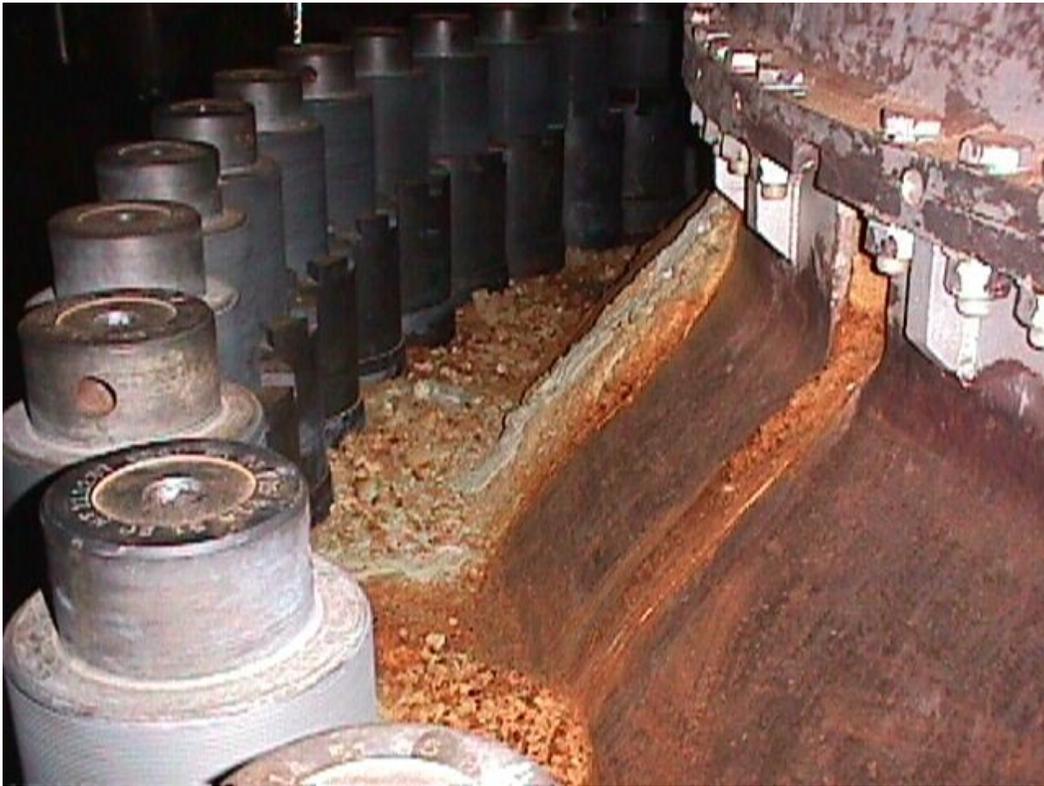
Figure 36. Red Rusty Boric Acid Deposits on Vessel Flange at 12RFO

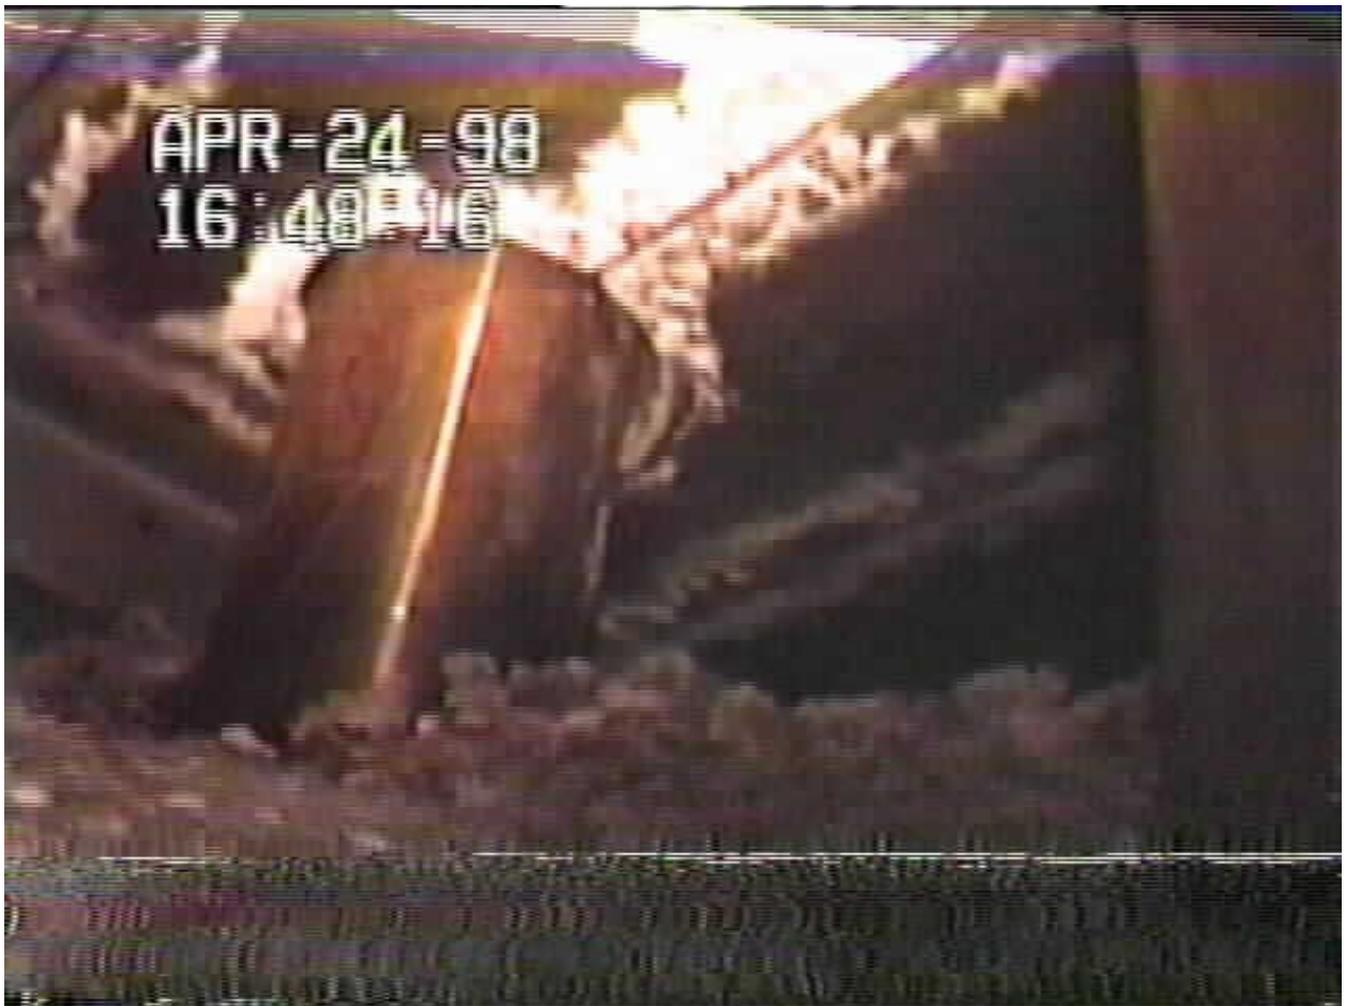
Figure 37. Boron Piled Under the Insulation (11RFO)

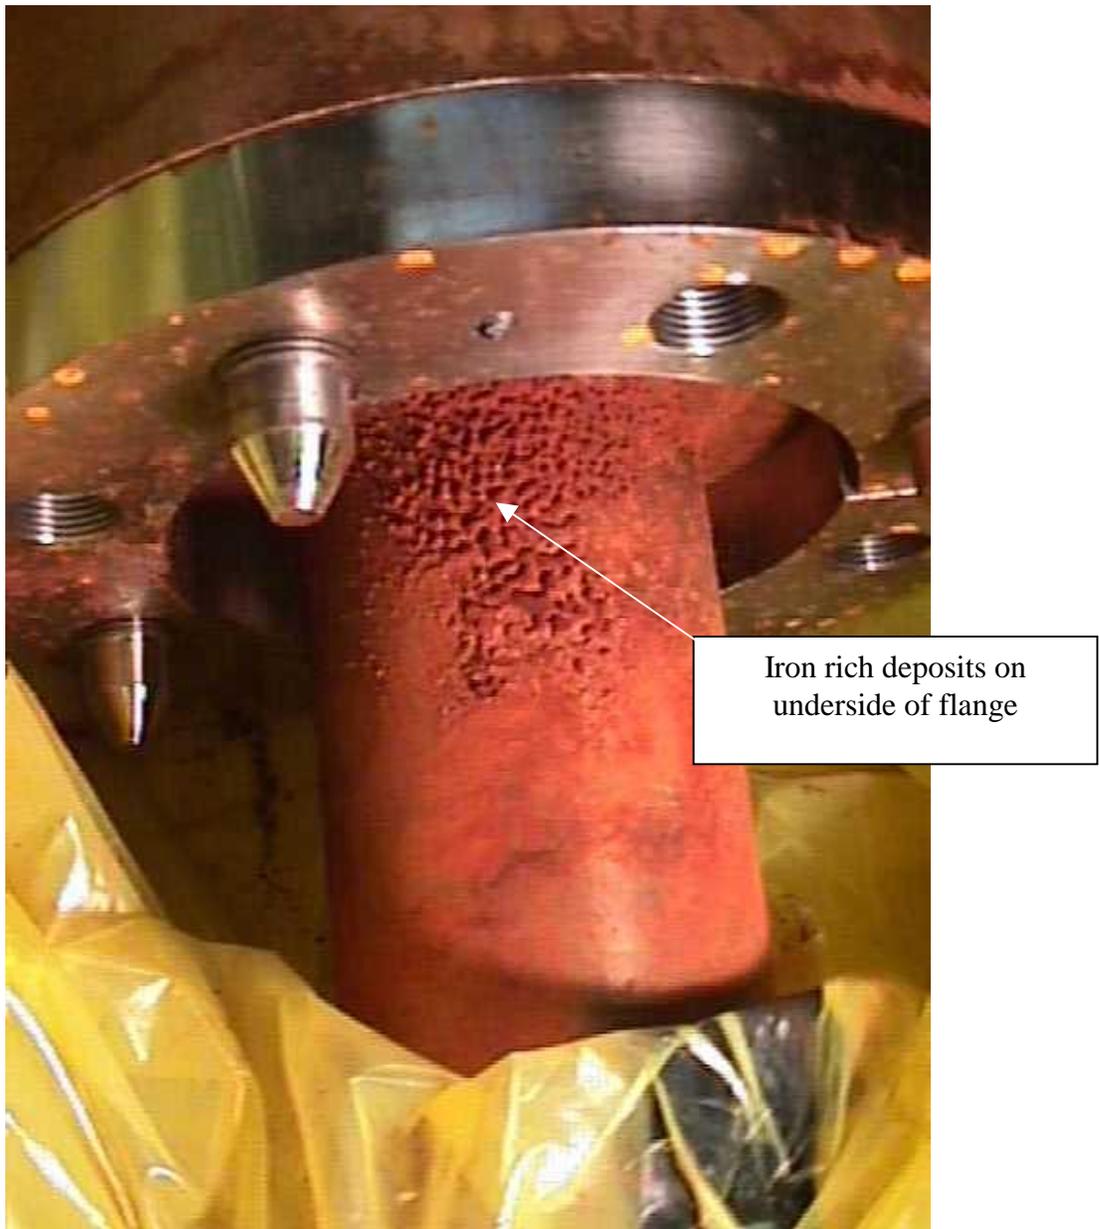
Figure 38. Boric Acid Deposits with Heavy Iron Concentration on Underside of Nozzle 3 (13RFO)
