Subject: Confirmatory Action Letter Response – Revision 1 to Root Cause Analysis
Report Regarding Reactor Pressure Vessel Head Degradation

Root Cause Analysis Report

Significant Degradation of the Reactor Pressure Vessel Head

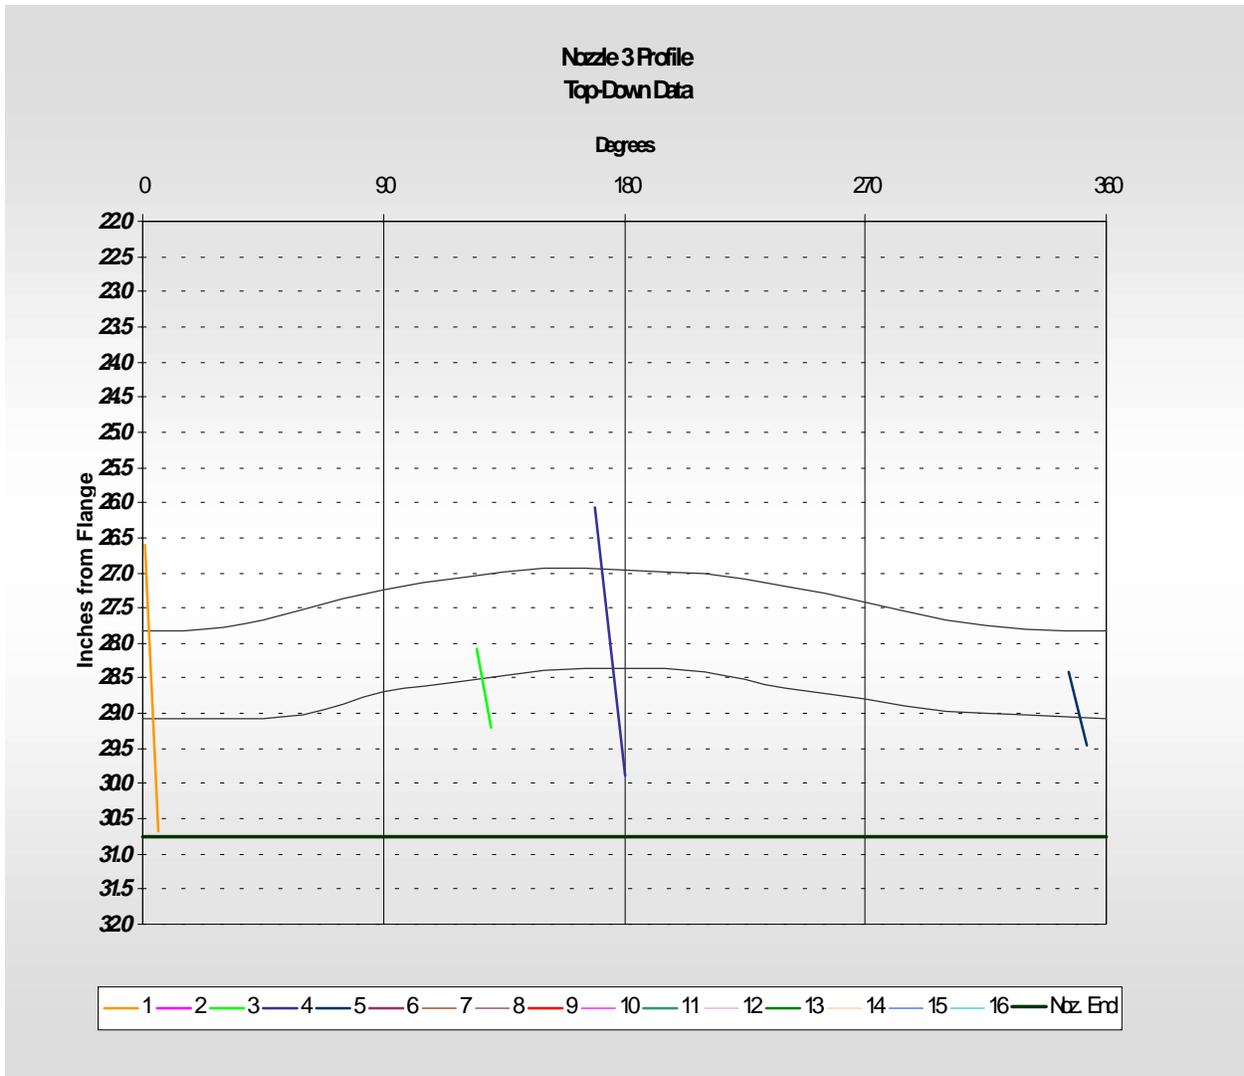
Figure 10. Nozzle 3 Crack Locations and Sizing

Nozzle #	Summary of NDE Results
1	9 Axial Flaws, 2 through-wall (TW) with a leak path
2	9 Axial Flaws, 1 Circ. Flaw, 6 TW with a leak path
3	4 Axial Flaws, 2 TW with a leak path
5	1 Axial Flaw
46	No Flaw Indication, potential leak path
47	1 Axial Flaw
58	No Recordable Indications

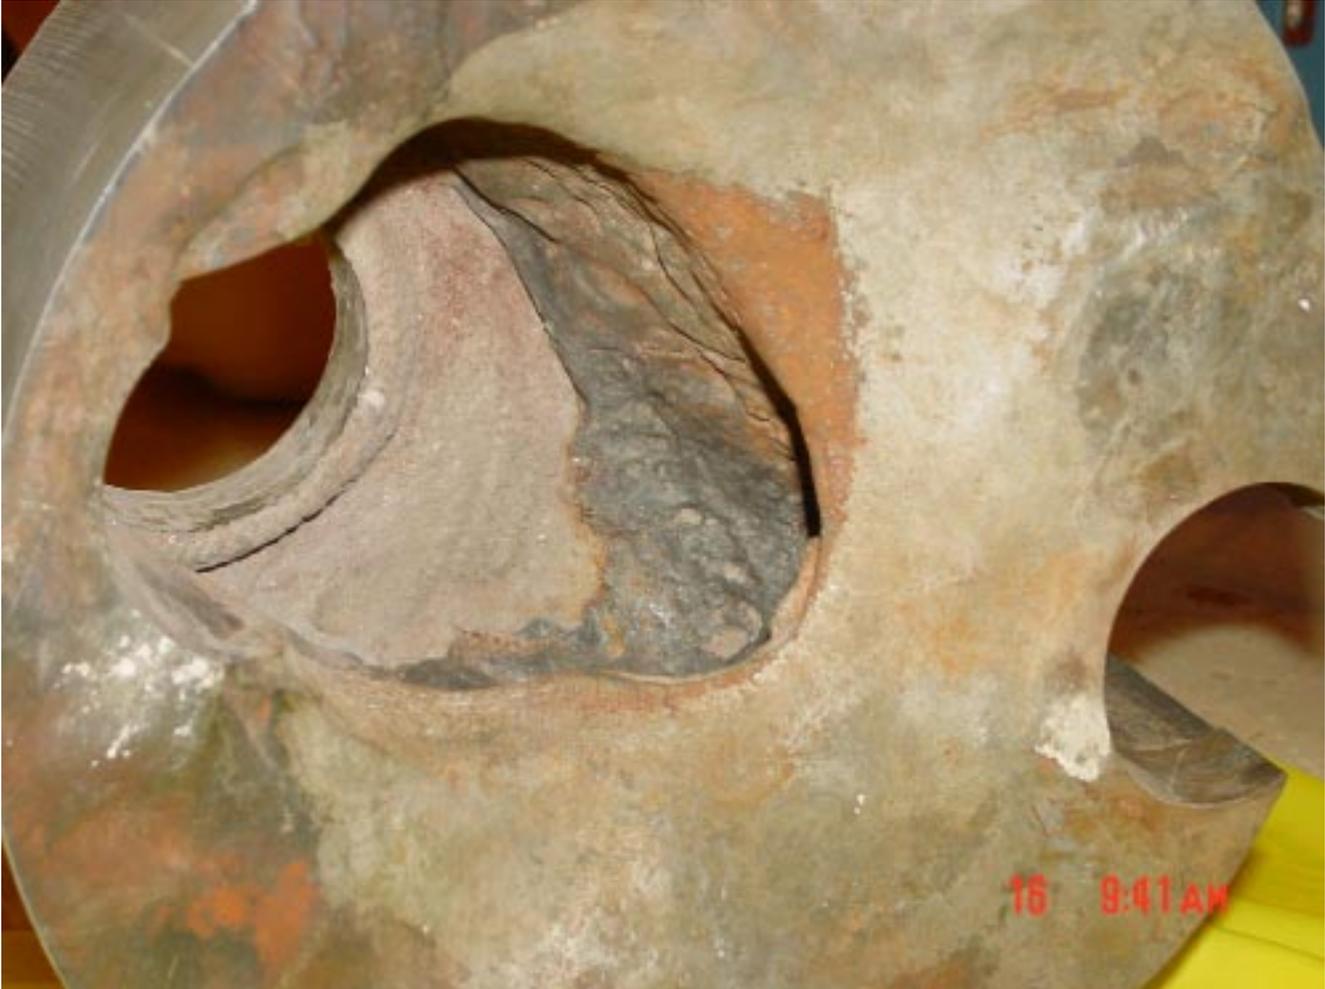
Figure 13. Corrosion and Possible Impingement at Nozzle N-3

Degradation observed at nozzle 3 is pictorially shown in Figure 13. The 180° (uphill toward nozzle 1) location is essentially intact, with little to no degradation. The 0° (downhill toward nozzle 11) location exhibits the worst degradation, with the low-alloy steel material corroded away, down to the stainless steel cladding, for approximately 6.6 inches in length and 4 to 5 inches at the widest part. Figure 14 shows cladding thickness measurements made by UT from the underside of the RPV head. (Note: There are several low readings outside the designated area of damage. These are attributed to inclusions or bad readings. These readings do not correspond with visual observations, and will be further verified following excavation of the damaged area.)

From the 270° location to the 0° location (counterclockwise looking down from the top of the RPV head), there is a large undercut area. From the 0° location to the 90° location (counterclockwise looking down from the top of the RPV head), the corrosion is less.

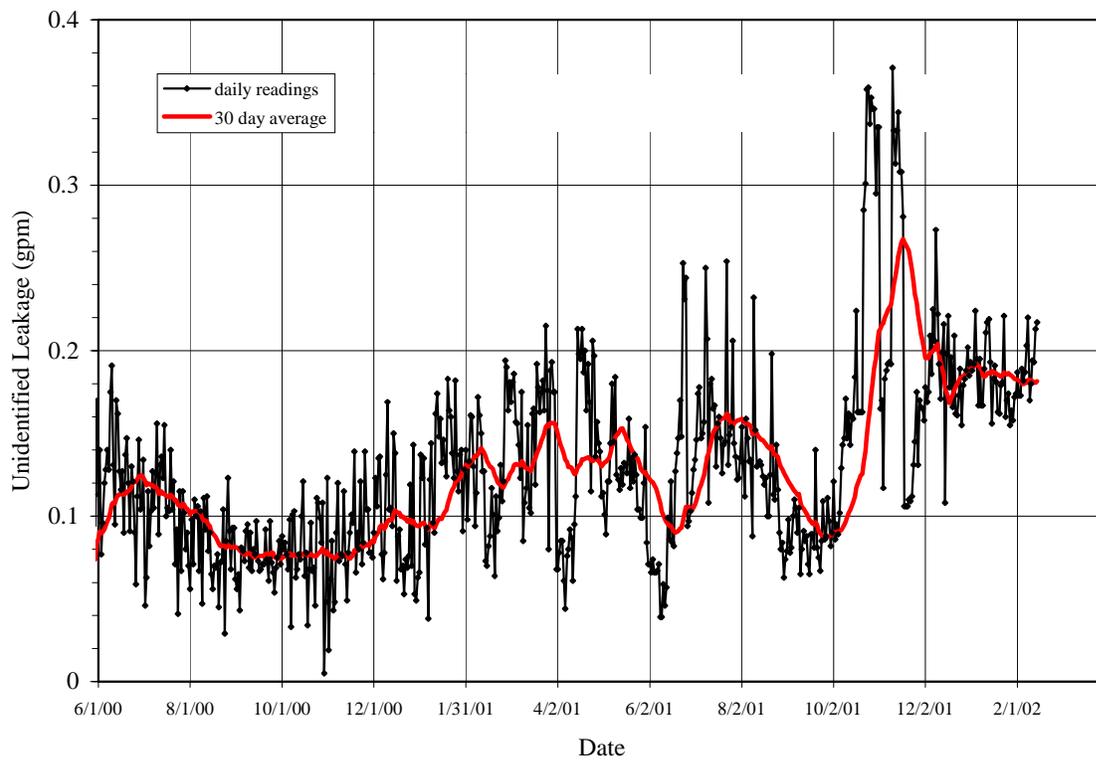
Figure 19. Unidentified Leak Rate at Davis-Besse (Cycle 13)

During operating cycles 10 through 13 (November 1994 through February 2002), measured unidentified leakage has ranged from slightly negative to as much as approximately 0.8 gpm in April 1999. From review of data over that time span, it would appear that average unidentified leakage tends to be in the range of 0.0 to 0.03 gpm when the plant is “tight” with no pending maintenance concerns. If unidentified leakage begins to trend upward, efforts are expended to determine the cause, and if necessary, effort is made to repair the source of the leakage. For example, the high leakage in April 1999 was identified as from the Pressurizer Code Safety Valves and the plant was shutdown to service the valves. Following that shutdown, unidentified leakage remained in the range of 0.15 to 0.25 gpm, some of which was attributable to CRDM flange leakage and some of which may have been attributed to CRDM nozzle leakage.
