Perry Nuclear Power Plant December 17, 2003

Emergency Service Water (ESW) Pump Coupling Failure

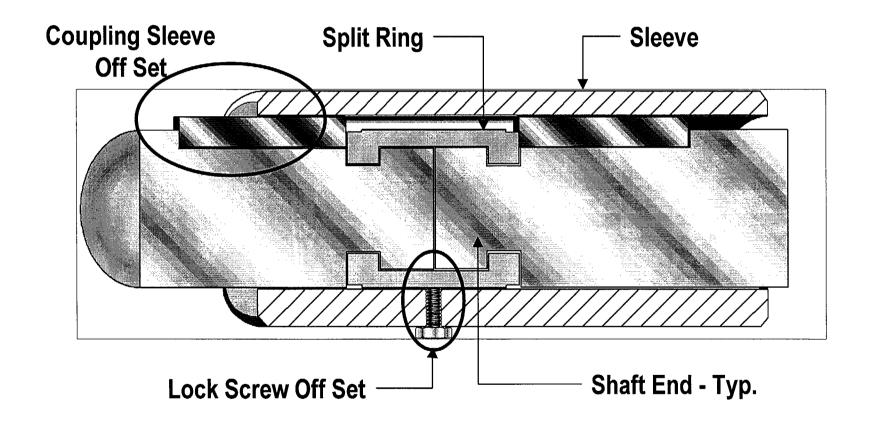
As Installed Coupling

- Stress corrosion cracking is the root cause
 - Improper installation due to inadequate procedure
 - Susceptible material
 - Environment considered in design/operation
- Corrective actions address both installation and material

- Revision of procedures for ESW pumps
- Material upgrades for all ESW pumps
 - New requirements for heat treatment, hardness, and documentation
 - 100% NDE of coupling sleeves
