WCAP-16180-NP  
Revision 0

December 2003

# **Operability Assessment for Combustion Engineering Plants with Hypothetical Circumferential Flaw Indications in Pressurizer Heater Sleeves**

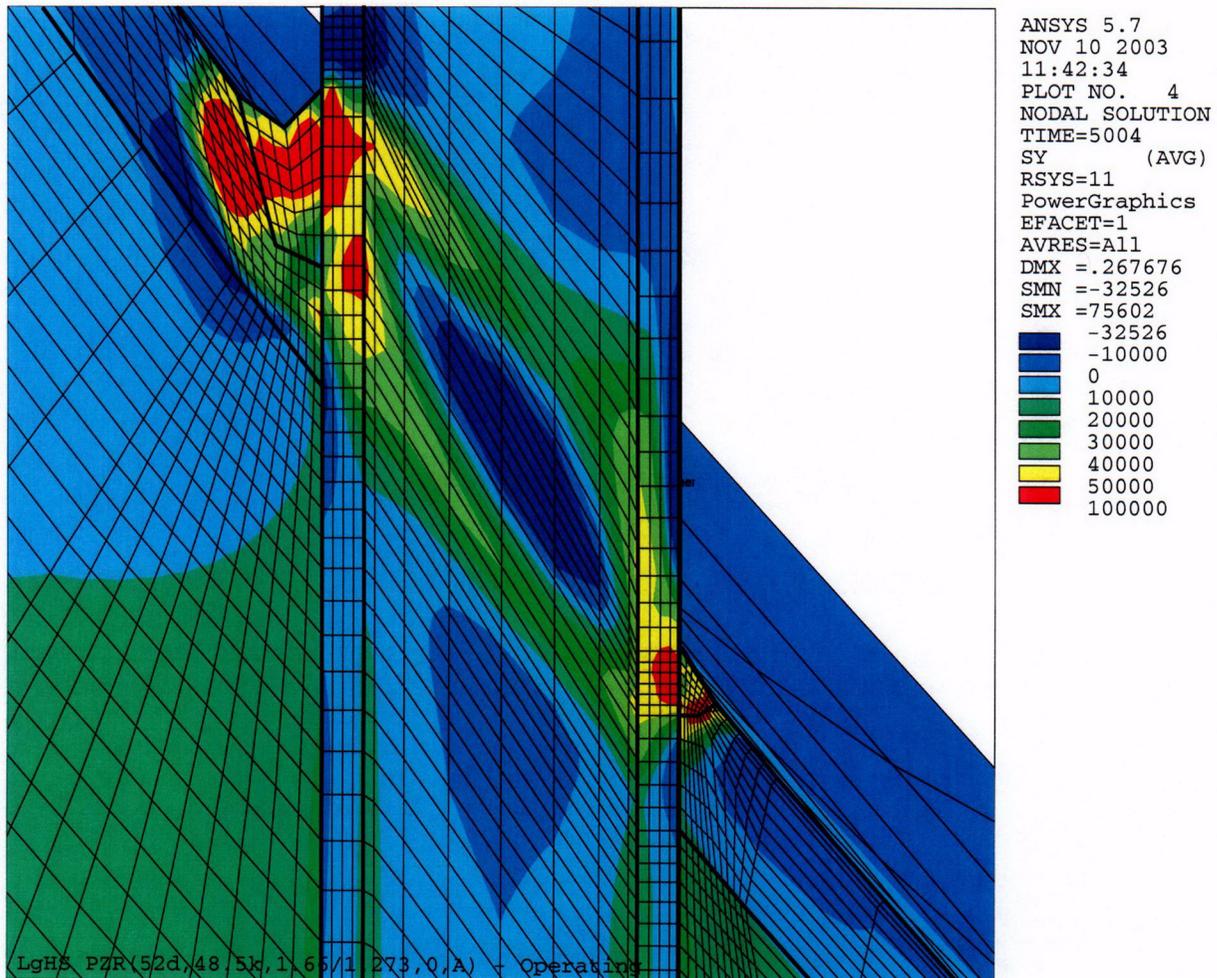
**Figure 5-2a: Hoop Stresses for the Steady State Condition for the Outermost (52.0°) Large Diameter Heater Sleeve**

Figures 5-2a and b presents the hoop and axial stresses for the steady state condition for the outermost large diameter heater sleeve. Similar results for a small diameter heater sleeve are shown in Figures 5-3a and b.

The hoop stresses for steady state operation are much greater than the axial stresses. This is consistent with the field findings, where the cracks discovered are generally oriented axially. Typically, in-service cracks will orient themselves perpendicular to the largest stress component. Also it should be noted from Figures 5-2 and 5-3 that the highest tensile hoop stresses are at the uphill side and downhill side locations rather than midway around the penetration, where they are compressive. This is consistent with the flaw locations as found in service. These steady state stresses were used to predict crack extension in the sleeves, as will be discussed further in Section 5.5.

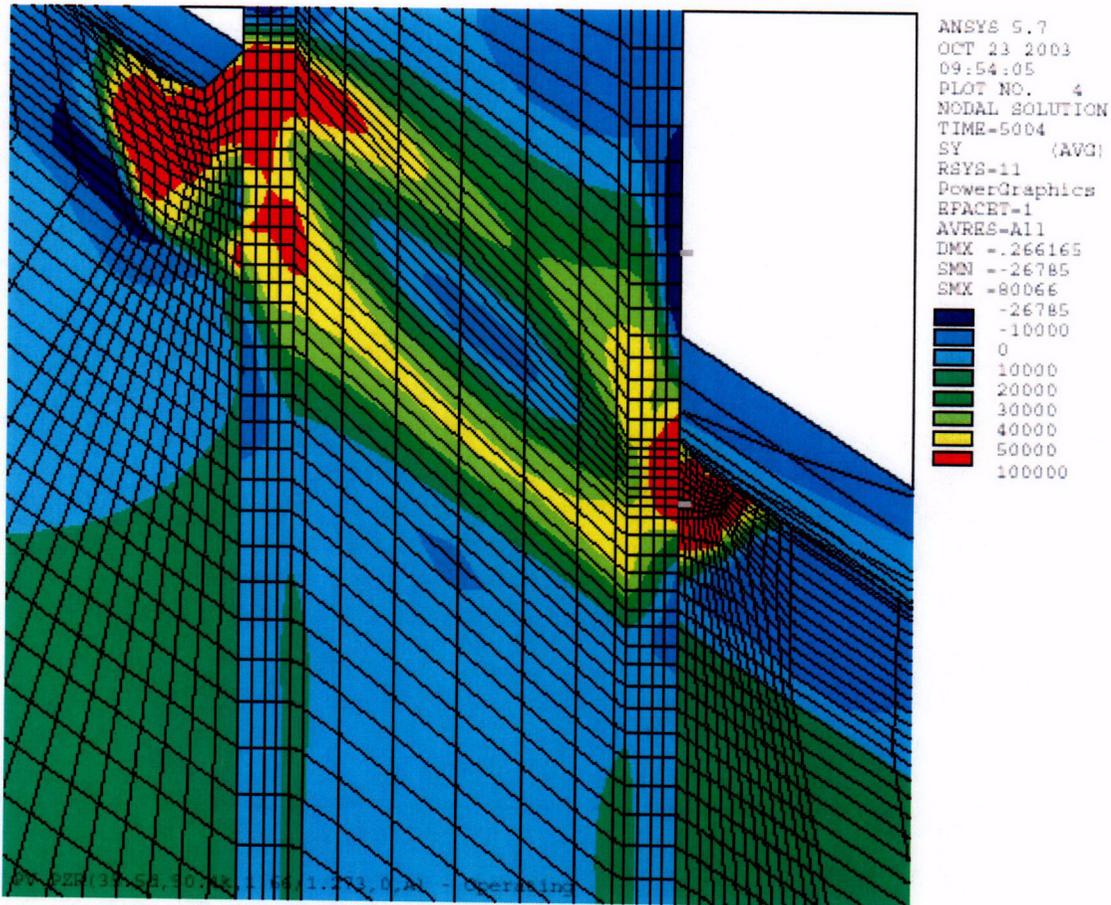
**Figure 5-4a: Hoop Stresses for the Steady State Condition for the 35.5° Penetration for the Large Diameter Heater Sleeve**

The stresses in these penetrations are similar to those at the outermost locations. Figures 5-4a and b show the hoop and axial stresses at steady state for the large diameter sleeve at the 35.5° location. Figures 5-5a and b show the same results for the 38.5° small heater sleeve. As with the outermost sleeves, the hoop stresses for steady state operation are greater than the axial stresses.

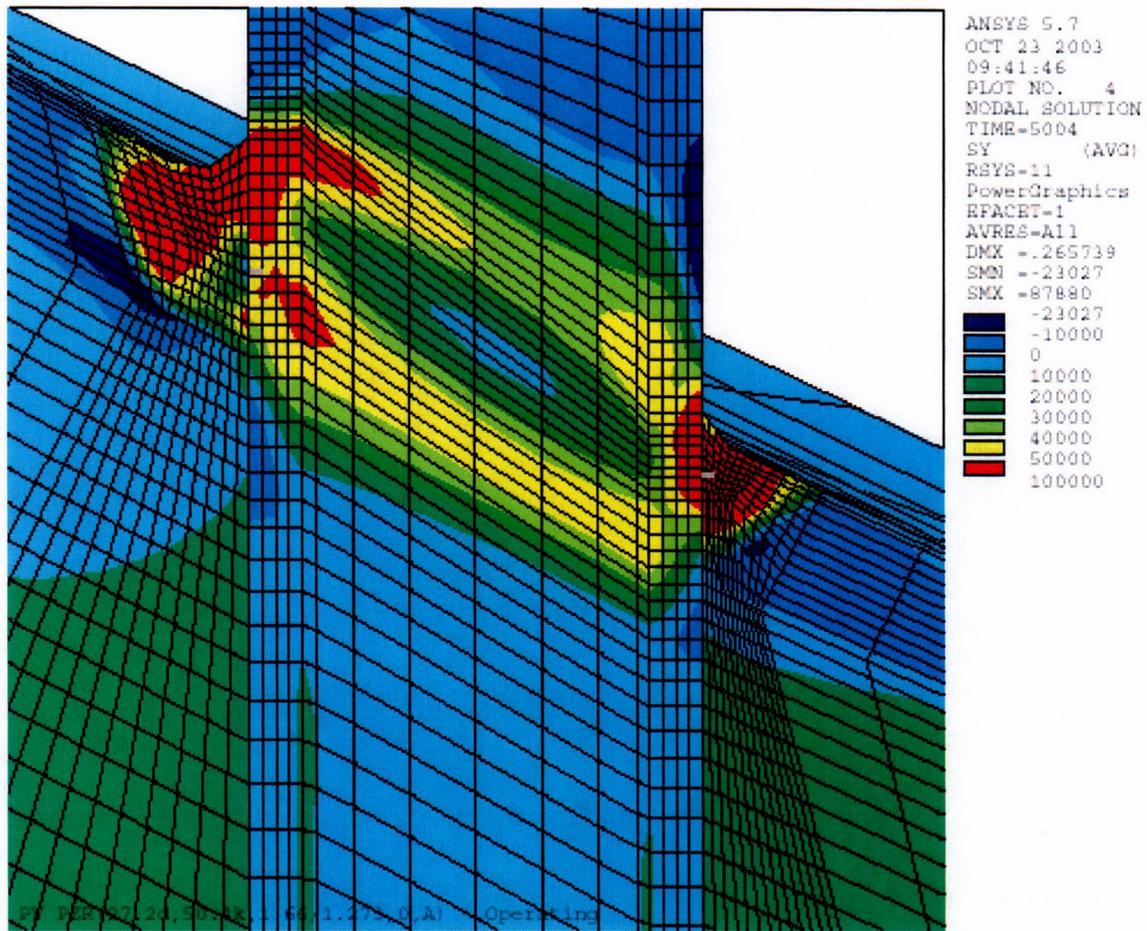
**Figure 5-6a: Hoop Stresses for the Steady State Condition for the 27.2° Penetration for the Large Diameter Heater Sleeve**

The stresses in these penetrations are similar to those in the intermediate and outermost penetrations. Figures 5-6a and b show the hoop and axial stresses at steady state for the 27.2° location in the large diameter heater sleeves. Figures 5-7a and b show the same results for the 23.5° small diameter heater sleeve penetration. As with the other sleeves, the hoop stresses for steady state operation are greater than the axial stresses.
