UNITED STATES
NUCLEAR REGULATORY COMMISSION
OFFICE OF NUCLEAR REACTOR REGULATION
WASHINGTON, D.C. 20555

January 8, 2004

NRC INFORMATION NOTICE 2003-11, SUPPLEMENT 1: LEAKAGE FOUND ON
BOTTOM-MOUNTED
INSTRUMENTATION NOZZLES

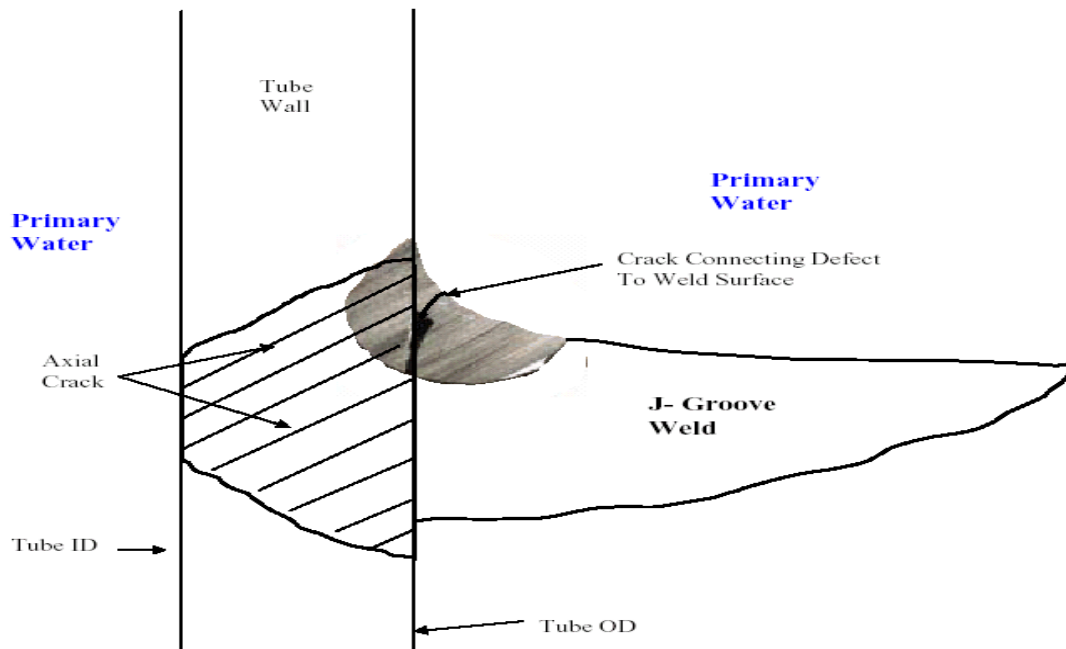
Figure 1 Overlay of cross section of boat sample from STP Unit 1 penetration 1 with drawing of penetration 1 tube and weld geometry.

- (1) The axial crack in the penetration 1 tube wall was entirely intergranular in nature and consistent with primary water stress corrosion cracking (PWSCC) as the mechanism of crack propagation. Essentially no PWSCC of the J-groove weld material was observed in the boat sample.

- (2) The UT discontinuity at the tube-to-weld interface which was captured in the boat sample (the dark area in the boat sample in Figure 1) was confirmed to be a weld lack-of-fusion zone from initial fabrication. A weld material ligament of approximately 80 mils (0.080 inch) separated the weld lack-of-fusion zone from the surface of the J-groove weld. The length of the lack-of-fusion zone in the circumferential direction was about 0.2 inch. The axial PWSCC crack in the tube wall was located at one end of the lack-of-fusion zone.

- (3) A second cracklike defect was observed in the weld material (the dark line in Figure 1), running in the circumferential direction. The length of this defect was about 0.2 inch, consistent with the length of the lack-of-fusion zone. This defect was completely through the 80 mil weld ligament and would have permitted primary water to leak into the lack-of-fusion zone. The precise mechanism for the initiation and propagation of this defect through the weld material could not be determined from the boat sample. However, its location and size relative to the associated lack-of-fusion zone suggest that the formation of this defect was also related to initial fabrication processes.
