Docket Number 50-346

Subject: Response to Questions Regarding the 2002 Steam Generator Tube Inspections  
(TAC No. MB9541)

RESPONSE TO REQUEST FOR ADDITIONAL INFORMATION  
DAVIS-BESSE NUCLEAR POWER STATION  
2002 STEAM GENERATOR INSPECTION (TAC NO. MB9541)

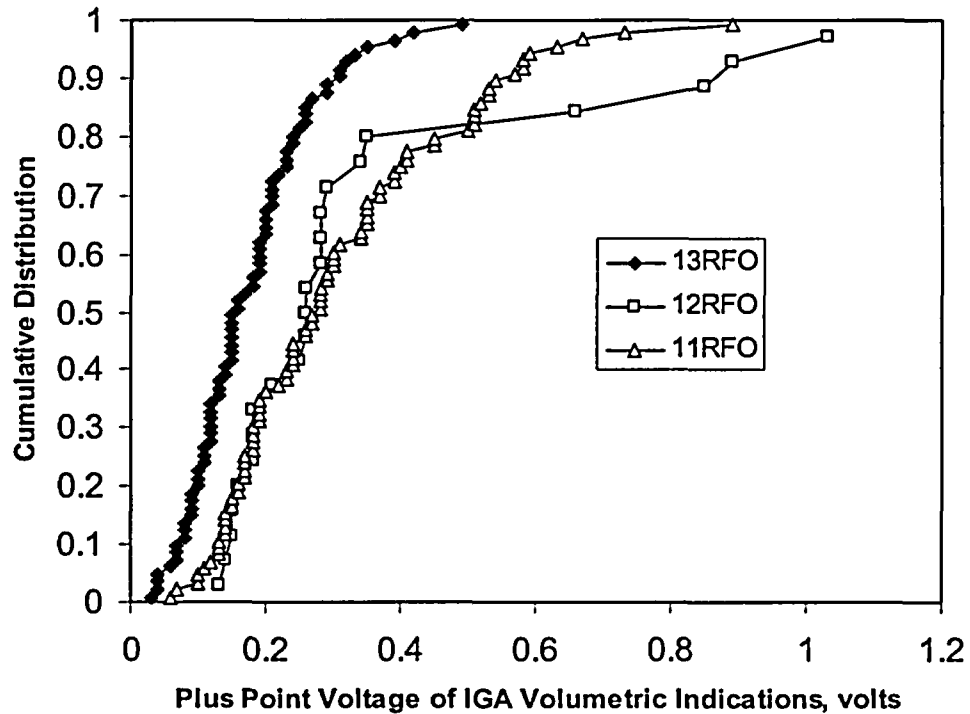
**Figure 1: Cumulative Distribution of Plus Point Voltages of Volumetric IGA Indications for the Past Three Outages at Davis-Besse**

The end-of-cycle severity of volumetric indications exhibits an overall downward trend at the DBNPS. This is illustrated in Figure 1, which shows that the cumulative distribution of +Point voltages is shifting towards lower values; and in Figure 2, which shows that the average and upper 95th percentile voltages are lower for 13RFO than for the previous two inspections.

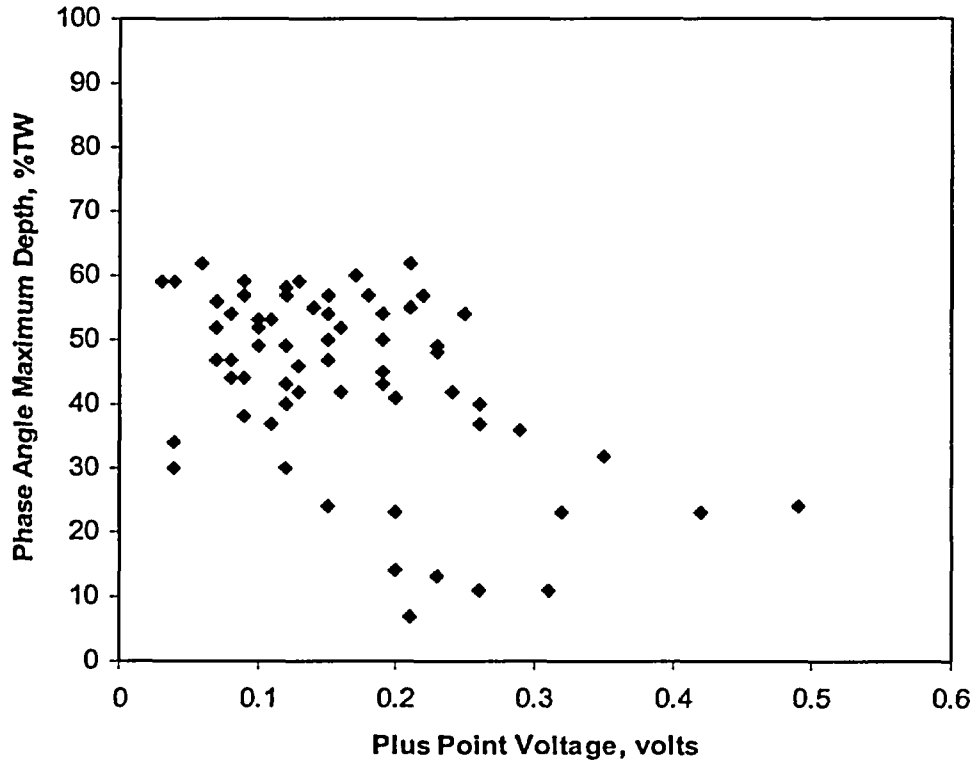
**Figure 3: NDE Phase Angle Maximum Depth versus Plus Point Voltage, Volumetric IGA Degradation at Davis-Besse**

Figure 3 shows that voltage is a better indicator of degradation severity than a non-destructive examination (NDE) phase angle maximum depth estimate, consistent with the data that was originally provided in response to Question #1 and discussed in response to Question #12 of the letter dated November 3, 2003 (DBNPS Serial Number 2989). Phase angle depth NDE measurement error increases markedly at lower voltages. Phase angle depths are more reliable for higher voltages. Figure 3 shows that reported phase angle depths near 60%TW are basically a reflection of increased depth sizing error rather than an indicator of significant degradation severity. Volumetric degradation severity at the DBNPS is relatively mild and is on a decreasing trend as a result of the repair on detection management of these indications and the relatively good bobbin coil probability of detection (POD).

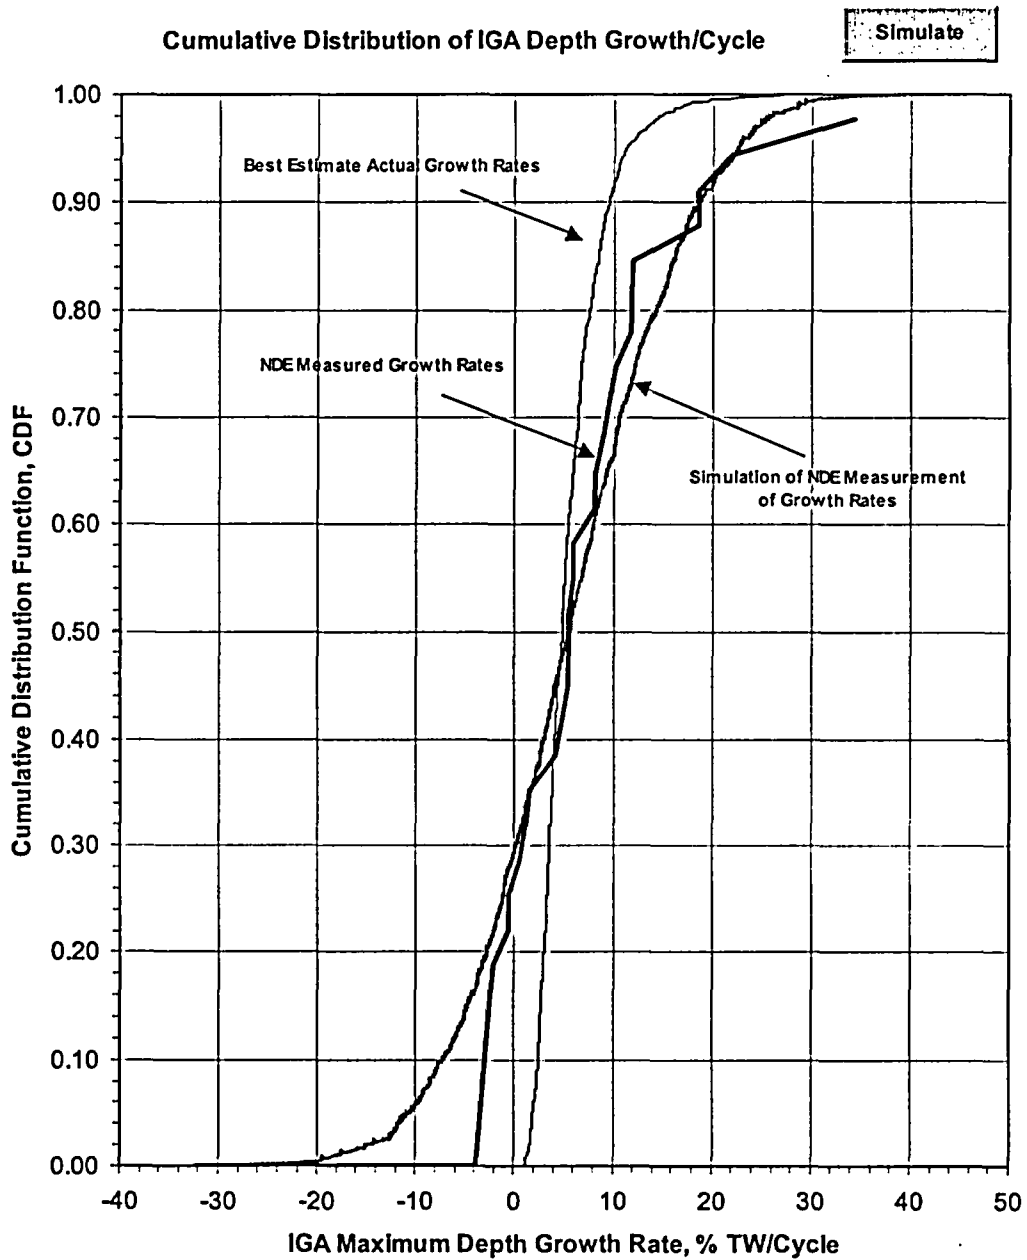
**Figure 4: Matching Results for NDE Measured Growth and Computer Simulation of NDE Measured Growth, Comparison with Actual Volumetric IGA Depth Growth, Davis-Besse 11RFO to 12RFO**

Because of the low signal amplitudes of the indications during 13RFO, determination of depth based growth rates is highly problematic. Additionally, back-to-back +Point is not available in most instances since a bobbin non-quantifiable indication (NQI) is first required to trigger a follow up examination with +Point. A good, conservative estimate of the growth rate of volumetric degradation is provided from 12RFO NDE data, with look-back sizing for corresponding 11RFO data. Figure 4 shows the growth rate analysis results. A computer simulation of NDE sizing errors was used to generate a best estimate of the actual physical growth rates. When the influence of NDE sizing errors is removed, the upper 95th percentile growth rate is estimated at

12%TW/Cycle, maximum depth. When NDE sizing errors are included, the apparent upper 95th percentile NDE depth based growth rate is 24%TW/Cycle, maximum depth. Neither value presents a challenge to structural or leakage integrity at end of cycle (EOC) conditions at the DBNPS.
