UNITED STATES
NUCLEAR REGULATORY COMMISSION
OFFICE OF NUCLEAR REACTOR REGULATION
WASHINGTON, D.C. 20555

January 21, 2004

NRC INFORMATION NOTICE 2004-01: AUXILIARY FEEDWATER PUMP
RECIRCULATION LINE ORIFICE FOULING -
POTENTIAL COMMON CAUSE FAILURE

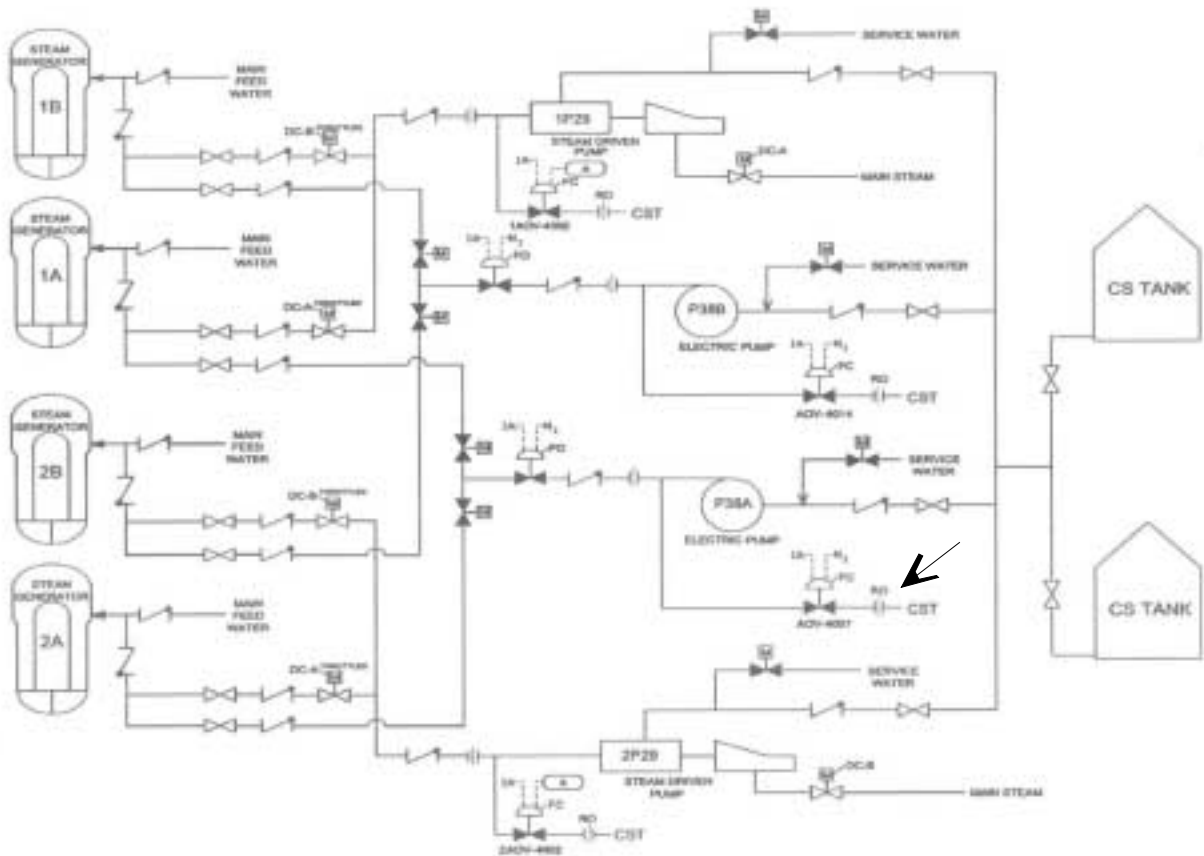
Figure 1. AFW System - Major Flow Paths

Point Beach Nuclear Plant (PBNP) is a two unit site. Each unit has a turbine-driven AFW pump (pumps 1P29 and 2P29) which can supply water to both steam generators. Additionally, the plant has two motor-driven AFW pumps (pumps P38A and P38B) each of which can be aligned to a steam generator in each unit. Each pump has a recirculation line back to the condensate storage tanks (CSTs) to ensure minimum flow to prevent hydraulic instabilities and dissipate pump heat. The recirculation line contained a pressure reducing, flow restricting orifice. An arrow is pointing to the recirculation flow restricting orifice (RO) in the major flow path AFW diagram provided in Figure 1 and a picture of the RO is provided in Figure 2.

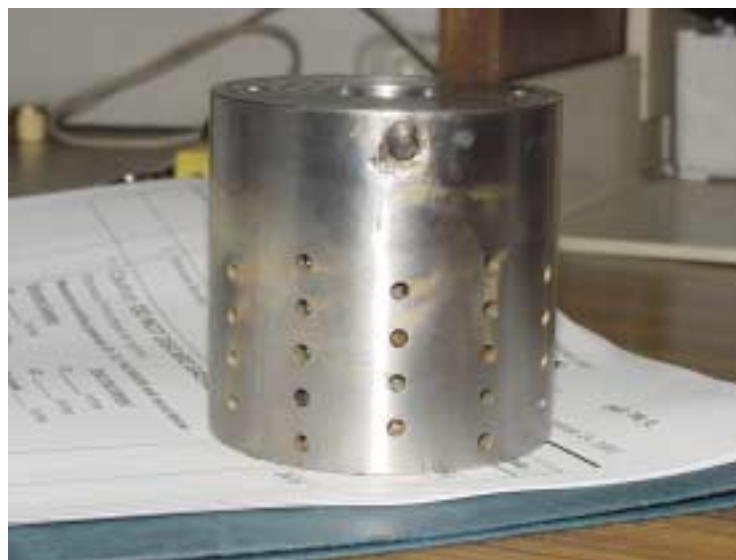
Figure 2. Recirculation Flow Restricting Orifice

The RO used a multi-stage, anti-cavitation trim package installed in the body of a globe valve to limit flow. This style of orifice or flow restrictor was installed in the AFW recirculation lines at PBNP in the past few years to eliminate cavitation caused by the old orifices. This type of flow restrictor used very small channels and holes in each stage combined with a tortuous path to limit flow and prevent cavitation.

After removal of the orifice internals, partial blockage was observed in 24 of the 54 holes in the outermost sleeve. No particles were found on any of the inner sleeves. Samples of the particles removed from the orifice were retained for analysis. A boroscope inspection of the recirculation piping at the orifice location revealed no evidence of debris. Following cleaning and reassembly, the orifice was reinstalled and the P38A AFW pump was successfully retested. Testing was successfully completed on the other three AFW pumps to verify acceptable recirculation flow by October 25, 2002.

Also, in January and February 2003, a specially fabricated orifice was tested at a contractor laboratory in an effort to determine a plugging probability with service water. Definitive testing occurred on February 21 when a debris mixture of sand, silt, and zebra mussel shells, representative of what would exist in the Point Beach SW system, was injected into a closed loop configuration of piping, an orifice, and a centrifugal pump. The orifice plugged in much less than one minute after the mixture was injected into the loop. These results were contrary to those of a previously performed computational particle fouling model analysis that indicated that plugging was unlikely because of the particle size distribution of debris in SW and the shear forces in the holes and channels of the orifices developed with the minimum flow required through the orifice for pump cooling.
