# 1991 Annual Prelicensing Inspection of the Burrell, Pennsylvania, UMTRA Vicinity Property Disposal Site

September 1992

U. S. Department of Energy  
Albuquerque Field Office  
Grand Junction Projects Office  
Grand Junction, Colorado

**Prepared by  
Chem-Nuclear Geotech, Inc.  
Under DOE Contract No. DE-AC04-86ID12584  
U.S. Department of Energy  
Grand Junction Projects Office  
Grand Junction, Colorado**

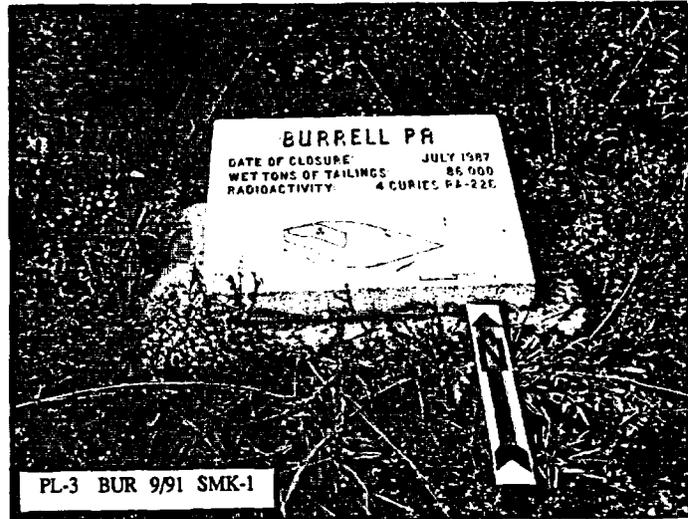
PL-3 BUR 9/91 SMK-1

Only one site marker (SMK-1) exists at the Burrell Vicinity Property. SMK-1 (PL-3) is located at the official entrance to the site near the entrance gate. The site marker is in excellent condition and shows no sign of deterioration. According to the Guidance Document (DOE, 1986), each site is to have two site markers. The Burrell site does not have the marker that is ordinarily found on the crest of the tailings embankment and, as such, is out of UMTRA Project compliance.

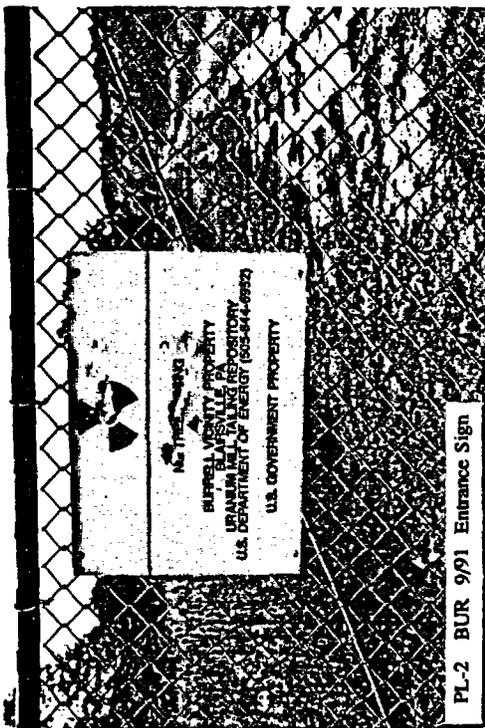
PL-2 BUR 9/91 Entrance Sign

The entrance sign (PL-2) is in place but has been significantly defaced with bullet holes. However, it is still legible and therefore is not recommended for replacement at this time. The original site inspection drawing (Drawing No. CAN-VP200-10-0104) does not show the entrance sign location or the entrance gate (PL-1). This error will be corrected on the inspection drawing in this report (Plate 1).

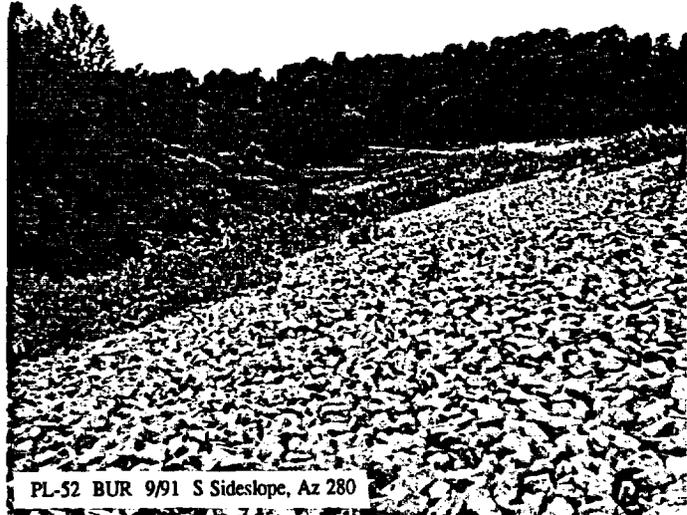
PL-52 BUR 9/91 S Sideslope, Az 280

The overall condition of the south sideslope is similar to that of the embankment top. Vegetative encroachment is significant (PL-52), but otherwise the riprap cover is in excellent condition. PL-55B is a photograph of a seep area near the toe of the south sideslope. The same seep was inspected and photographed the previous year (1990 PL-101; DOE, 1990). This year the seep was damp mud and not visibly flowing. During the 1990 inspection, the seep was flowing significantly. Western Pennsylvania was experiencing a drought throughout the summer of 1991, which could account for the lack of moisture in the seep in the 1991 inspection.

5. Significant brush and sapling growth was noted on the crest and sideslopes of the tailings embankment. Some of the growing species are believed to be capable of developing root systems of sufficient size that could eventually damage the radon barrier. A growth mitigation effort is recommended.

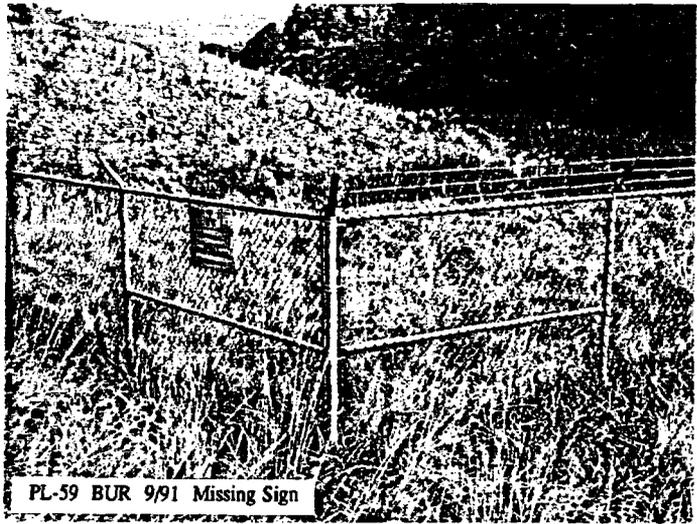
PL-59 BUR 9/91 Missing Sign

Fifteen perimeter signs should be in place at this site, but sign P9 is missing (PL-59) and sign P15 (PL-60) is severely damaged from rifle and shotgun blasts. These two signs need replacing and will be so noted in the Conclusions section of this report. The locations of all signs are shown on Plate 1.

1. Two perimeter signs need replacing. Sign P9 is missing and sign P15 is obliterated by rifle and shotgun blasts. The positions of both signs are noted on the inspection drawing, Plate 1.
2. The saplings and brush growing on the tailings embankment should be destroyed before their root systems compromise the radon barrier.

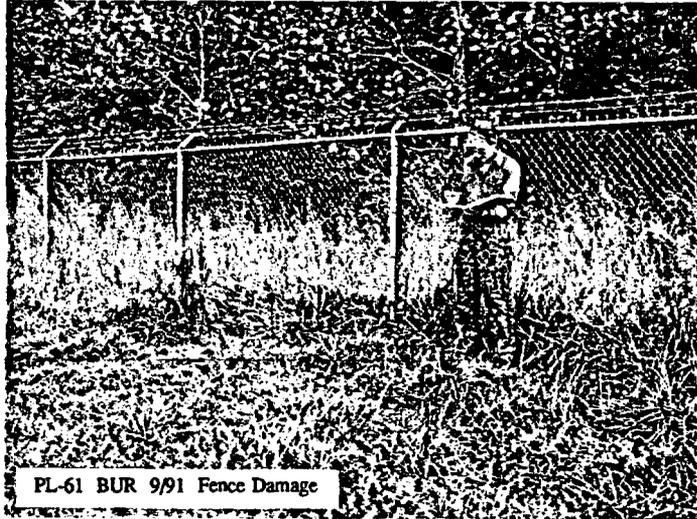
PL-61 BUR 9/91 Fence Damage

Damage to the barbed-wire portion of the perimeter fence was noted at two places (PL-61 and PL-62) along the southern perimeter. In each case, the metal brackets that hold the barbed wire in place were bent or broken. Repairs are not recommended at this time but continued surveillance will be necessary. The positions of the damaged fence are noted on Plate 1.
