1991 Annual Prelicensing Inspection of the Green River, Utah, UMTRA Project Disposal Site

September 1992

U. S. Department of Energy
Albuquerque Field Office
Grand Junction Projects Office
Grand Junction, Colorado

**Prepared by
Chem-Nuclear Geotech, Inc.
Under DOE Contract No. DE-AC04-86ID12584
U. S. Department of Energy
Grand Junction Projects Office
Grand Junction, Colorado**

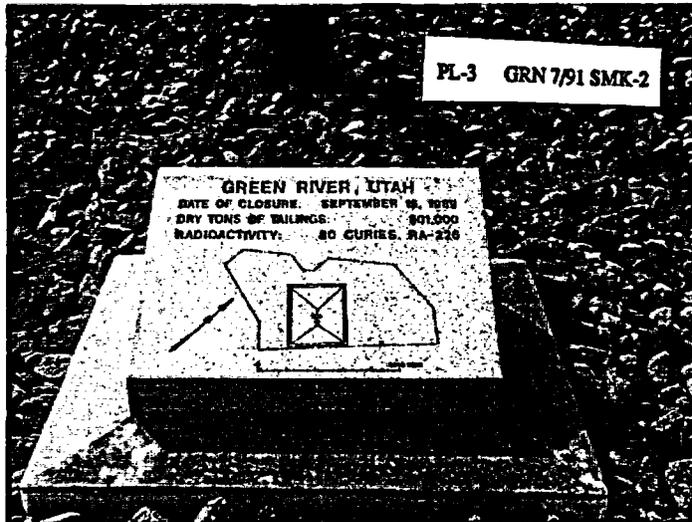
PL-3 GRN 7/91 SMK-2

There are two site markers at the Green River disposal site: SMK-1 and SMK-2. SMK-1 (PL-2) is located at the official entrance to the site near the entrance sign; SMK-2 is centrally located on the crest of the tailings embankment (PL-3). Both site markers are in excellent condition and show no sign of deterioration.

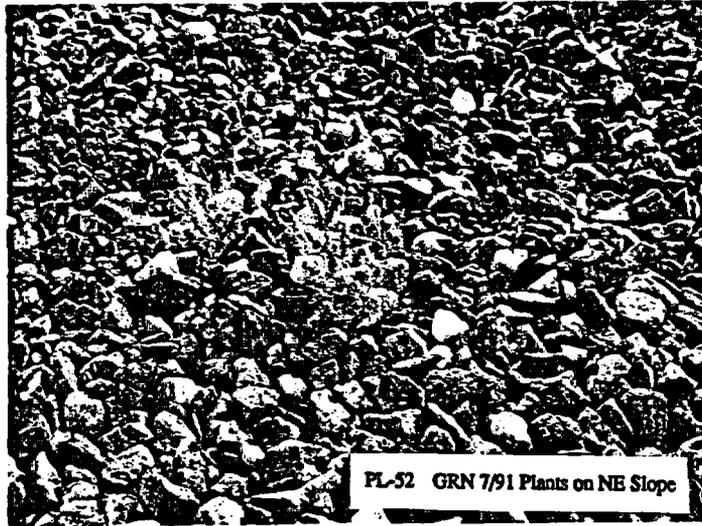
PL-52 GRN 7/91 Plants on NE Slope

The sideslopes and the crest of the Green River tailings embankment are in excellent condition (PL-45 through PL-50). The riprap is in fine condition and the riprap placement and size distribution are excellent. There are two instances of plant growth on the southwest and

northeast sideslopes (PL-51 and PL-52). In each case, single Russian thistle plants were removed after noting their positions. Plant growth on the tailings embankment will continue to be monitored.

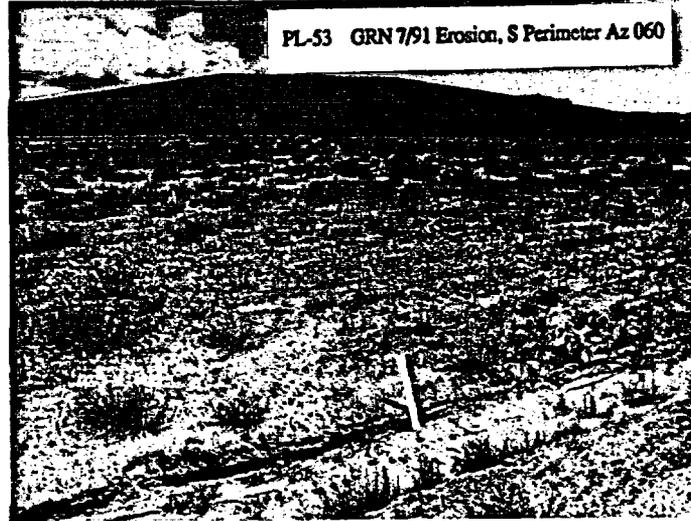
PL-53 GRN 7/91 Erosion, S Perimeter Az 060

The other off-site area subject to erosion is roughly parallel to the site boundary in the vicinity of perimeter signs P2 and P3 and is noted on Plate 1, the inspection drawing. This area (PL-53 and PL-54) is a natural drainage created by the contour of the immediate area. This erosion presently is not a threat to the site integrity but will be observed in future annual inspections.

1. Reseeded areas should be monitored for future progress in establishing vegetation, especially on the steeper, north slope of the site.
2. Off-site water tower operations and their erosional impact should continue to be monitored.
3. Erosion along the southwestern site boundary in the existing drainage contour should continue to be monitored.
4. Observe/monitor rill development along the north perimeter slope.

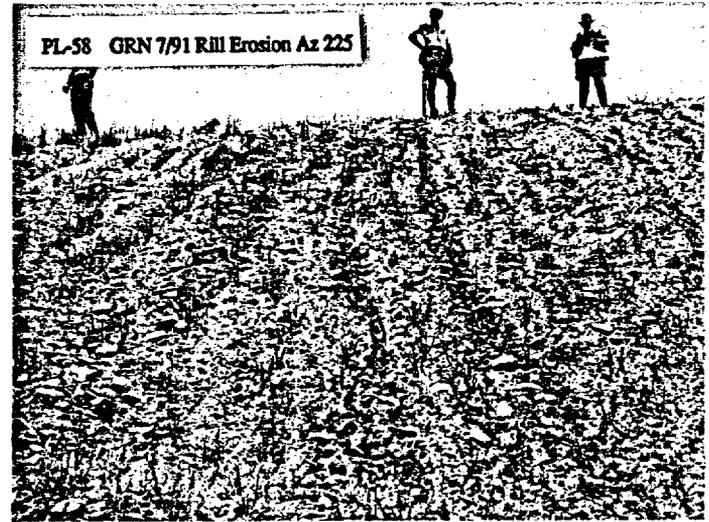
PL-58 GRN 7/91 Rill Erosion Az 225

On-Site Erosion—The on-site erosion consists of minor rill erosion (PL-58) on the north-facing hillslope south of boundary monuments 7 and 8 (also noted on Plate 1). Near BM-7, rill depth is as great as 18 inches. Near BM-8, where the slope is less steep, 4-inch deep rills were noted. This area will be a subject of continued monitoring during future site inspections. This erosion condition is expected to abate as the vegetation on the hillslope becomes better established.
