# **1991 Annual Prelicensing Inspection of the Salt Lake City (South Clive), Utah, UMTRA Project Disposal Site**

**September 1992**

**U. S. Department of Energy  
Albuquerque Field Office  
Grand Junction Projects Office  
Grand Junction, Colorado**

**Prepared by  
Chem-Nuclear Geotech, Inc.  
Under DOE Contract No. DE-AC04-86ID12584  
U. S. Department of Energy  
Grand Junction Projects Office  
Grand Junction, Colorado**

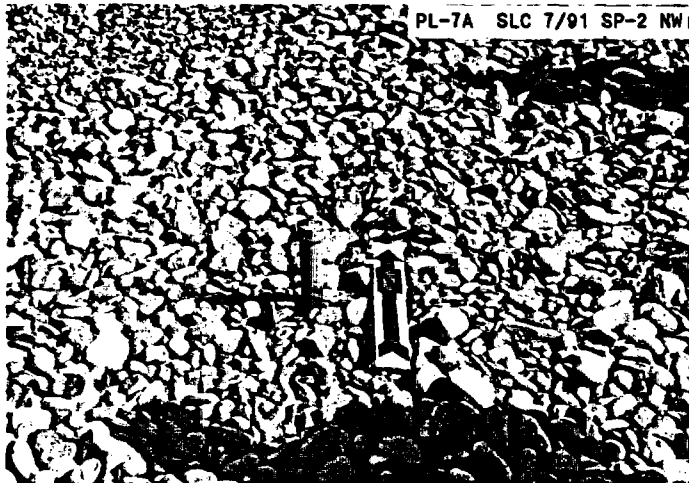
PL-7A SLC 7/91 SP-2 NW

Nine settlement plates are in place at the site: SP-1, SP-2 NW, SP-2 SE, SP-3, SP-7, SP-8, SP-10, SP-11, and SP-12. The numbers were difficult to read. All nine settlement plates are on top of the embankment and noted on Plate 1. All are identified by orange-colored threaded caps with numbers stamped on the caps. The numbering of the plates is random with two plates numbered "2." For purposes of this report the plates numbered "2" have been labeled SP-2 NW and SP-2 SE. SP-2 NW, SP-1, and SP-10 are located along the northern edge of the top transect (PL-7, PL-8, and PL-9). SP-3, SP-7, and SP-12 are located across the middle of the top transect, west to east (PL-10, PL-11, and PL-12). SP-11, SP-8, and SP-2 SE are located along the southern edge of the top transect (PL-13, PL-14, and PL-15). All settlement plate casings are in good condition except that the die-stamped numbers on the casing caps were difficult to discern and two caps are stamped with the same number "2."

**Recommendation:** When the settlement plates are resurveyed to first-order levels, replace the caps with caps which have numbers that are readable and are in sequential order. Weld the caps onto the settlement-plate casings.

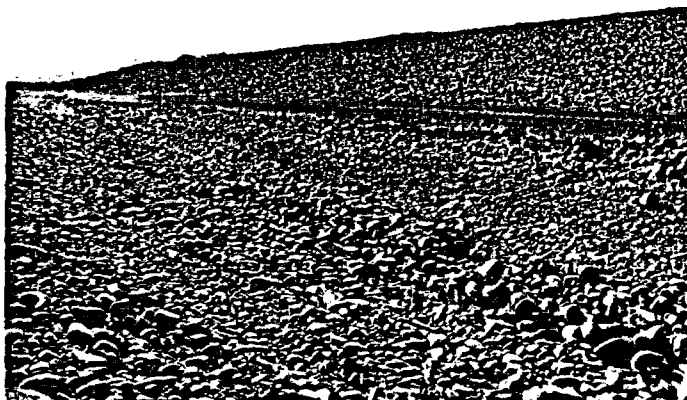
PL-33B SLC 7/91 N Diversion Channel, Missing Riprap

channel is shown in photographs taken at PL-32A, PL-32B, and PL-34A. There is evidence of plant growth (PL-32B) and missing riprap in photographs PL-33A and PL-33B. The riprap is missing on the south side of the northern section from the top to just above the bottom of the channel. The missing riprap extends for about 100 yards along the channel.

| Photographer's<br>Location No. <sup>a</sup> | Azimuth <sup>b</sup> | Photo Description/Remarks |
|---|---|---|
| 33B | 135 | N perimeter diversion channel; missing riprap. |

The SMP did not define the construction and emplacement specifications for the riprap erosion barriers. The riprap specifications should be determined and the missing riprap put in place.

**Recommendation:** Determine the specification for riprap for the diversion channel. Place sufficient riprap where appropriate.

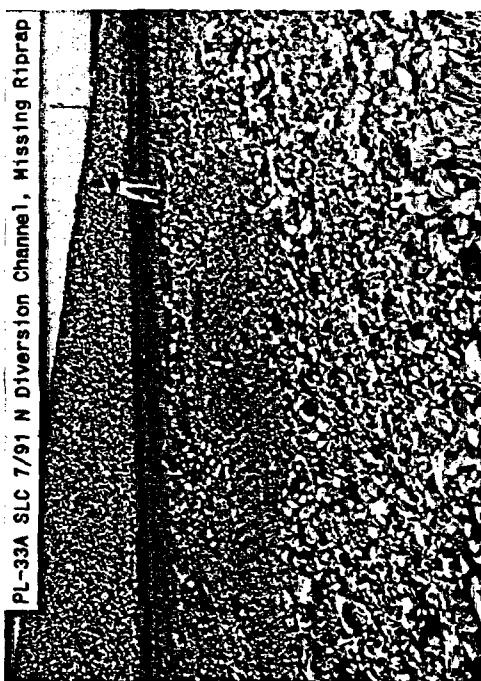
PL-33A SLC 7/91 N Diversion Channel, Missing Riprap

| Photographer's<br>Location No. <sup>a</sup> | Azimuth <sup>b</sup> | Photo Description/Remarks |
|---|---|---|
| 33A | 225 | N perimeter diversion channel; missing riprap. |
