**TECHNICAL REPORT  
TR-3270-9-90**

**AN OPERATIONAL ASSESSMENT OF THE  
BABCOCK & WILCOX AND COMBUSTION ENGINEERING  
CONTROL ROD DRIVES**

**September 1990**

**E. Grove and W. Gunther  
Engineering Technology Division**

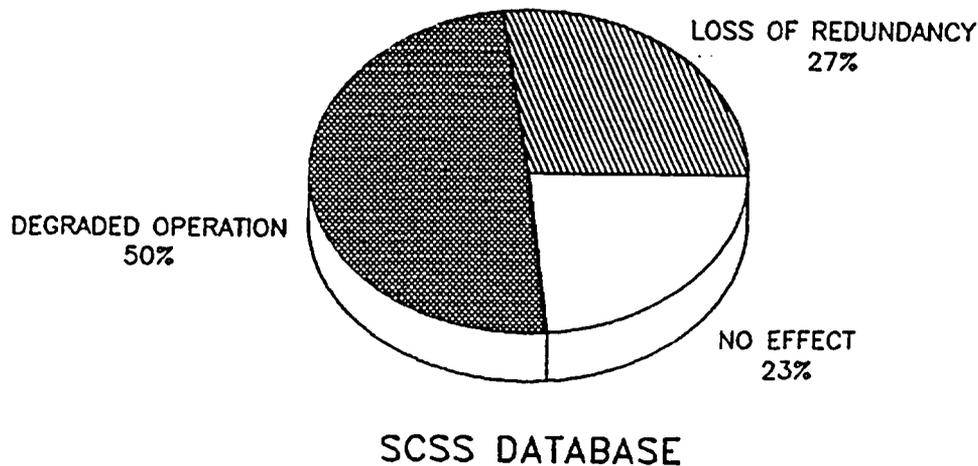
Figure 4.7. Effect of failure on CRD system SCSS database.

Failures of the Control Rod Drive System for B&W plants, as shown in Figure 4.7, resulted in degraded plant operations 50% of the time, and loss of redundancy an additional 27%. As described above for CE, malfunctions and failures accounted for the majority of the redundancy losses.

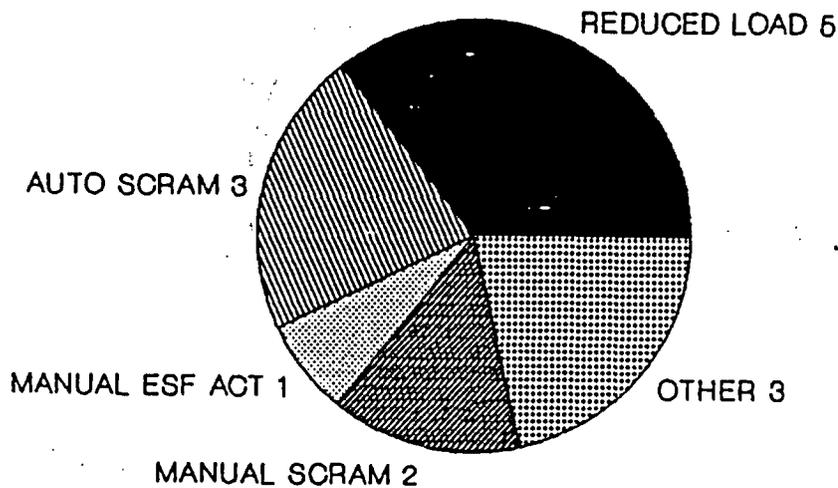
Figure 4.8. B&W significant plant effects 1980-1989.

CRD system failures also caused significant perturbations on plant operations as shown on Figure 4.8. Control Rod assembly slippage or complete dropping were the primary cause of reduced load incidents. A loose power connection twice caused rod drops resulting in a reactor tilt exceeding the Technical Specification limits. A failed fuse in a control rod power supply accounted for another rod drop occurrence.

The manual actuation of the ESF was initiated by a dropped rod and subsequent reactor trip due to low reactor system pressure. The feedwater block valves failed to close causing a high steam generator level. The emergency feedwater system was manually activated, and the main feedwater pumps manually tripped.

During the time period, two plant manual scrams were also reported. Multiple dropped rods due to a failed power supply initiated one event. The other manual scram was caused by a loose solder joint on a control rod sequencing card resulting in a power loss to the control rods.

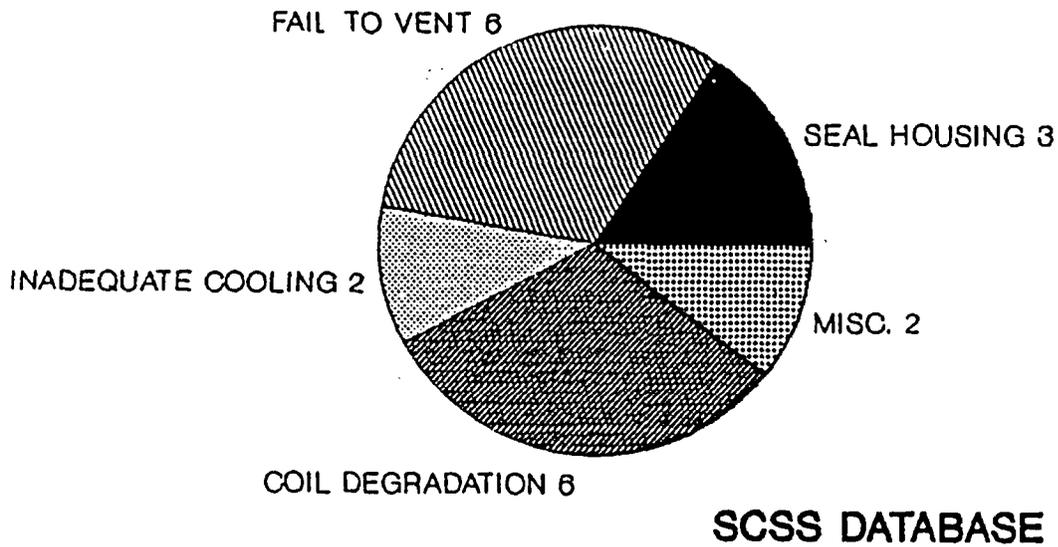
Figure 4.9. CE CEDM failures 1980-1989.

A review of the reportable failures indicates that CEDM failures occurred frequently. For the period, nineteen LER's were written documenting CEDM failures at CE plants. The specific failure causes are shown on Figure 4.9. A similar review of the NPRDS data base is presented in Figure 4.10. Since many of the failures resulting in primary coolant leakage are found during outages, LER's are not necessarily written, since it did not affect the safe operation of the plant.

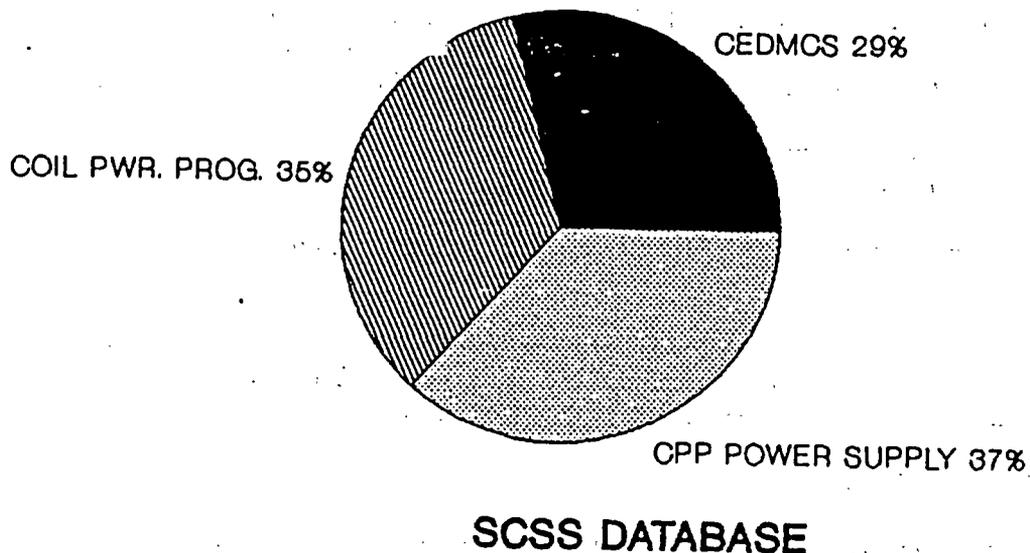
Figure 4.11. CE control system failures 1980-1989.

Control system failures accounted for the greatest occurrence of failures in CE plants. The result of the failures normally were dropped, slipped, or immovable CEA's. The control system was also susceptible to exterior stresses as well, since several instances of component overheating due to inadequate cooling system operation were reported. The specific component failures frequency are shown in Figure 4.11.

Failures of the coil power programmer were common, as sluggish upper gripper operation accounted for a large number of slipped or dropped CEA's. Corrective action consisted of adjusting the gripper timing sequences and increasing the coil voltages. Some plants have replaced the existing magnetic coils, with larger System 80 coils, designed to produce stronger magnetic fields resulting in improved latching capability.

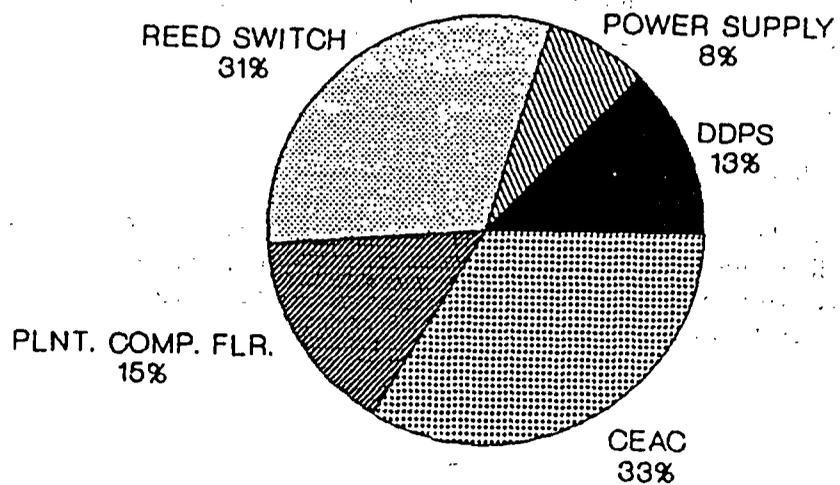
Figure 4.13. CE rod position indication failures 1980-1989.

CE plants utilize two systems to provide rod position indication, the reed switch and the pulse counting systems. For the period reviewed, component failures of each accounted for a significant portion of the reportable events, as shown on Figure 4.13.

Control Element Assembly Calculator (CEAC) failures accounted for the highest frequency of failures. The CEAC is an integral part of the position indication system, and its loss could generate spurious rod position signals leading to a reactor trip. The typical CEAC failure was related to circuit board malfunctions, however, each report did not provide sufficient detail in each instance to determine exact failure cause. It is interesting to note that one CEAC failure was credited to natural end of life failure during the first cycle of operation.

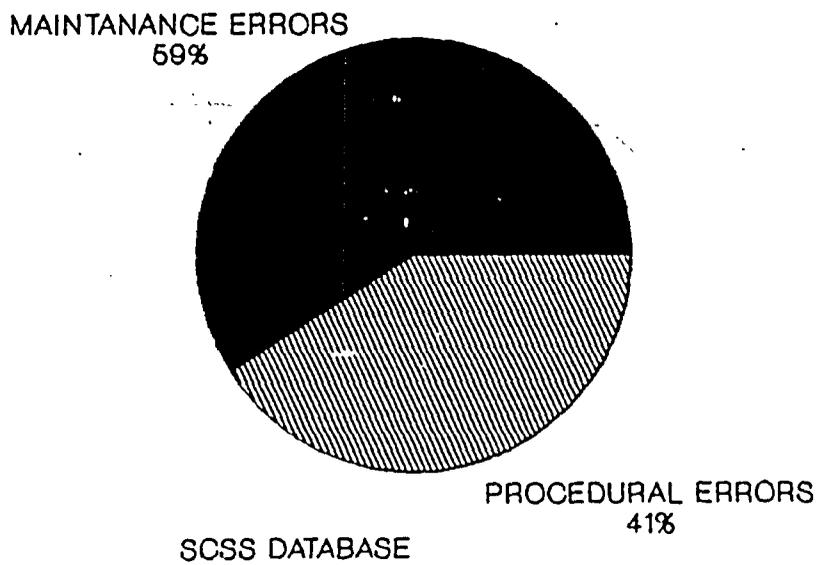
Figure 4.16. CE CED related human errors 1980-1989.

The control element drive system was susceptible to component failures and environmental degradation as well as human errors. As shown on Figure 4.16, human errors could be divided into either maintenance errors or procedural errors. While it may be argued that errors of this type are not aging related, they do stress the plant systems, particularly when scrams, power reductions and ESF actuations result.

The majority of maintenance errors resulted in dropped rods and power reductions. Other events were caused by procedural errors which either did not account for proper position verification of the CEA's, or caused a portion of the system to be out of service. While it did not result in any particular system effect, in many instances a loss of redundancy resulted.
