Subject: Licensee Event Report

1. FACILITY NAME LaSalle County Station, Unit 1						2. DOCKET NUMBER 05000373			3. PAGE 1 of 4		
4. TITLE Manual Reactor Scram on Low Reactor Vessel Water Level Due to Stuck Open Feedwater Pump Discharge Check Valve

Crane 24 inch Tilting Disc Check Valve, Model 973A.

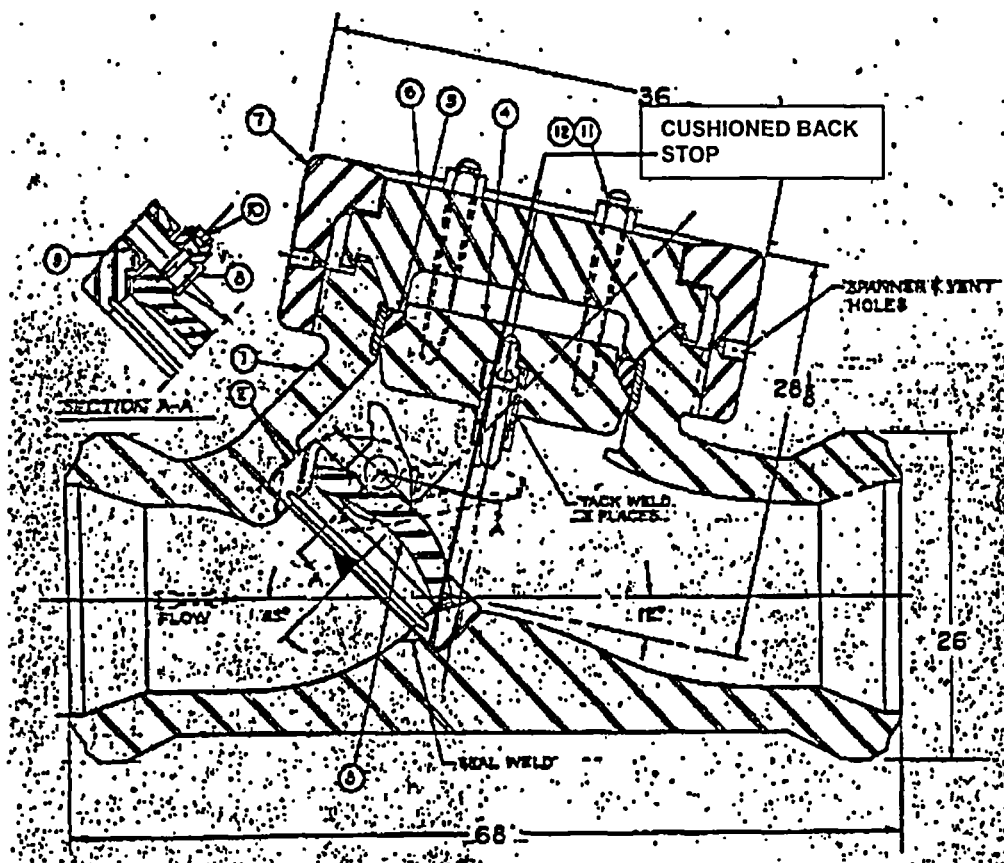
Figure 1

The root cause of the failure was inadequate design. The cross-section of the integral over travel disc stop contact surface, due either to original casting or excessive final grinding during manufacture, was reduced to the point that the disc stop would strike on the angled surface of the seat ring rather than the flat area. This imparted a lateral force to the disc that resulted in binding between the disc hinge ears and the seat ring hinge ears (See Figure 1).

Check Valve Assembly

1. TDRFP discharge check valve 1FW001A was inspected, and new hinge pins and a cushioned back stop were installed prior to the restart of Unit 1 on 11/28/03. This action is complete.
2. The integral over travel disc stops for the TDRFP and MDRFP discharge check valves on both Units (1/2FW001A/B and 1/2FW002) and the Condensate Booster Motor Driven Reactor Feed Pump supply bypass discharge check valves on both Units (1/2FW023) will be inspected for proper contact with the seat ring. Where necessary, the assembly will be replaced, or the contact surface area of the disc stop will be increased using weld build-up in accordance with vendor recommendations (AT#188345-29 to 34).
3. The design of the cushioned back stop for the affected valves will be revised to incorporate vendor configuration enhancements and to revise the weld configuration and size (AT# 188345-35, 36).
