**SUBJECT: AUGMENTED INSPECTION TEAM REVIEW OF THE DECEMBER 22, 2003,  
SITE AREA EMERGENCY (INSPECTION REPORT NO. 40-3392/2004-001 -  
HONEYWELL)**

AUGMENTED INSPECTION TEAM CHARTER  
HONEYWELL INTERNATIONAL, INC.  
URANIUM HEXAFLUORIDE RELEASE

Report No. 40-3392/2004-001

Licensee: Honeywell International, Inc.

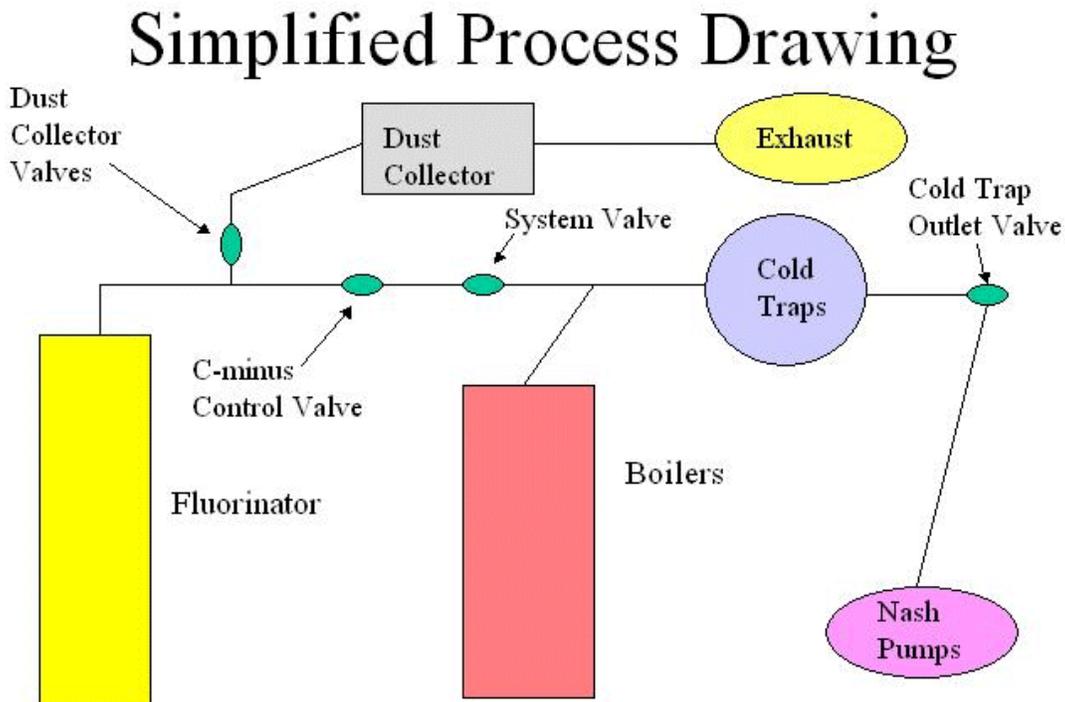
A simple drawing of the process that illustrates the relationship of the various valves, piping and equipment involved in the release is provided below. Pictures of the C-minus control valve, the system valve and piping and the dust collector exhaust stack are on the next page.

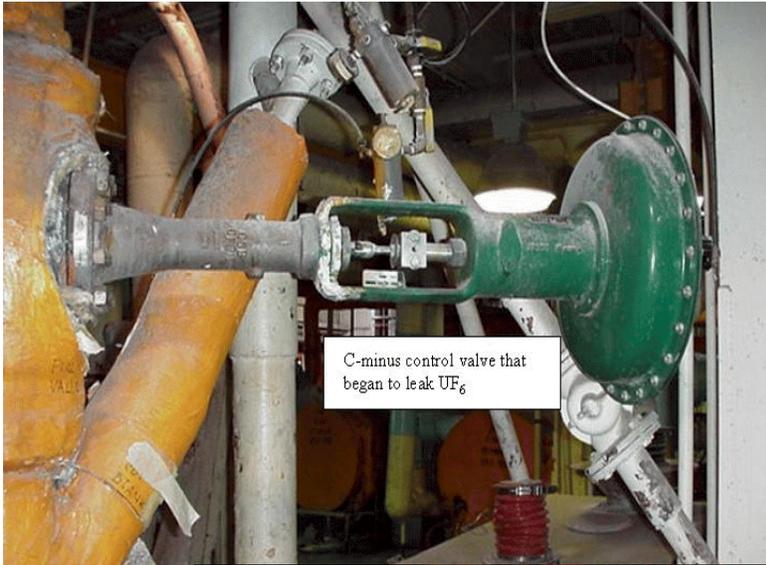
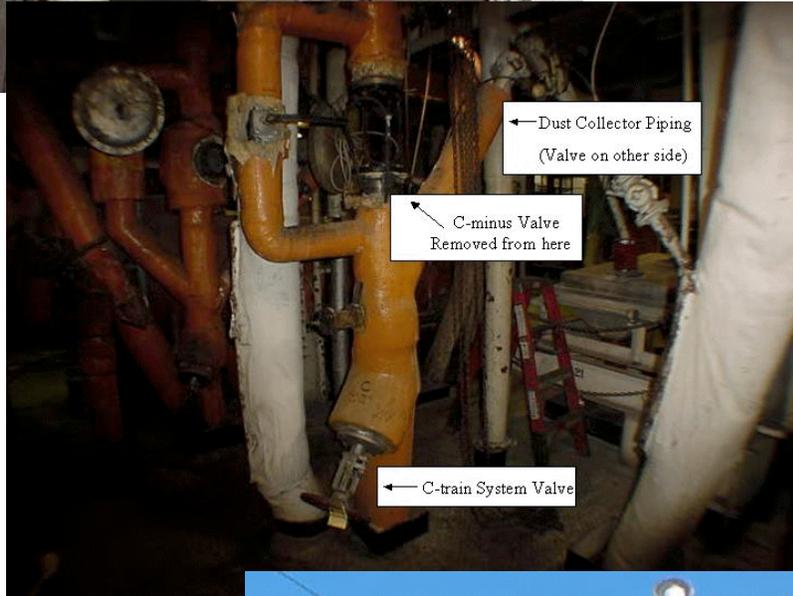
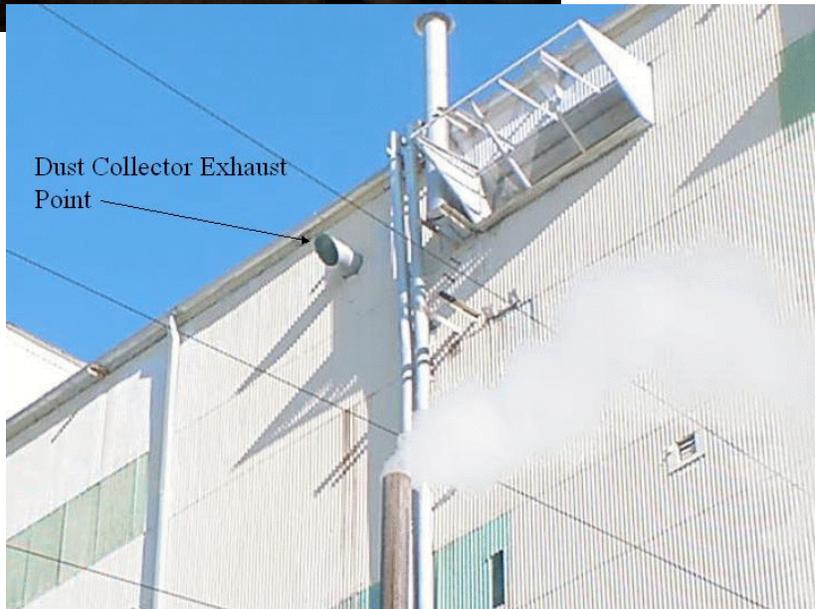
At about 3:15 a.m., the fifth team to enter the FMB searched the area for leaks and found that the only visible leak was a wisp of white "smoke" coming from the C-minus control valve on the fifth floor. They tightened down on the valve packing and

the leak stopped. The inspectors determined that this valve was the primary source of the  $UF_6$  that leaked into the FMB. Several minor leak points were detected throughout the system later during subsequent plant walkdowns.

Control room logbooks for the FMB Foreman and Fluorination Operator indicated that the C-minus control valve exhibited in-leakage during the day shift on December 6, 2003. The inspectors discovered from interviews that the packing on the valve had been tightened shortly after the discovery of the leak to remedy the in-leakage. A repair notifications list was reviewed to see if a work order was issued for the valve at that time. No record of a notification was found. Therefore, no work order was written to repair the valve, although in-leakage of the valve packing indicated that the bellows had failed. Following the event, a repair notification was issued as a part of the event recovery activities. When the valve was examined, the licensee discovered that the bellows had completely ruptured due to the pressure that built up in the system and this caused the valve to begin leaking UF<sub>6</sub>.
