**SUBJECT: AUGMENTED INSPECTION TEAM REVIEW OF THE DECEMBER 22, 2003,  
SITE AREA EMERGENCY (INSPECTION REPORT NO. 40-3392/2004-001 -  
HONEYWELL)**

Report No. 40-3392/2004-001

Licensee: Honeywell International, Inc.

Facility: Metropolis Works

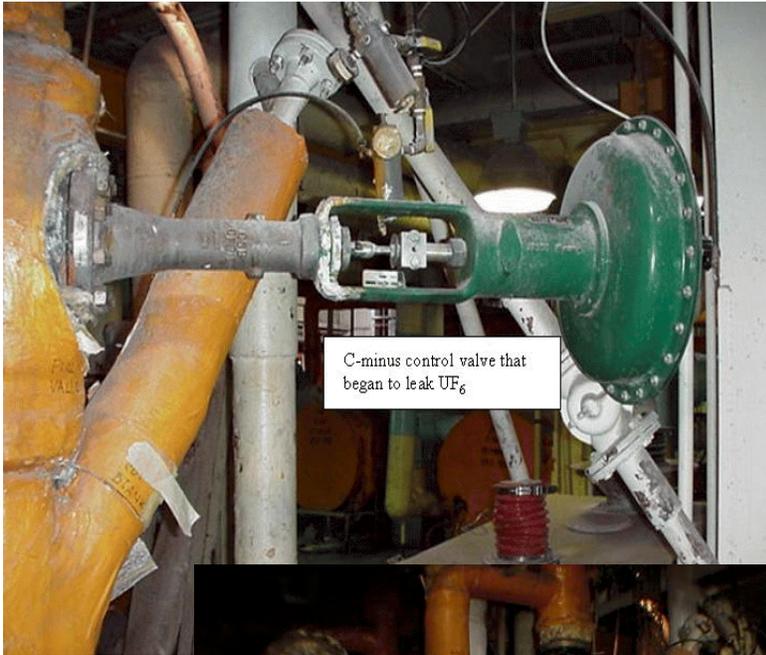
At about 3:15 a.m., the fifth team to enter the FMB searched the area for leaks and found that the only visible leak was a wisp of white "smoke" coming from the C-minus control valve on the fifth floor. They tightened down on the valve packing and

the leak stopped. The inspectors determined that this valve was the primary source of the  $UF_6$  that leaked into the FMB. Several minor leak points were detected throughout the system later during subsequent plant walkdowns.

A simple drawing of the process that illustrates the relationship of the various valves, piping and equipment involved in the release is provided below. Pictures of the C-minus control valve, the system valve and piping and the dust collector exhaust stack are on the next page.

Control room logbooks for the FMB Foreman and Fluorination Operator indicated that the C-minus control valve exhibited in-leakage during the day shift on December 6, 2003. The inspectors discovered from interviews that the packing on the valve had been tightened shortly after the discovery of the leak to remedy the in-leakage. A repair notifications list was reviewed to see if a work order was issued for the valve at that time. No record of a notification was found. Therefore, no work order was written to repair the valve, although in-leakage of the valve packing indicated that the bellows had failed. Following the event, a repair notification was issued as a part of the event recovery activities. When the valve was examined, the licensee discovered that the bellows had completely ruptured due to the pressure that built up in the system and this caused the valve to begin leaking UF<sub>6</sub>.
