Subject: 2003 Annual Site Inspection and Monitoring Report for UMTRCA Title I  
Disposal Sites

# 2003 Annual Site Inspection and Monitoring Report for Uranium Mill Tailings Radiation Control Act Title I Disposal Sites

January 2004

GJO-2003-528-TAC

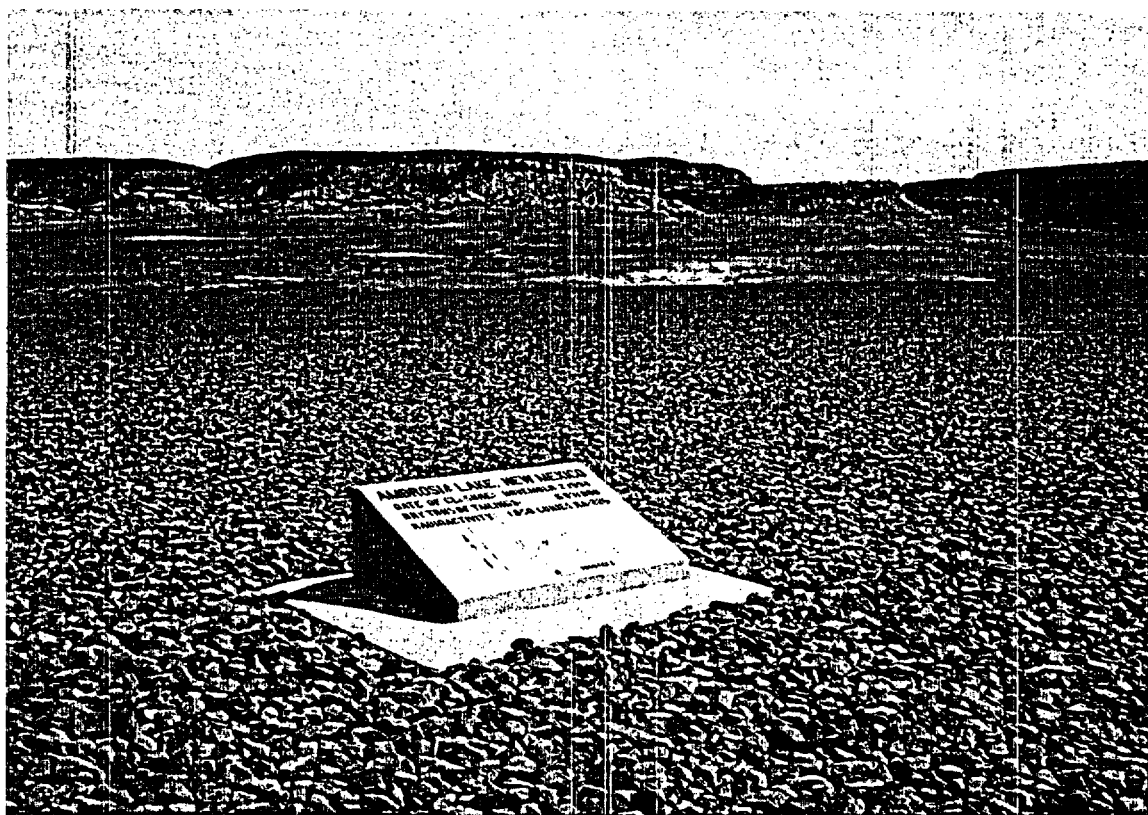
**Top of Disposal Cell**—The top of the disposal cell generally was in good condition (PL-1). With the exception of one location there was no evidence of cracking, settling, slumping, or erosion. A small shallow depression around settlement plate SP-4 was first noted during the 1997 inspection; however, there has been no evidence to suggest the depression holds water. At the time of the 2003 annual inspection, the subsidence was estimated to measure approximately 1 foot in depth (PL-2). The depression will continue to be monitored to determine if it is increasing and to ensure that the integrity and performance of the cell cover is maintained. The elevation of SP-4 and the diameter of the depression will be surveyed in 2004.

*AMB 5/2003. PL-1. Site marker SM-2 at the center of the cell cover.*

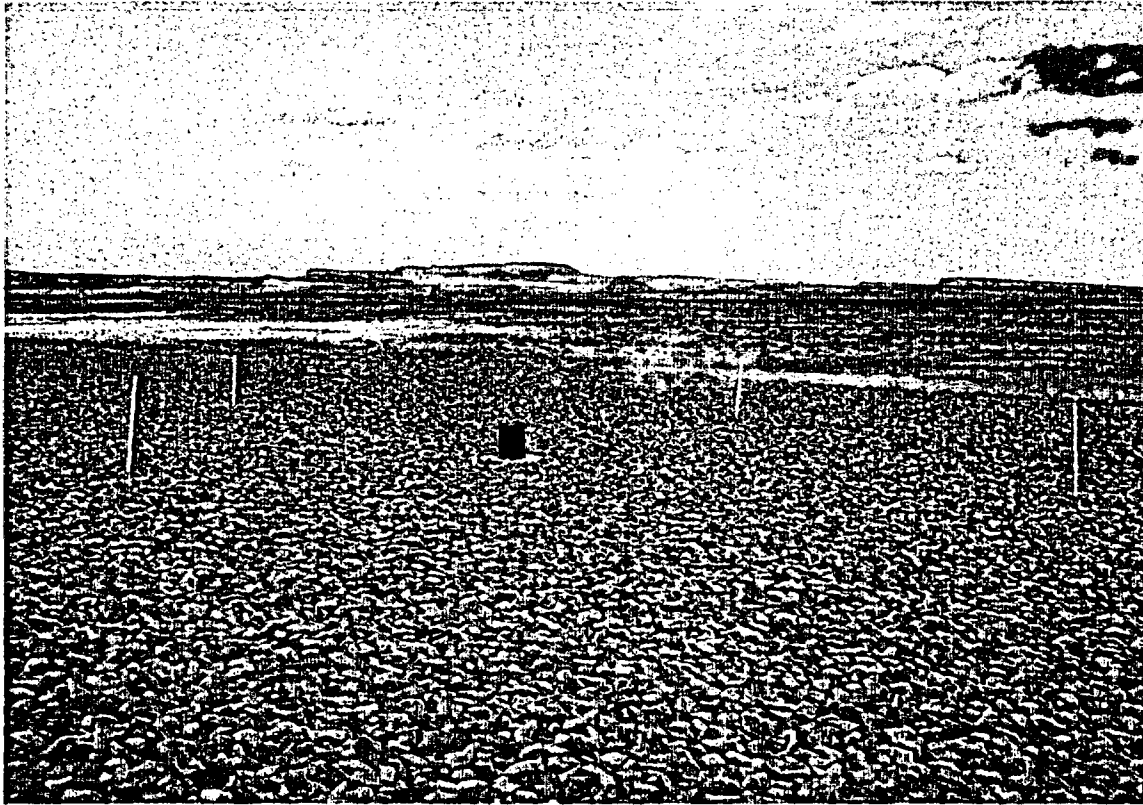
*AMB 5/2003. PL-2. Depression centered around settlement plate SP-4.*

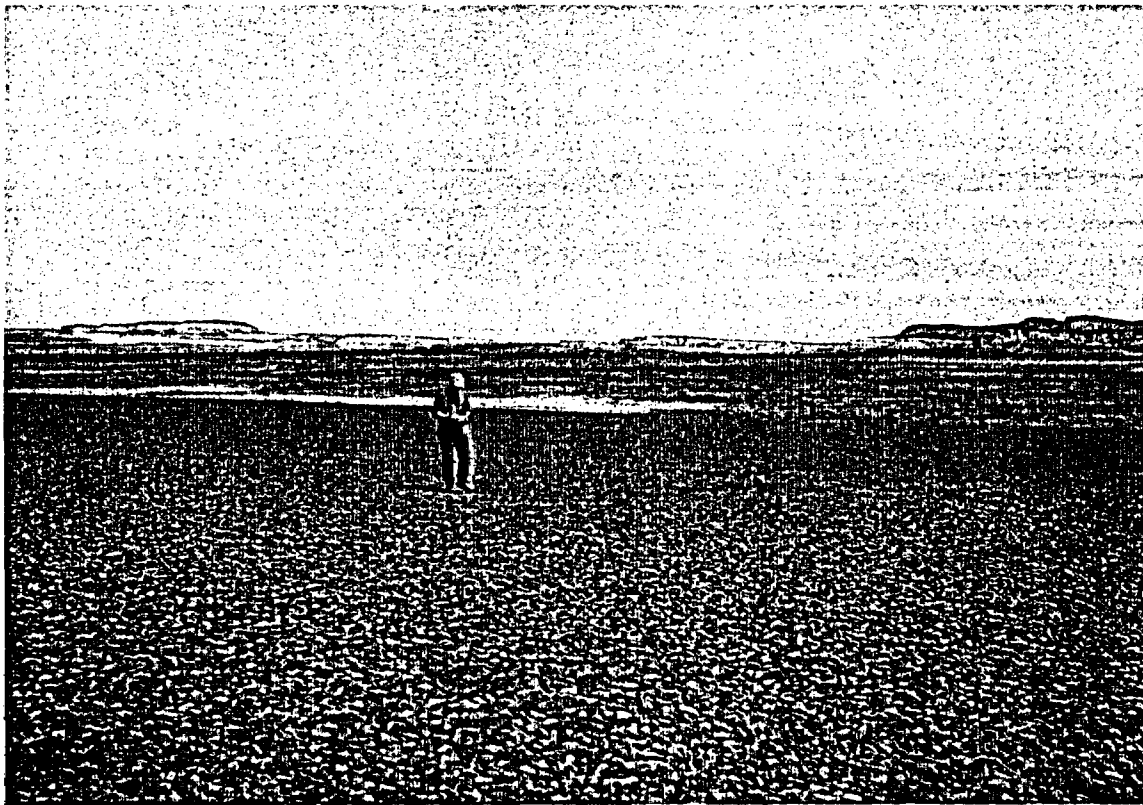
Trespassing was evident on top of the disposal cell. An all-terrain vehicle (ATV) had been driven to the top of the cell and used to mark four circles with diameters between 40 and 60 feet (PL-3). Another area of surface disturbance was noted near the southeast corner of the cell top. The tracks were very shallow and do not impair the integrity or performance of the cover.

*AMB 5/2003. PL-3. Circular-shaped vehicular disturbance on the north facet of the cell cover.*

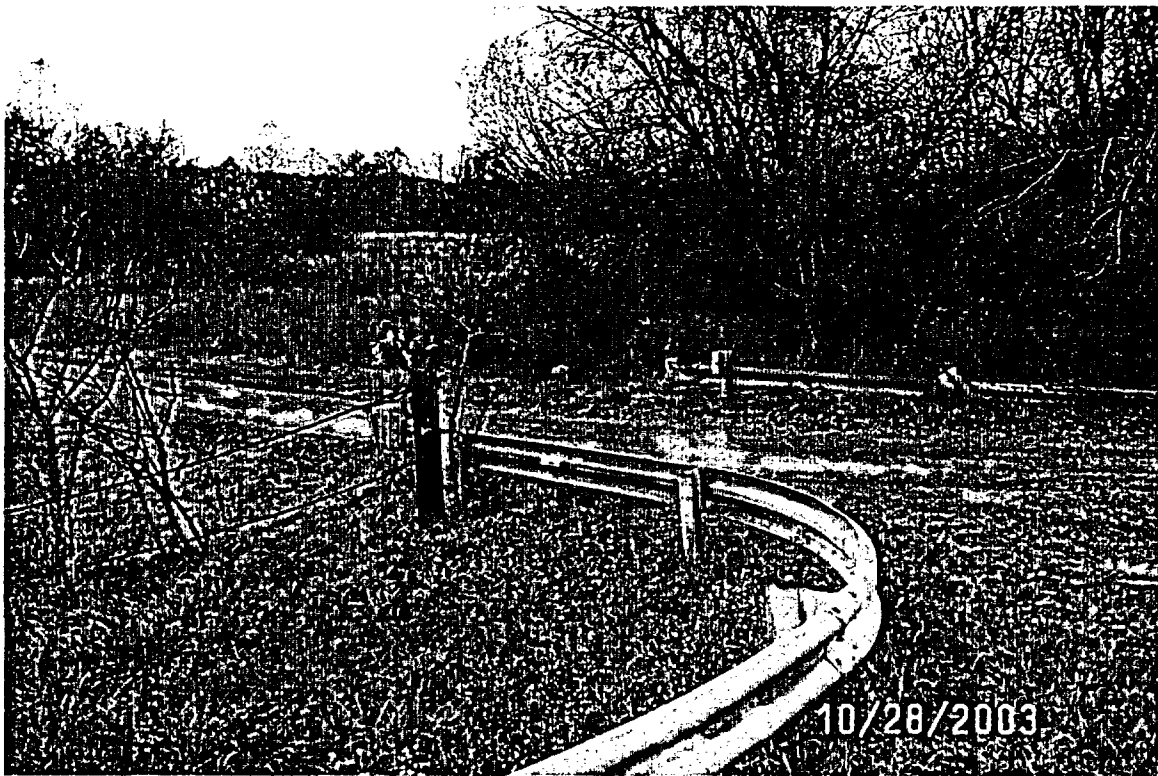
**Site Access, Fence, Gates, and Signs**—An access road leads from Strangford Road to the security fence at the site boundary. The former access gate at Strangford Road was unsuccessful in keeping people off the access road and out of the areas adjacent to the site, and was open and heavily damaged at the time of the 2002 inspection. DOE determined that limiting site access at Strangford Road did not enhance site security or protectiveness, and received concurrence from the U.S. Nuclear Regulatory Commission on April 28, 2003, to remove the gate. The gate was removed prior to the 2003 inspection (PL-1). The hard-packed graveled access road runs southwest across DOE's perpetual right-of-way (Tract 201-E) and DOE's leased crossing over Norfolk Southern Railroad right-of-way to the site. There were shallow potholes in the road but it was easily passable in a passenger car.

*BUR 10/2003. PL-1. Location of the former access gate at Strangford Road.*

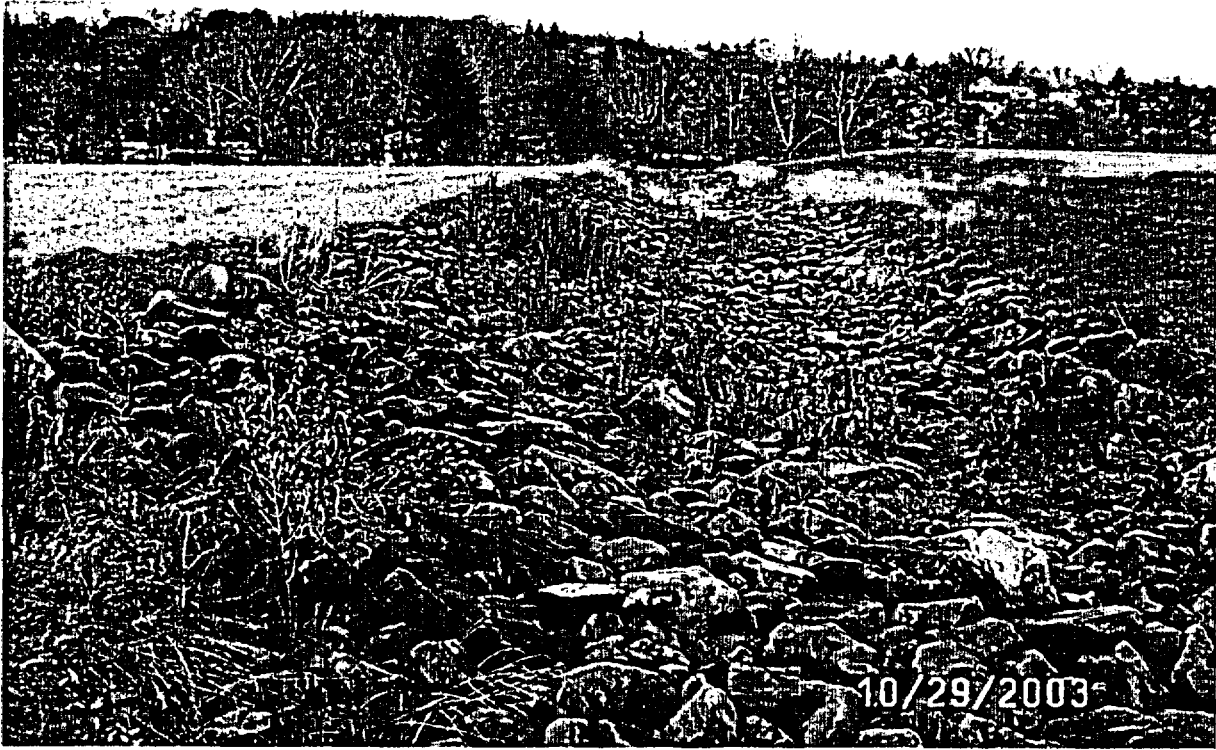
*CAN 10/2003. PL-1. Vegetation encroachment in the western diversion channel.*

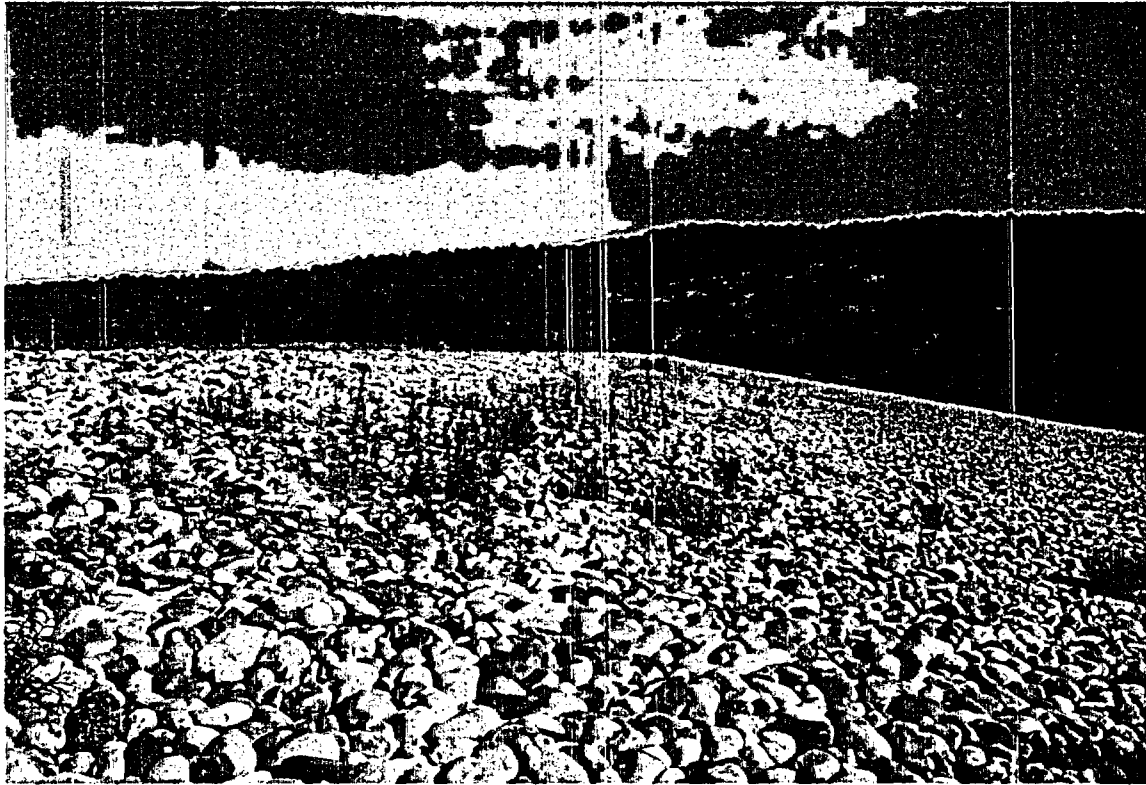
*DUR 6/2003. PL-1. Vegetation, including Canada thistle, on the east side slope of the cell.*

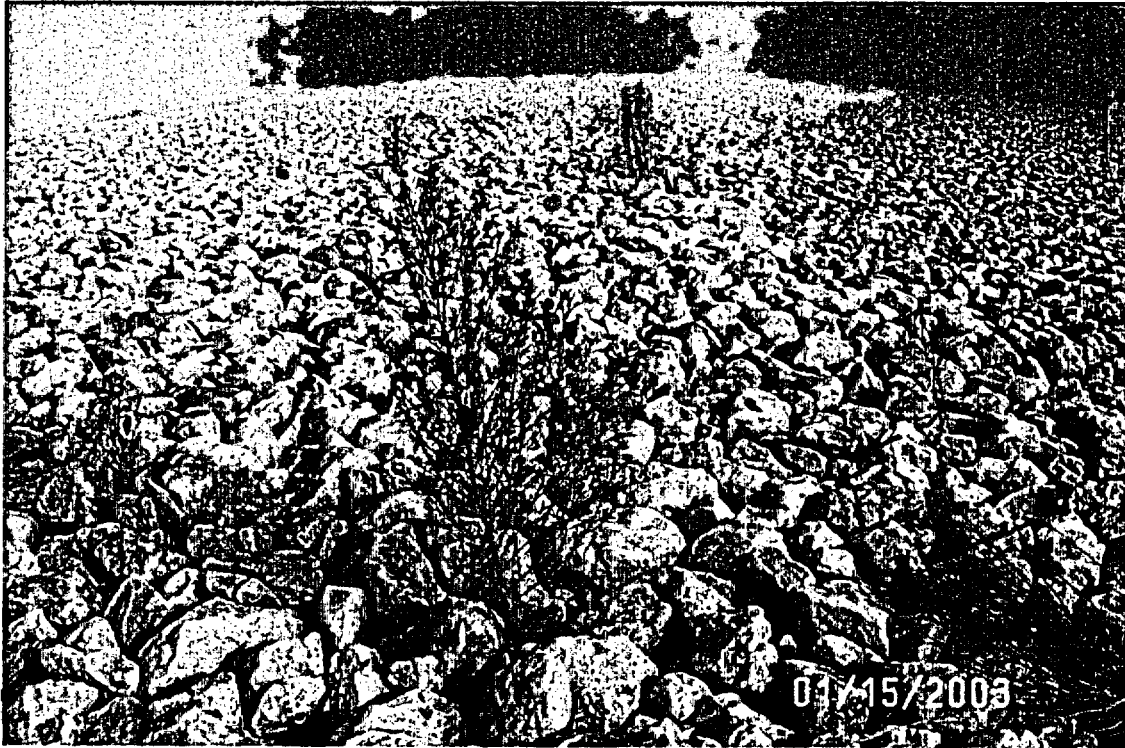
*FCT 1/2003. PL-2. Woody plants on the side slope at the south corner of the disposal cell.*

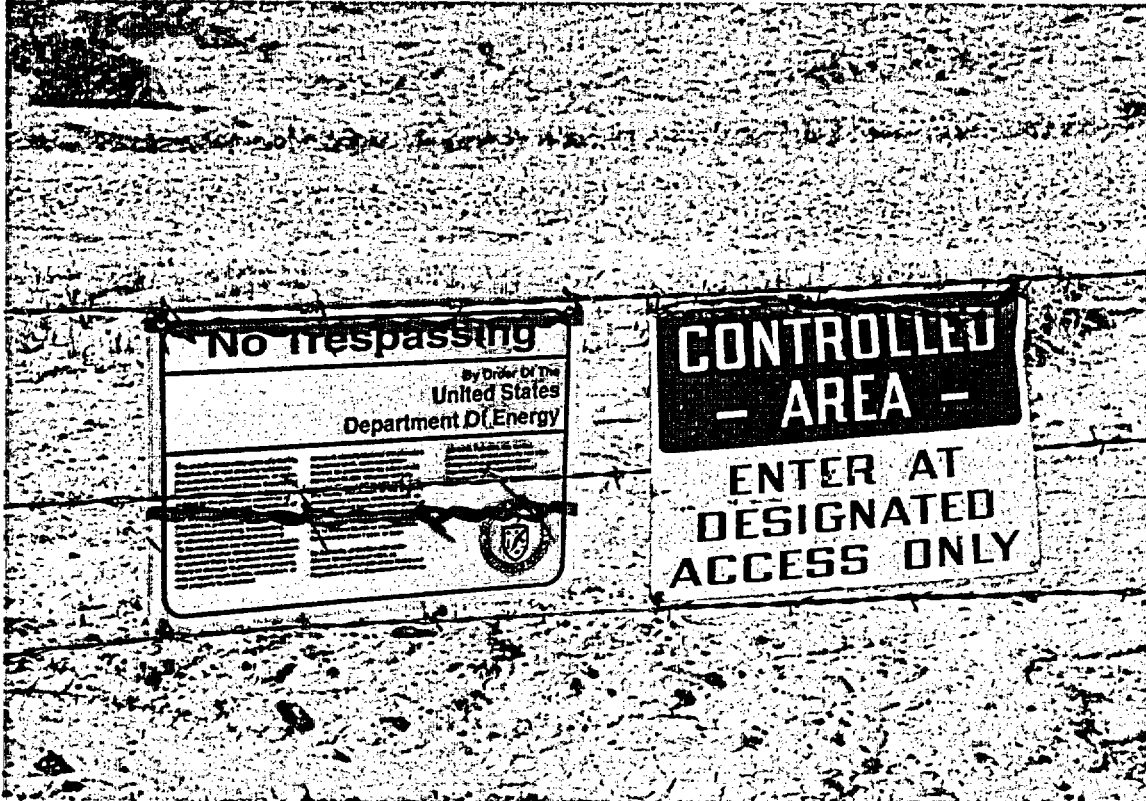
GRJ 03/2003. PL-1. Warning signs on the perimeter fence.

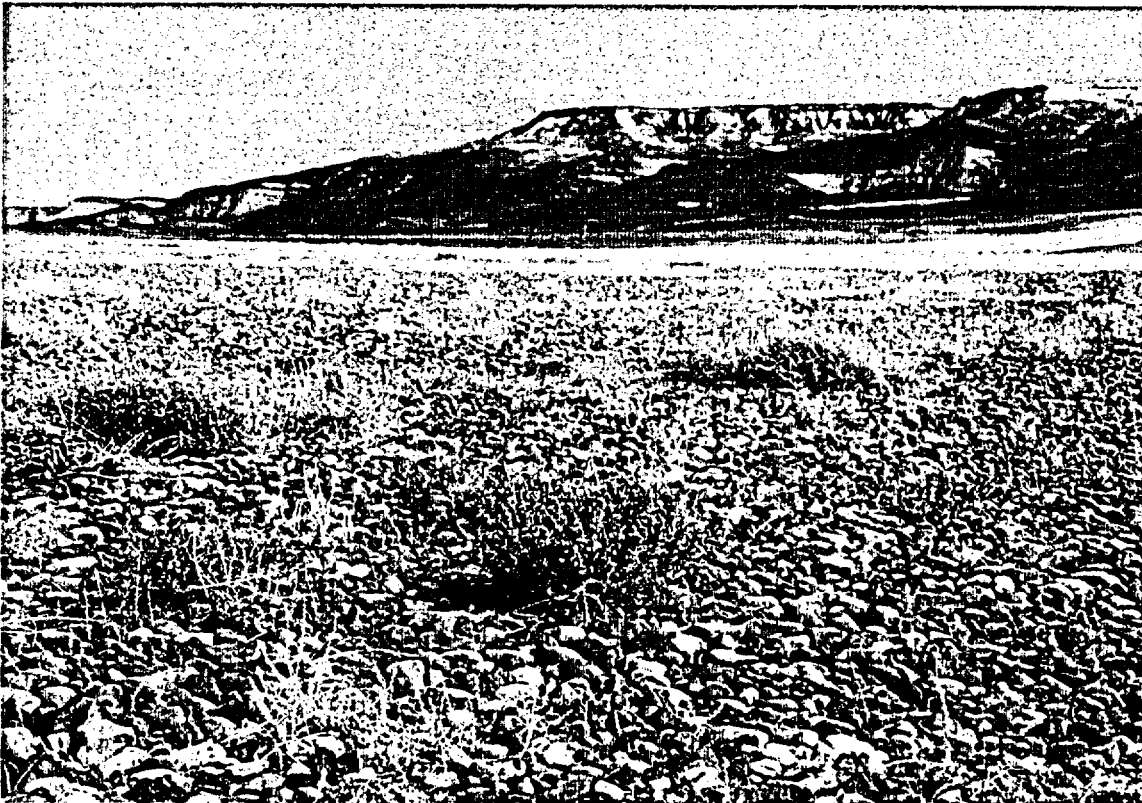
GRJ 03/2003. PL-2. Scattered vegetation on cell top near the southeast corner of disposal cell.

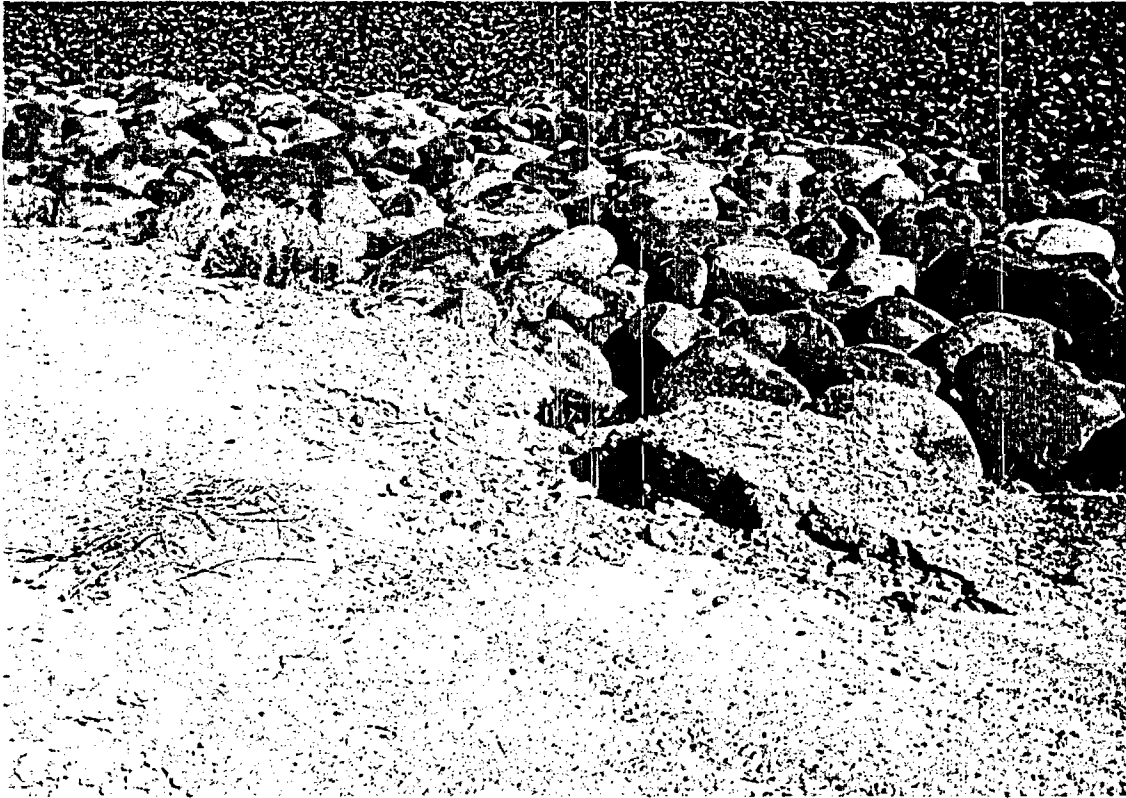
*GRN 03/2003. PL-1. Erosion in the cell perimeter road along the southwest side of the disposal cell.*

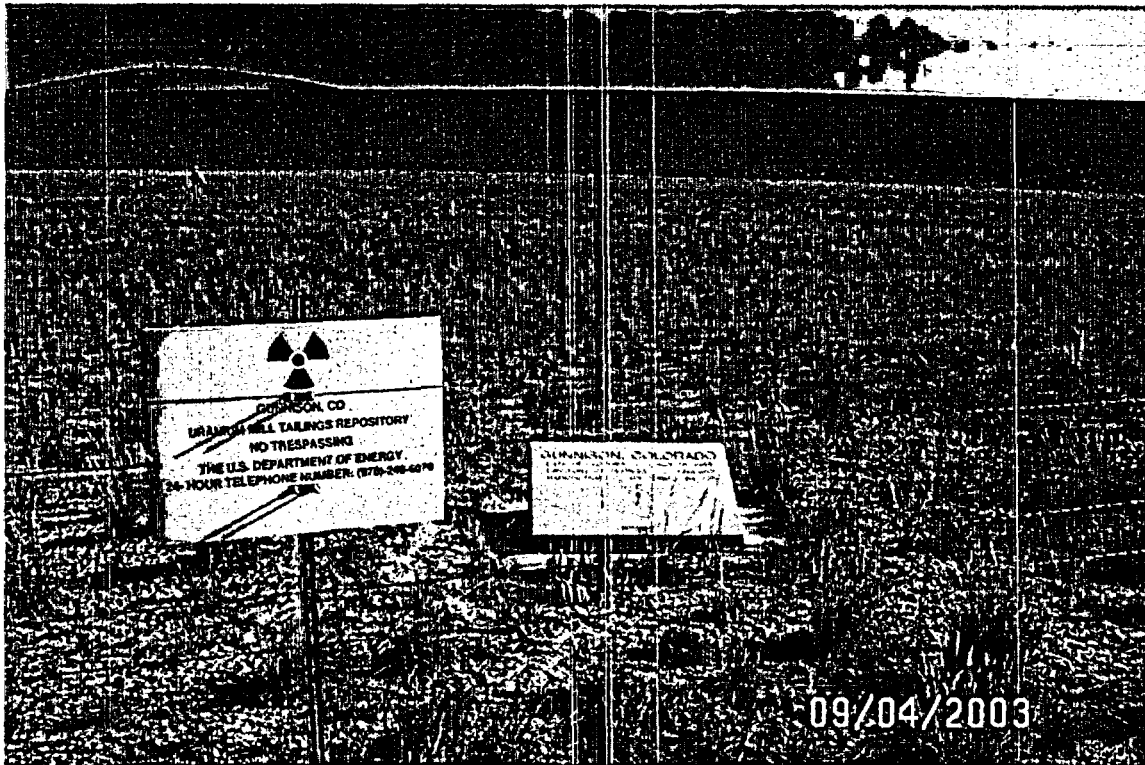
*GUN 9/2003. PL-1. Site marker SMK-1 and the new entrance sign.*

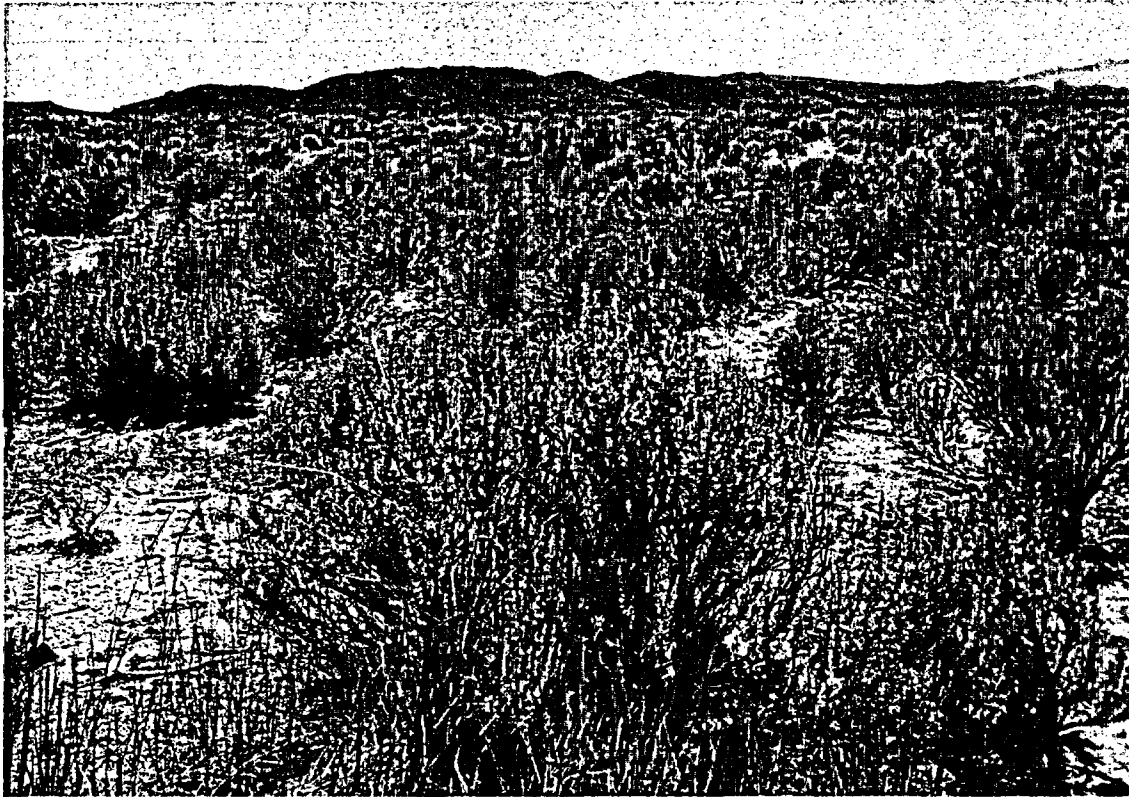
*LKV 6/2003. PL-1. Shrubs growing on the top slope of the disposal cell.*

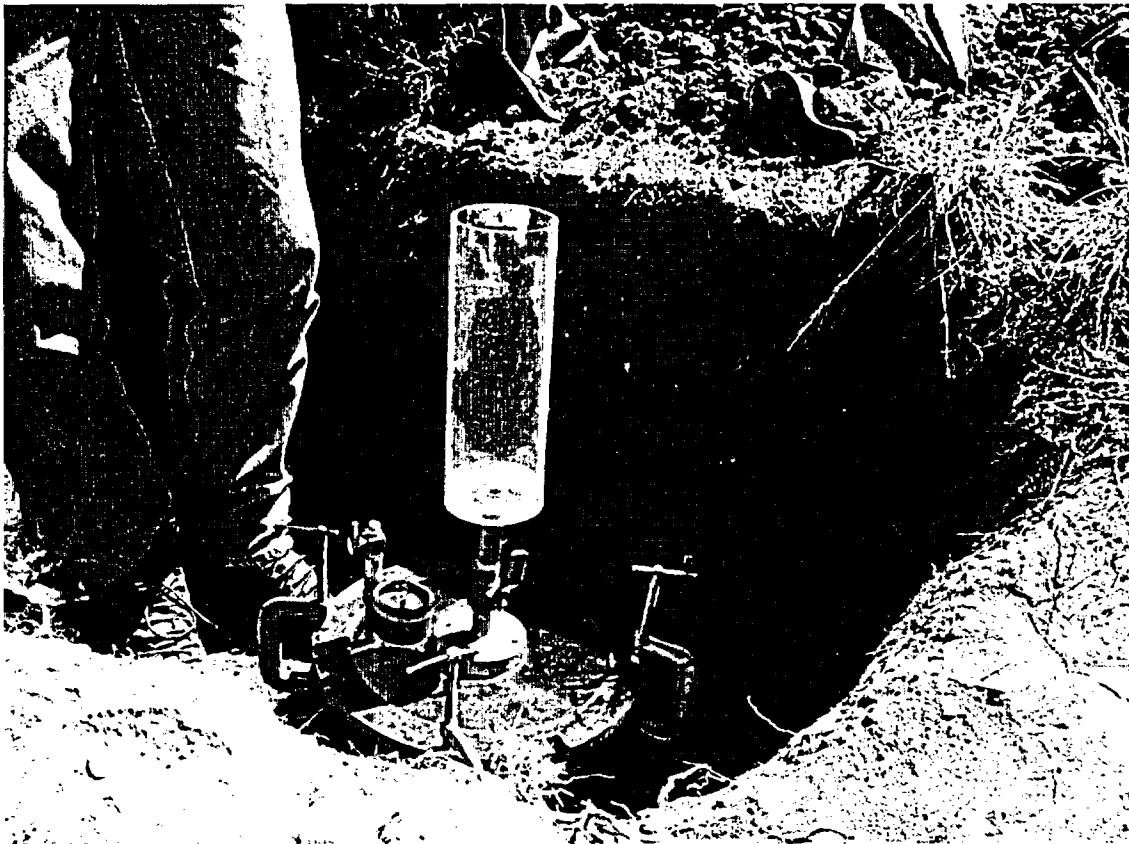
*LKV 6/2003. PL-2. Air-entry permeameter test at a soil analog site.*

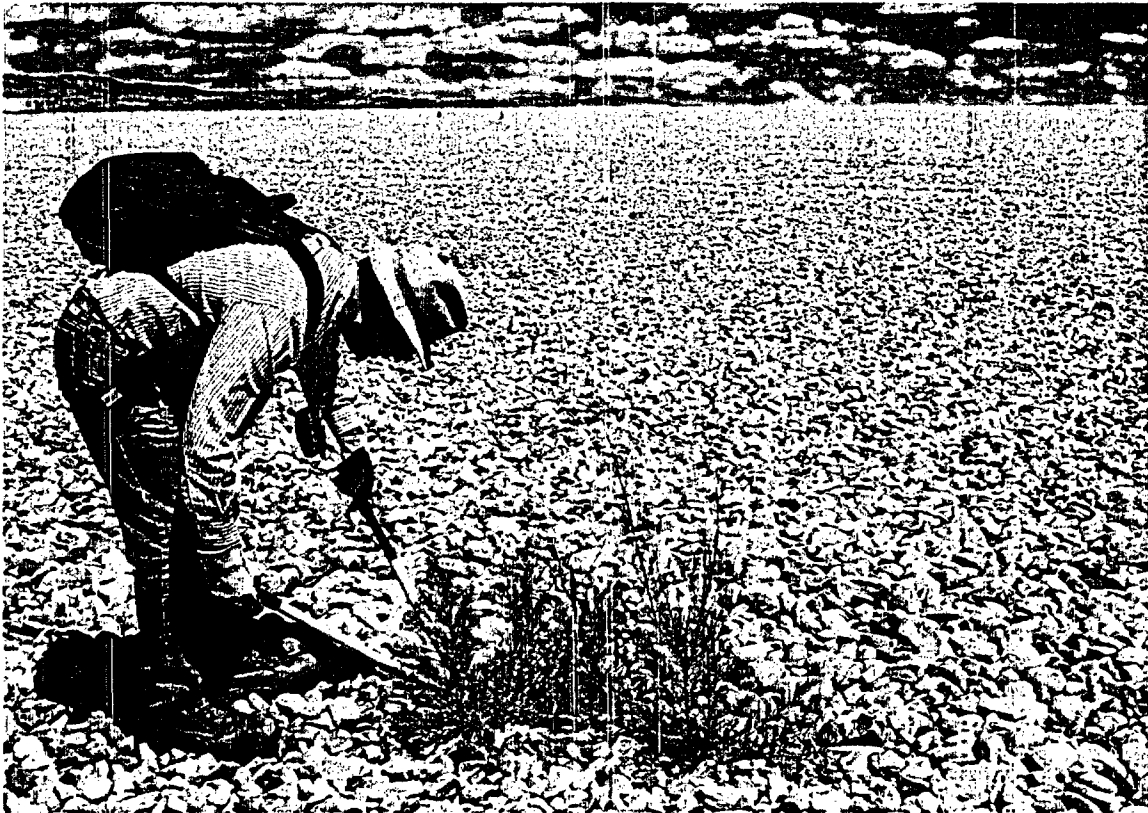
*MAY 8/2003. PL-1. Tamarisk on the cell top being cut.*

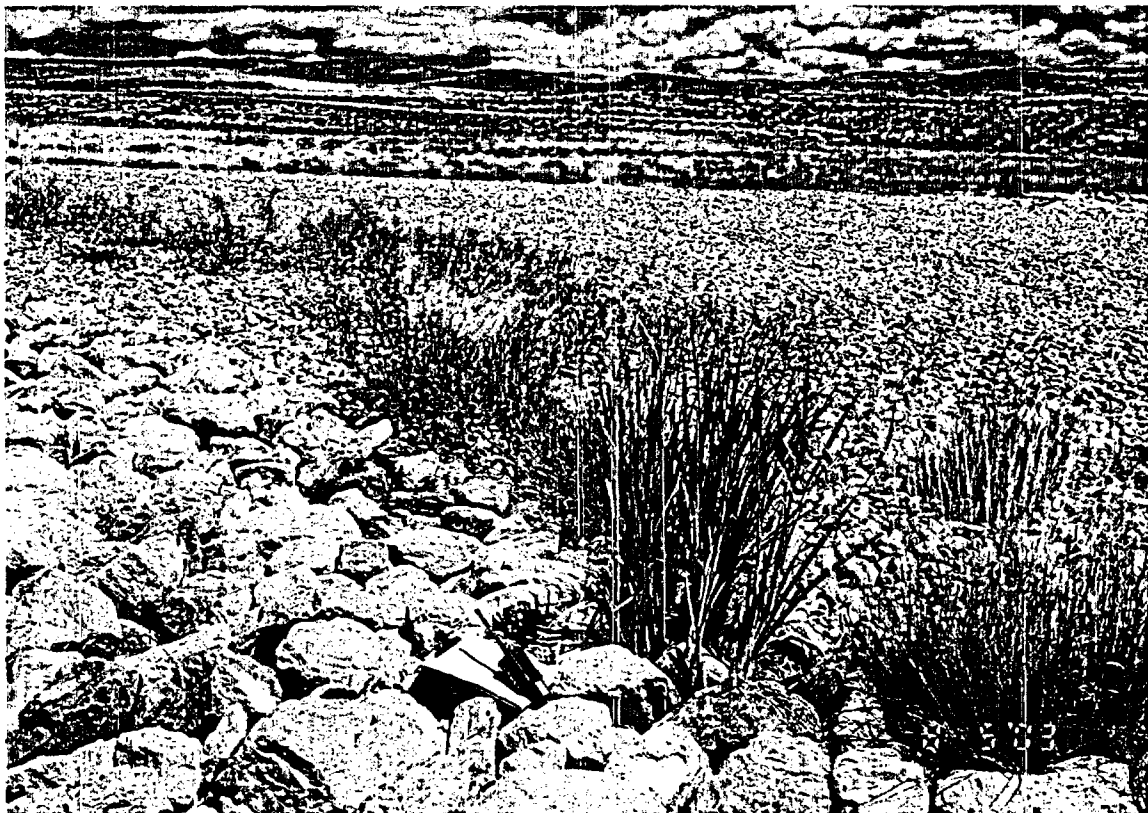
*MAY 8/2003. PL-2. Vegetation in the cobble blanket at the east corner toe of the cell.*

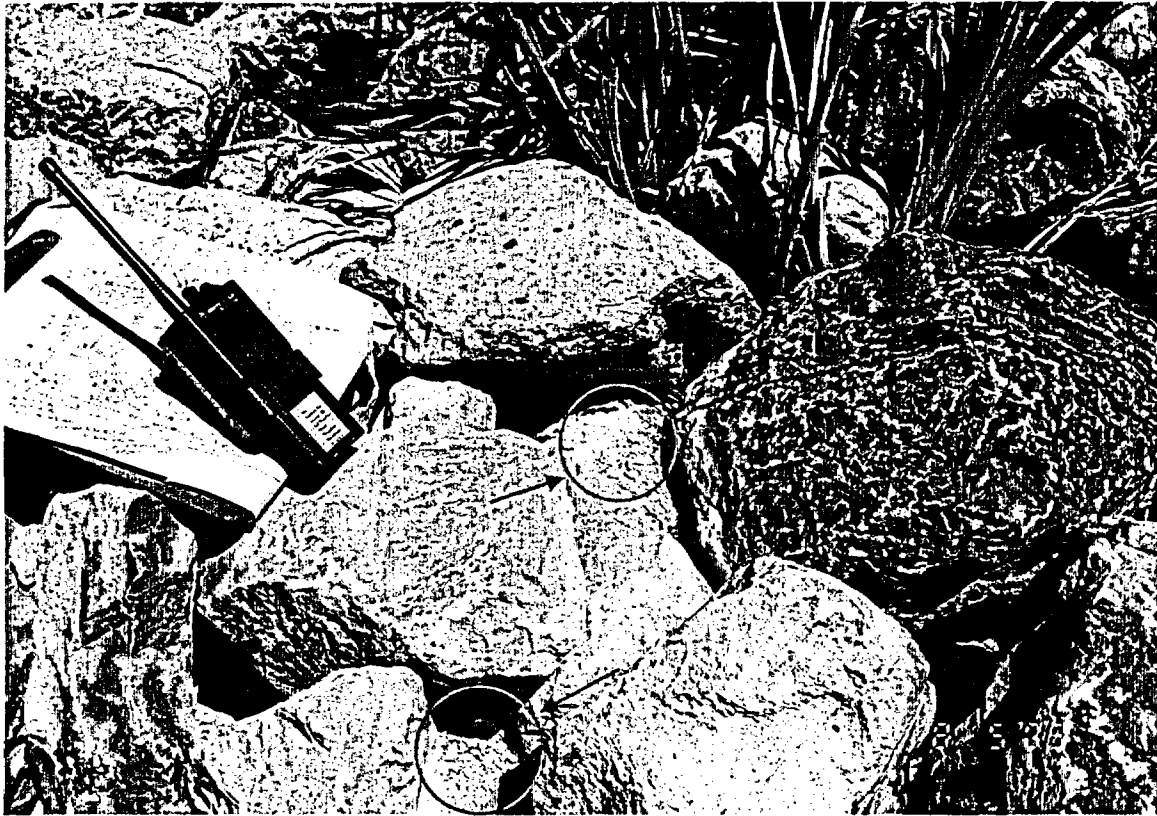
*MAY 8/2003. PL-3. Evaporite deposits on apron riprap at the east corner of the cell.*

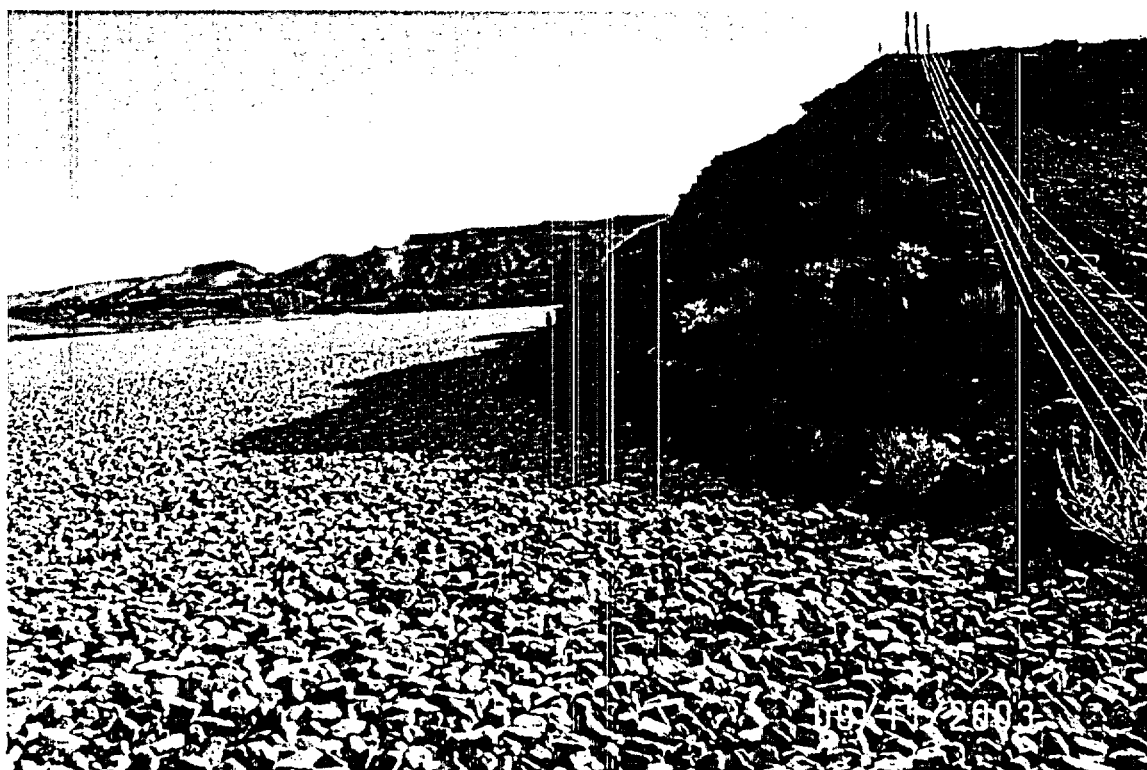
*HAT 9/2003. PL-1. Baseline location photograph of sloughing hill slope materials along the south apron.*

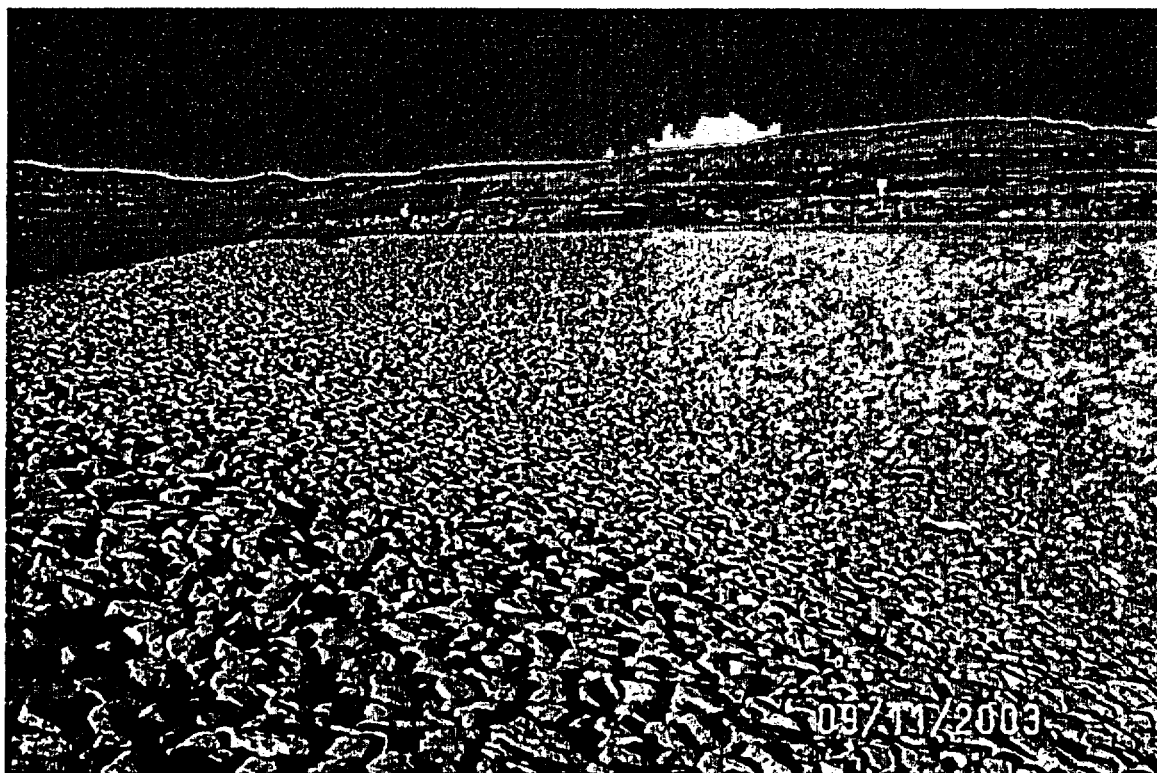
*HAT 9/2003. PL-2. Repaired washout area at the head of West Ditch.*

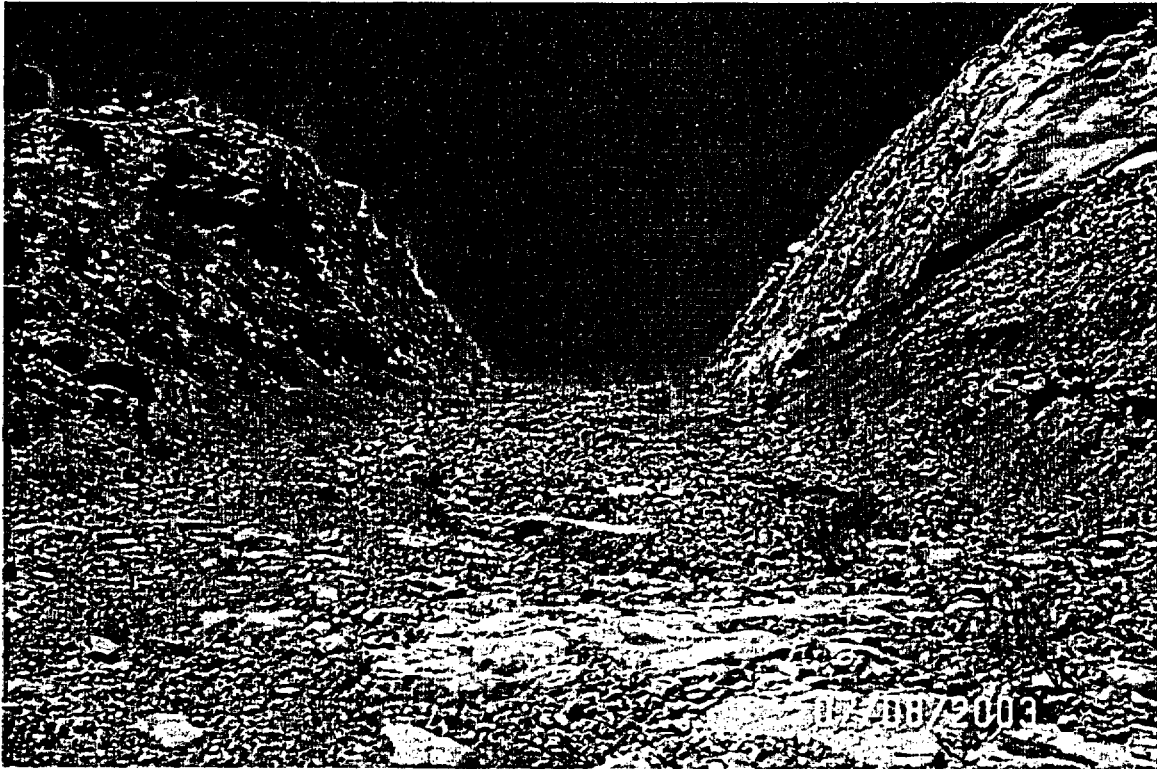
*NAT 07/2003. PL-1. Erosion in the western toe drain outlet channel.*

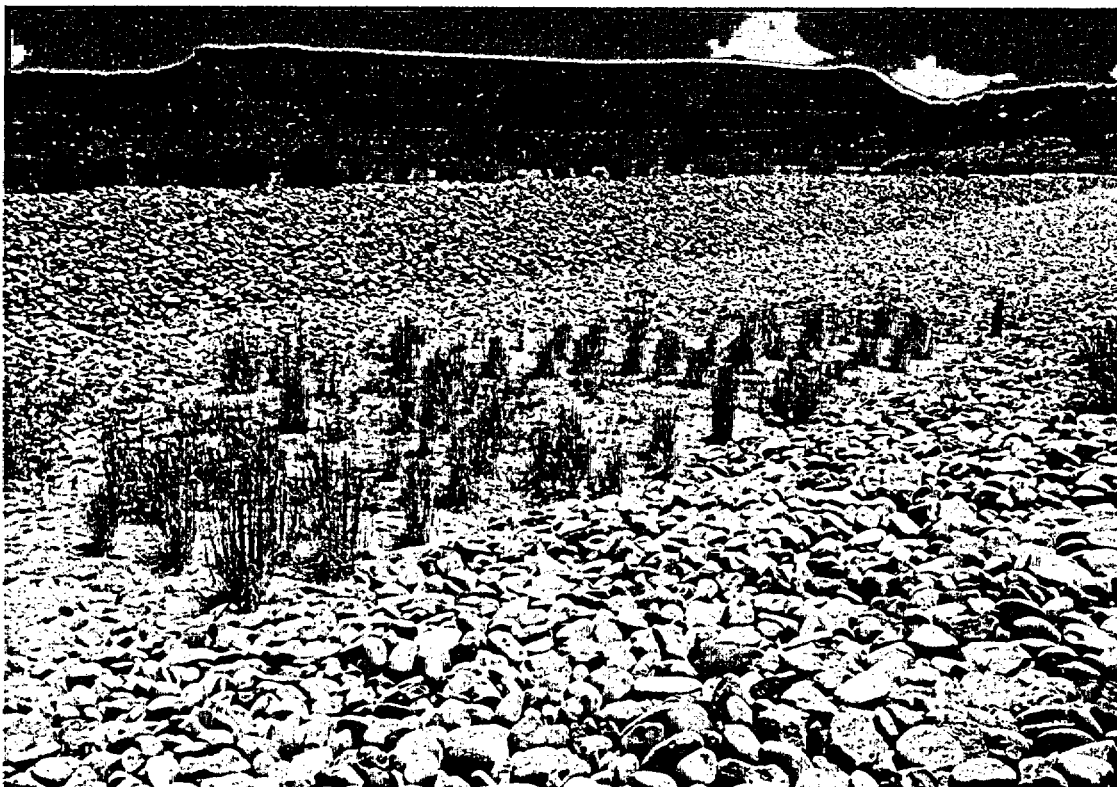
*NAT 07/2003. PL-2. Sediment accumulation in the interceptor channel.*

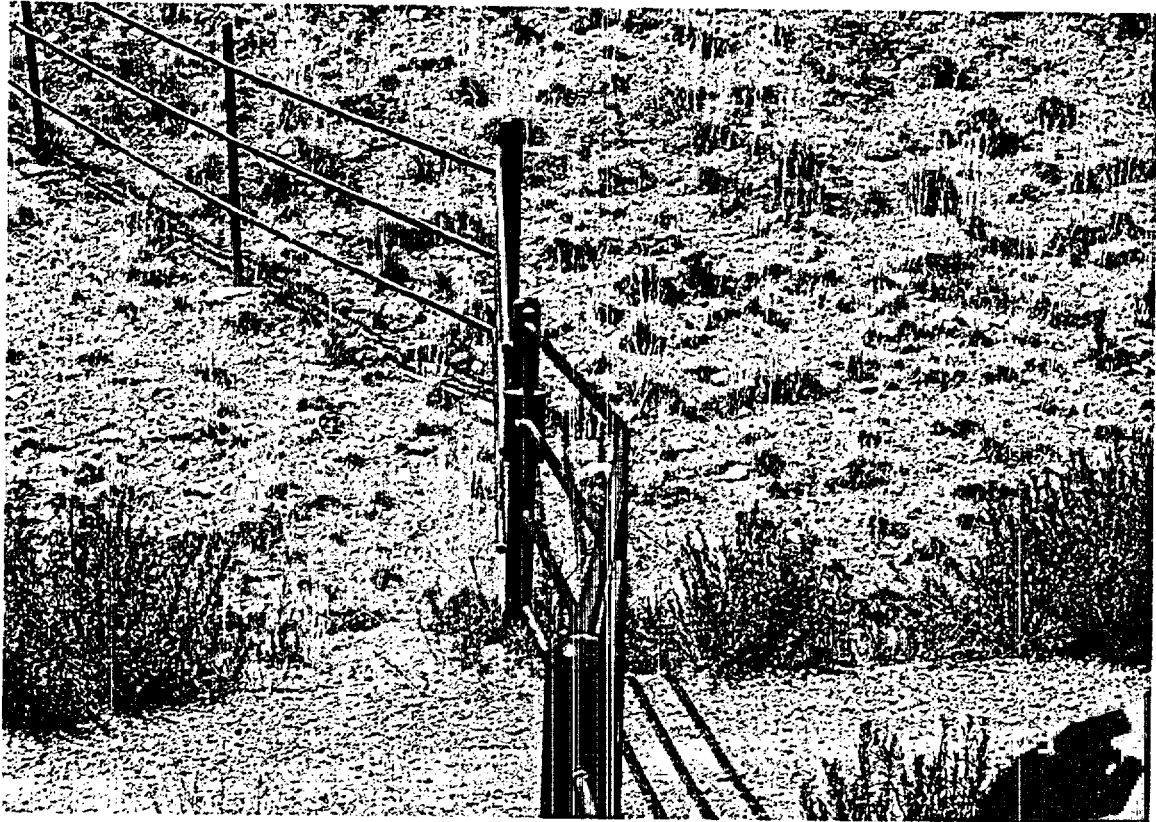
*RFL 8/2003. PL-1. Bent access road gate (subsequently repaired).*

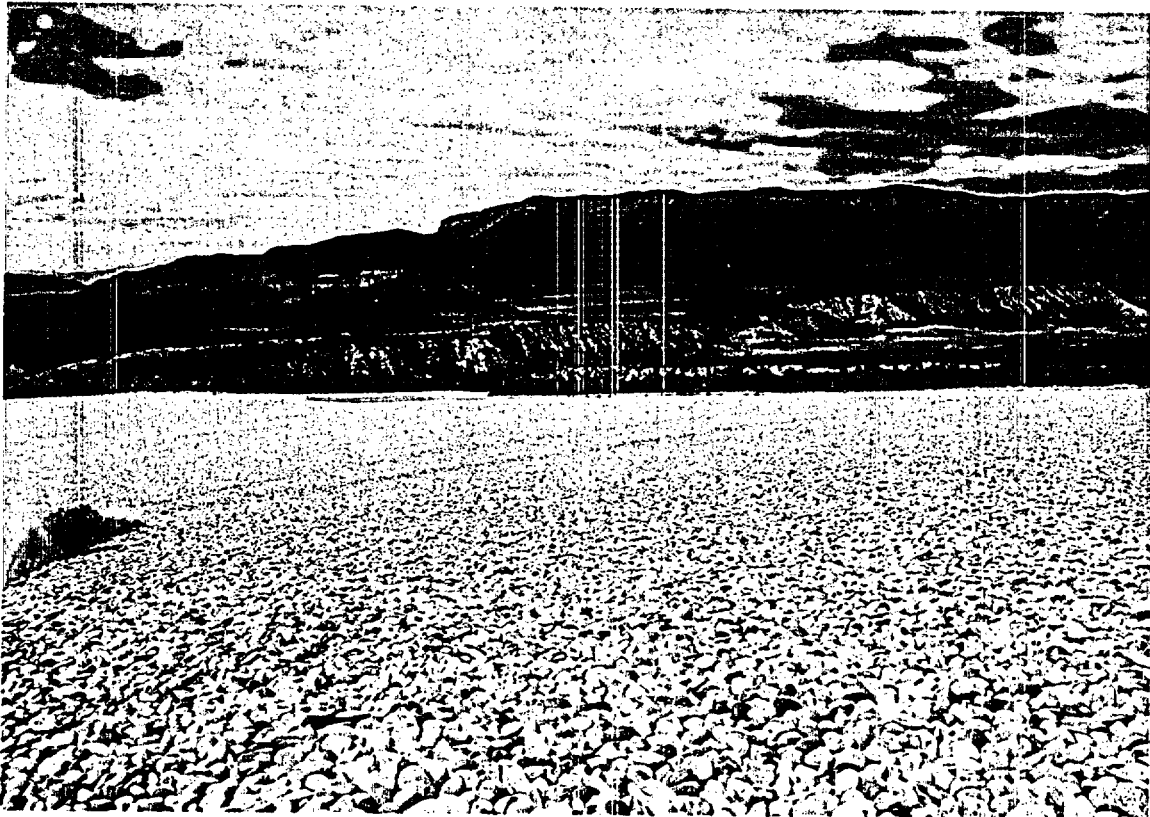
*RFL 8/2003. PL-2. Vehicle tracks across the disposal cell top.*

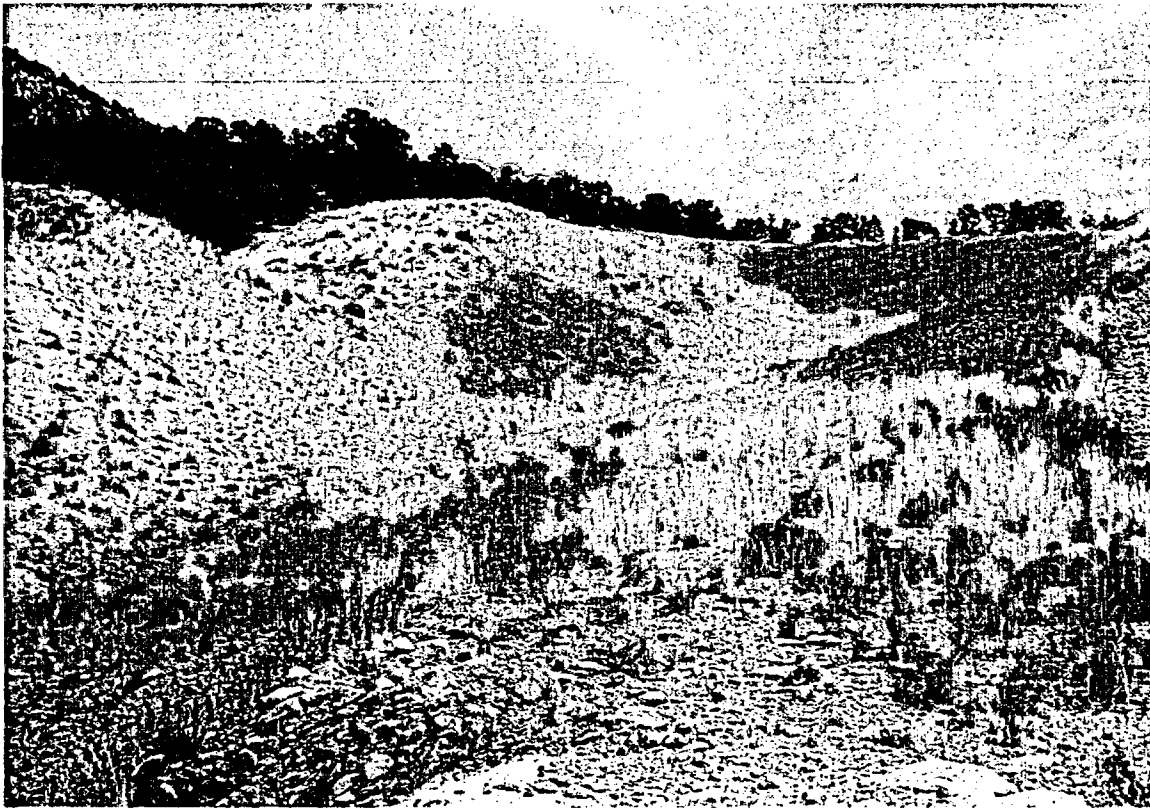
*RFL 8/2003. PL-3. Interceptor trench at the north end of the disposal cell.*

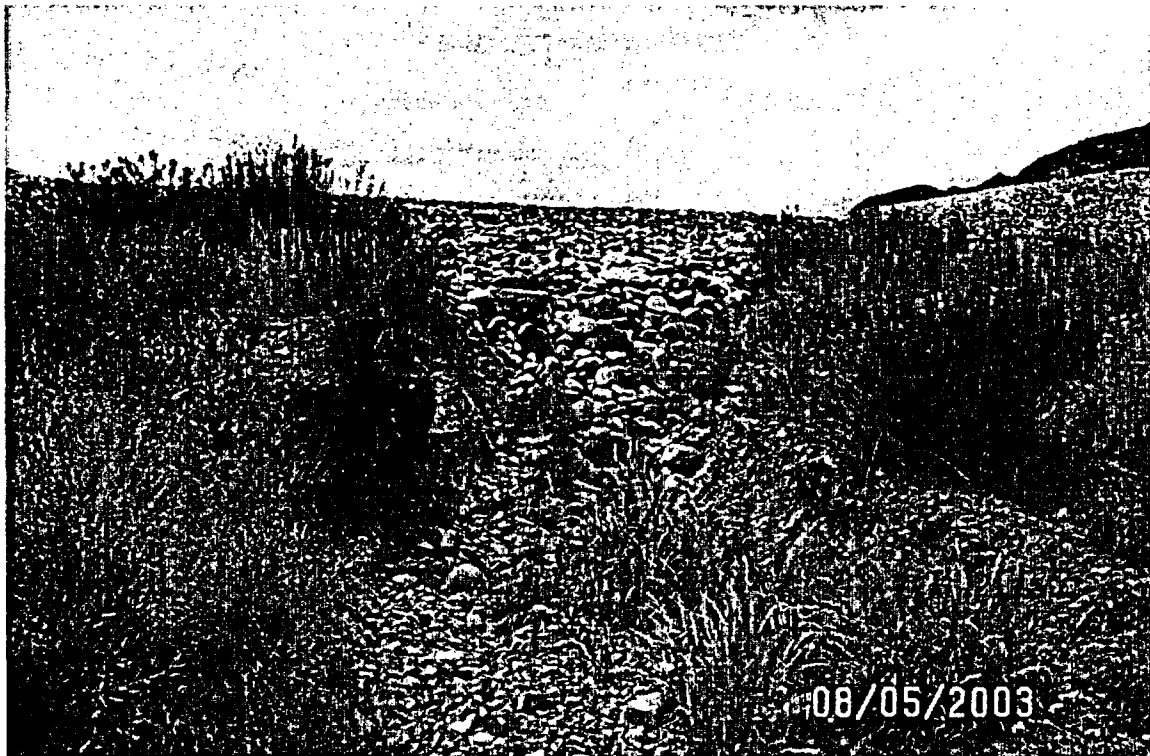
*RFL 8/2003. PL-4. Stabilized erosion at the toe ditch outlet.*
