Subject: 2003 Annual Site Inspection and Monitoring Report for UMTRCA Title I  
Disposal Sites

# 2003 Annual Site Inspection and Monitoring Report for Uranium Mill Tailings Radiation Control Act Title I Disposal Sites

January 2004

GJO-2003-528-TAC

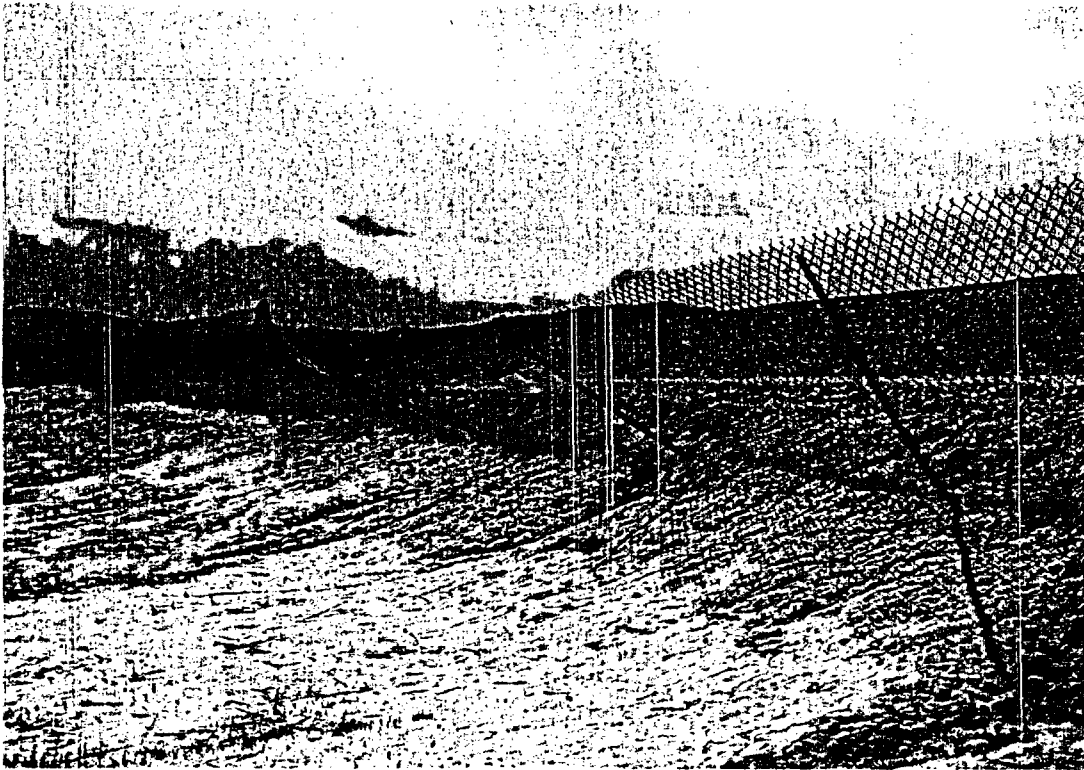
*SLC 6/2003. PL-1. Envirocare fence damage.*

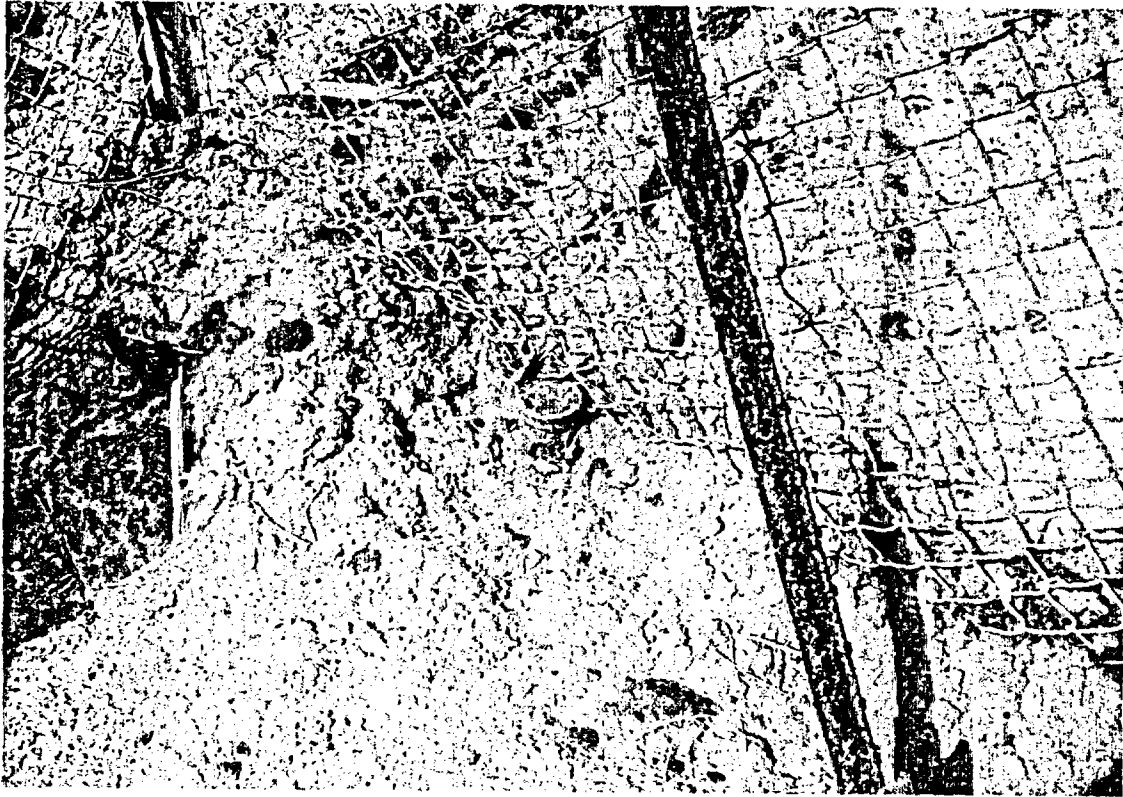
*SLC 6/2003. PL-3. Boundary monument BM-4 uncovered by Envirocare.*

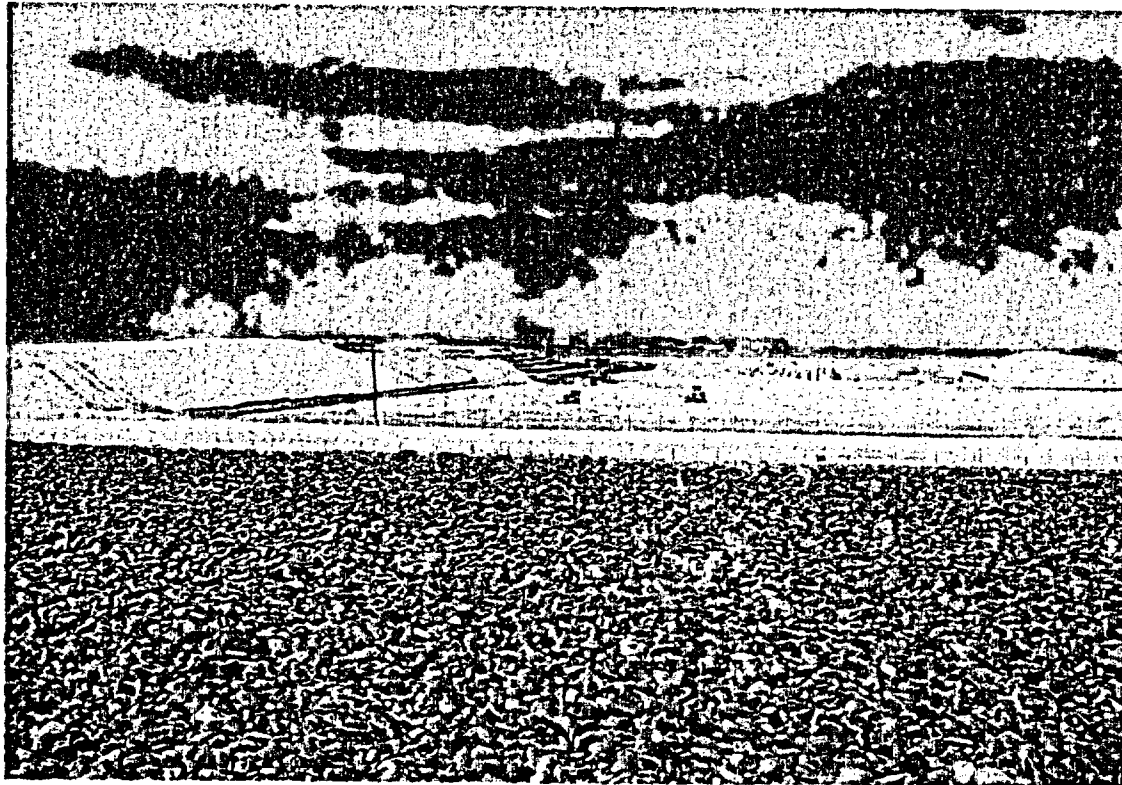
*SLC 6/2003. PL-4. Envirocare Class A cell under construction west of the DOE disposal cell.*

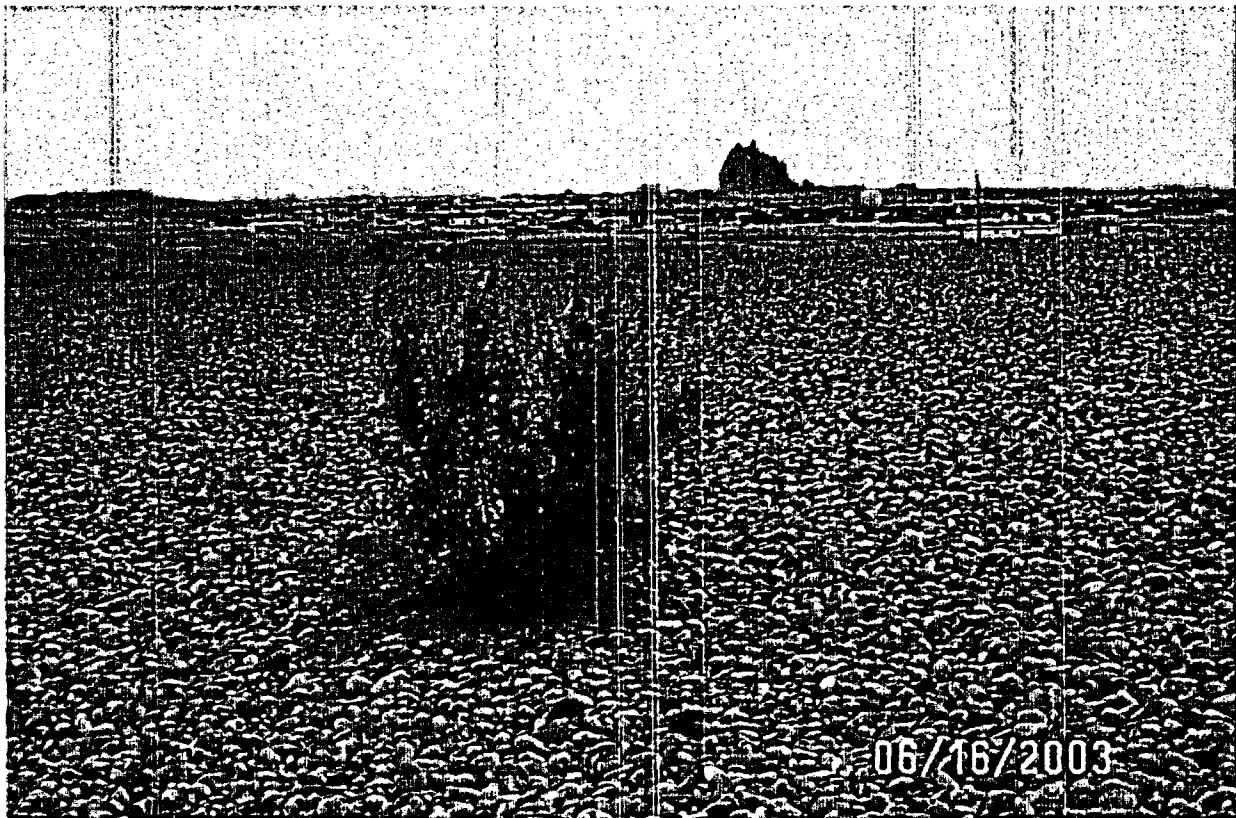
SHP 6/2003. PL-1. Tamarisk on the cell top before being cut and treated with herbicide.

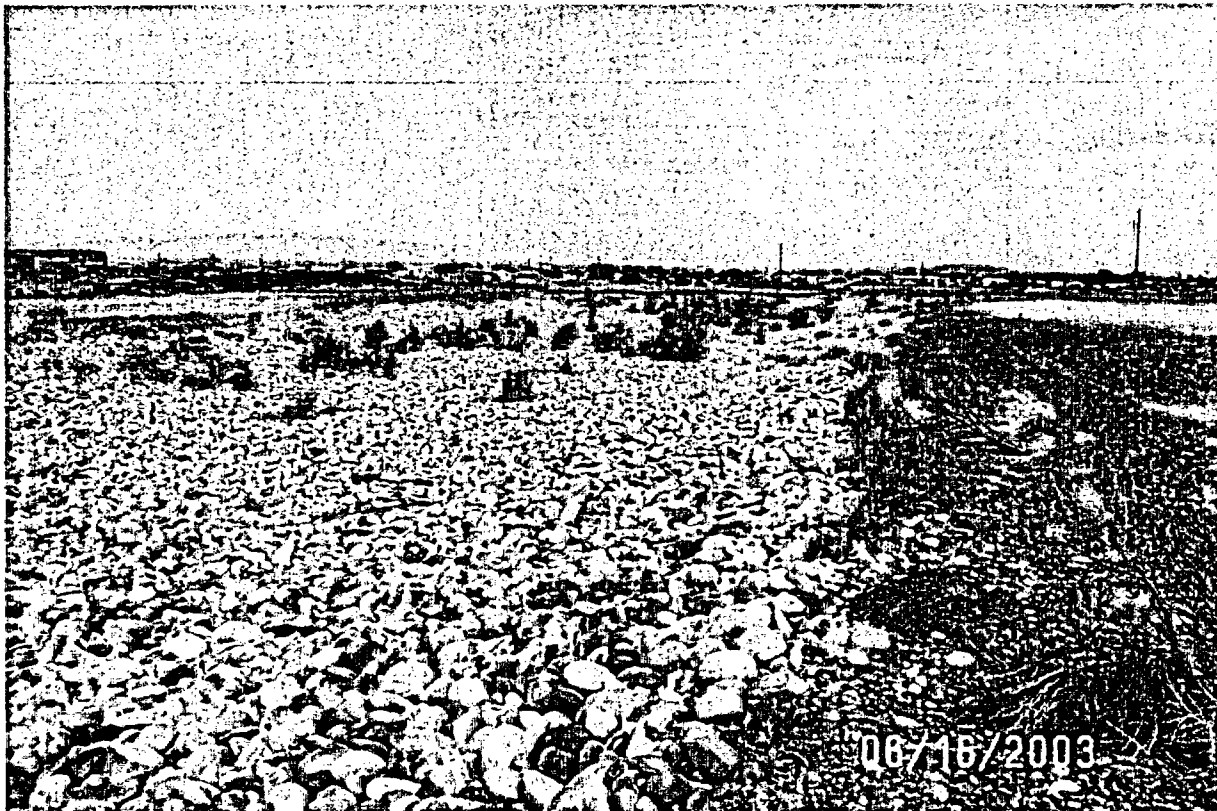
*SHP 6/2003. PL-2. Vegetation in the outflow channel.*

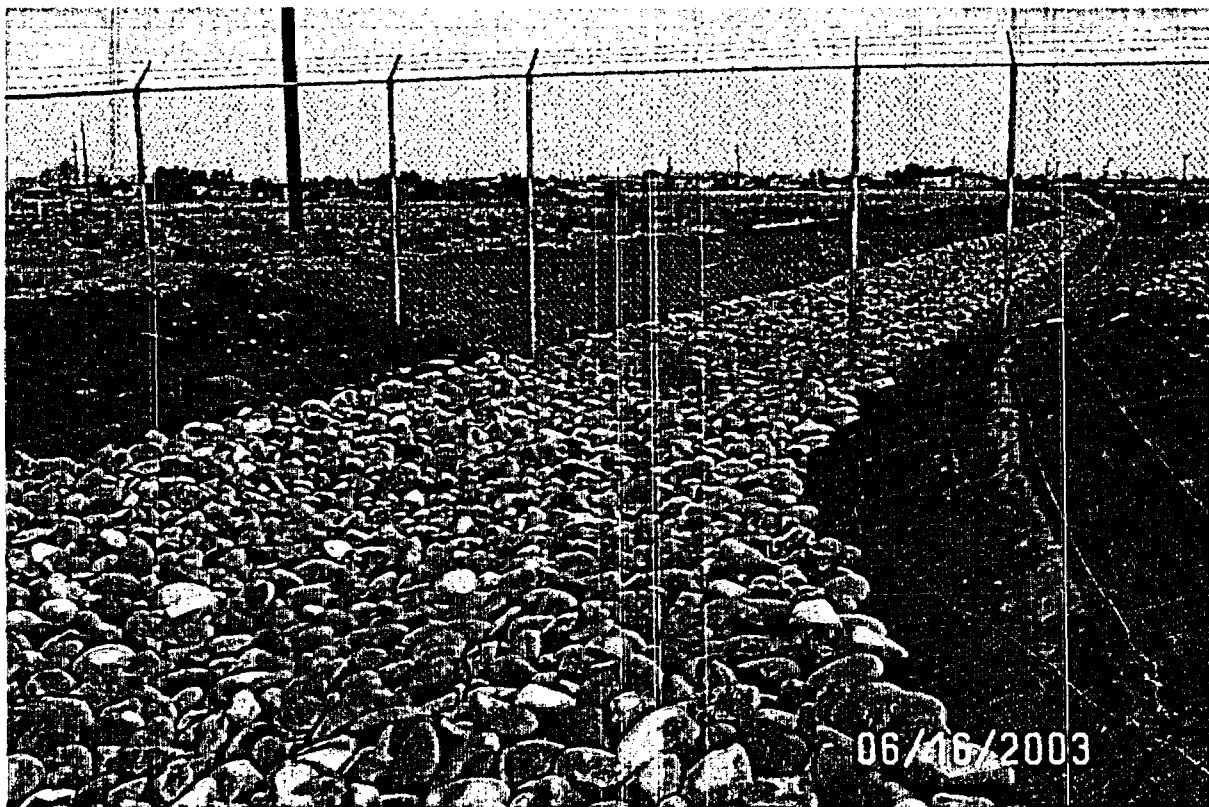
*SHP 6/2003. PL-3. Reconstructed outflow channel where it exits the property.*

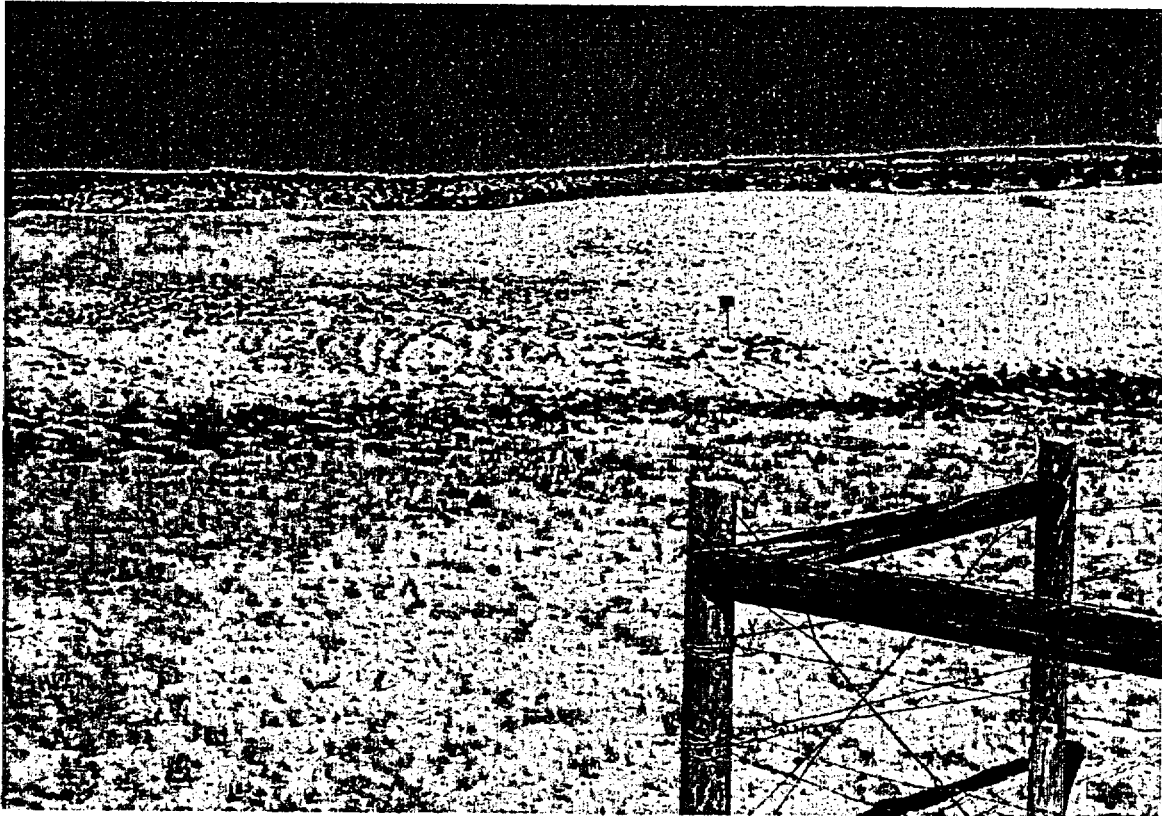
*SRK 7/2003. PL-1. Sparse vegetation on the northeast slope of the regraded spoils pile.*

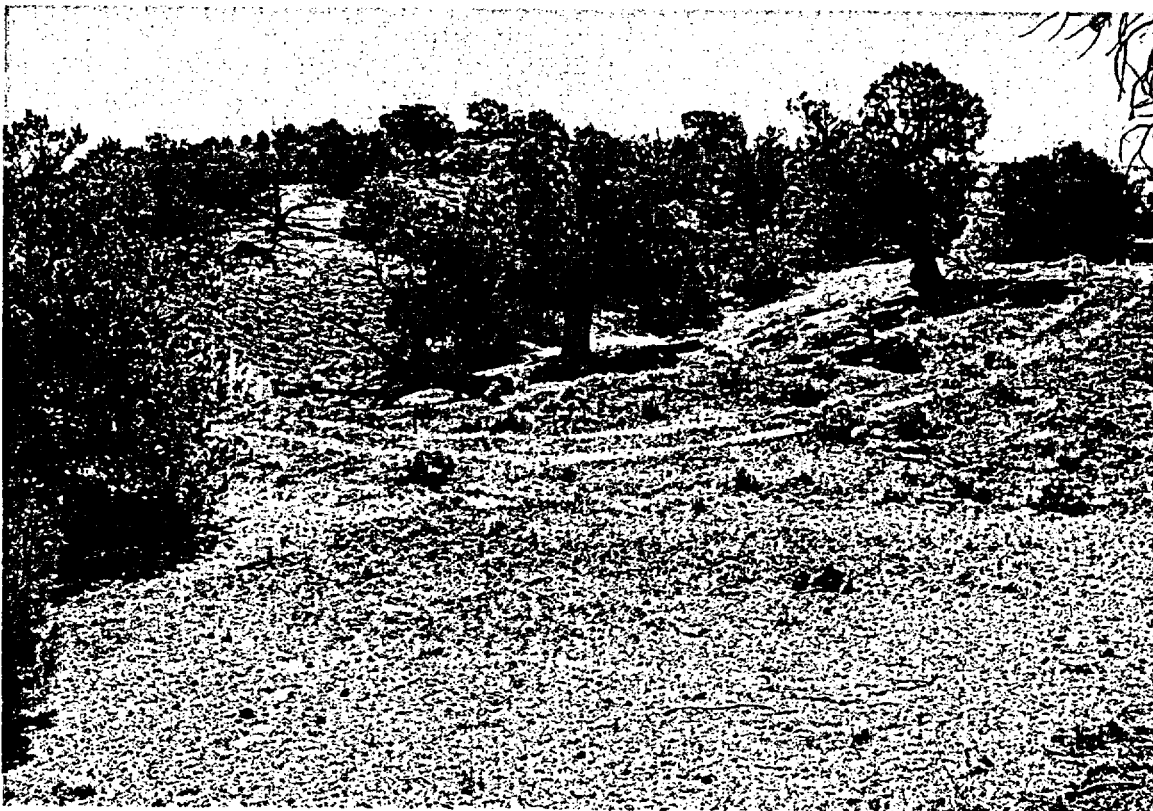
*SRK 7/2003. PL-2. All-terrain vehicle tracks in the northwest corner of the property.*

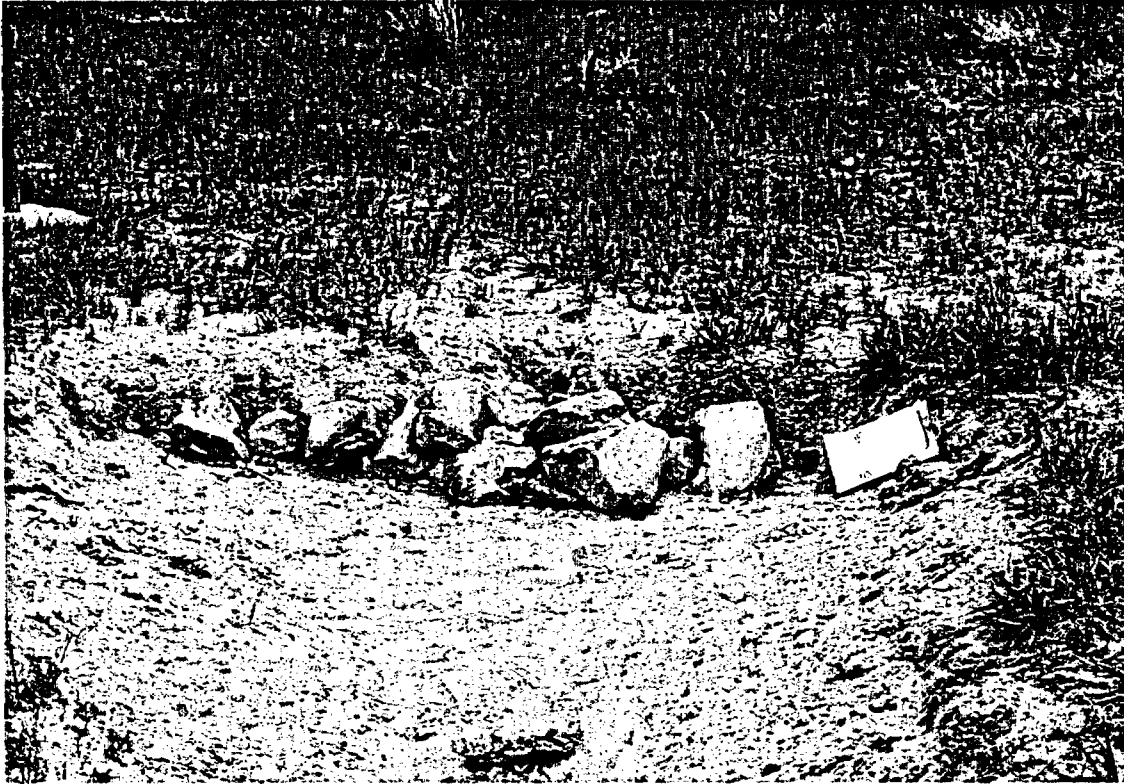
*SPK 6/2003. PL-2. Rocks placed at a gully knickpoint near perimeter sign P4.*

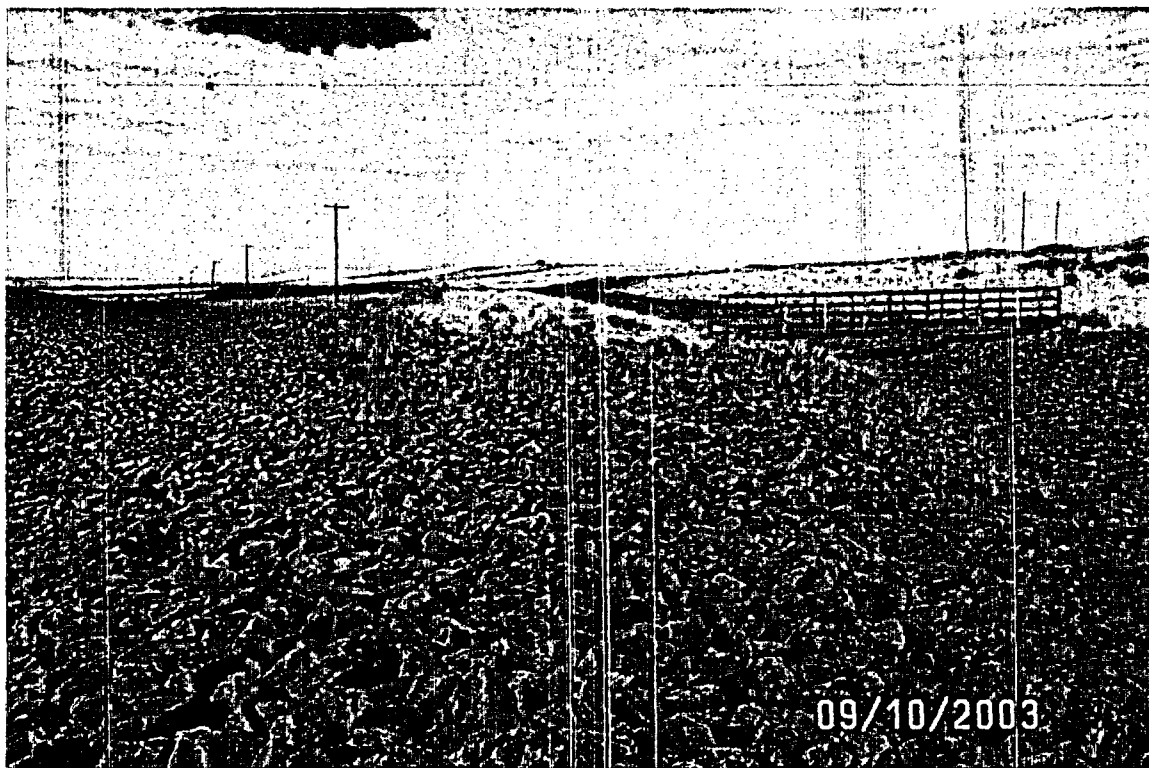
*TUB 9/2003. PL-2. Sand accumulation and vegetation between the toe drainage channel (left) and the storm water diversion channel (right).*
