Subject: Routine Inspection No. 90-001

U.S. NUCLEAR REGULATORY COMMISSION  
REGION I

Facility Name: Safety Light Corporation

Inspection Summary: Inspection conducted March 19, 1990 (Combined Report Nos. 030-05980/90-001, 030-05982/90-001, 030-05981/90-001, 030-08335/90-001, and 030-08444/90-001)

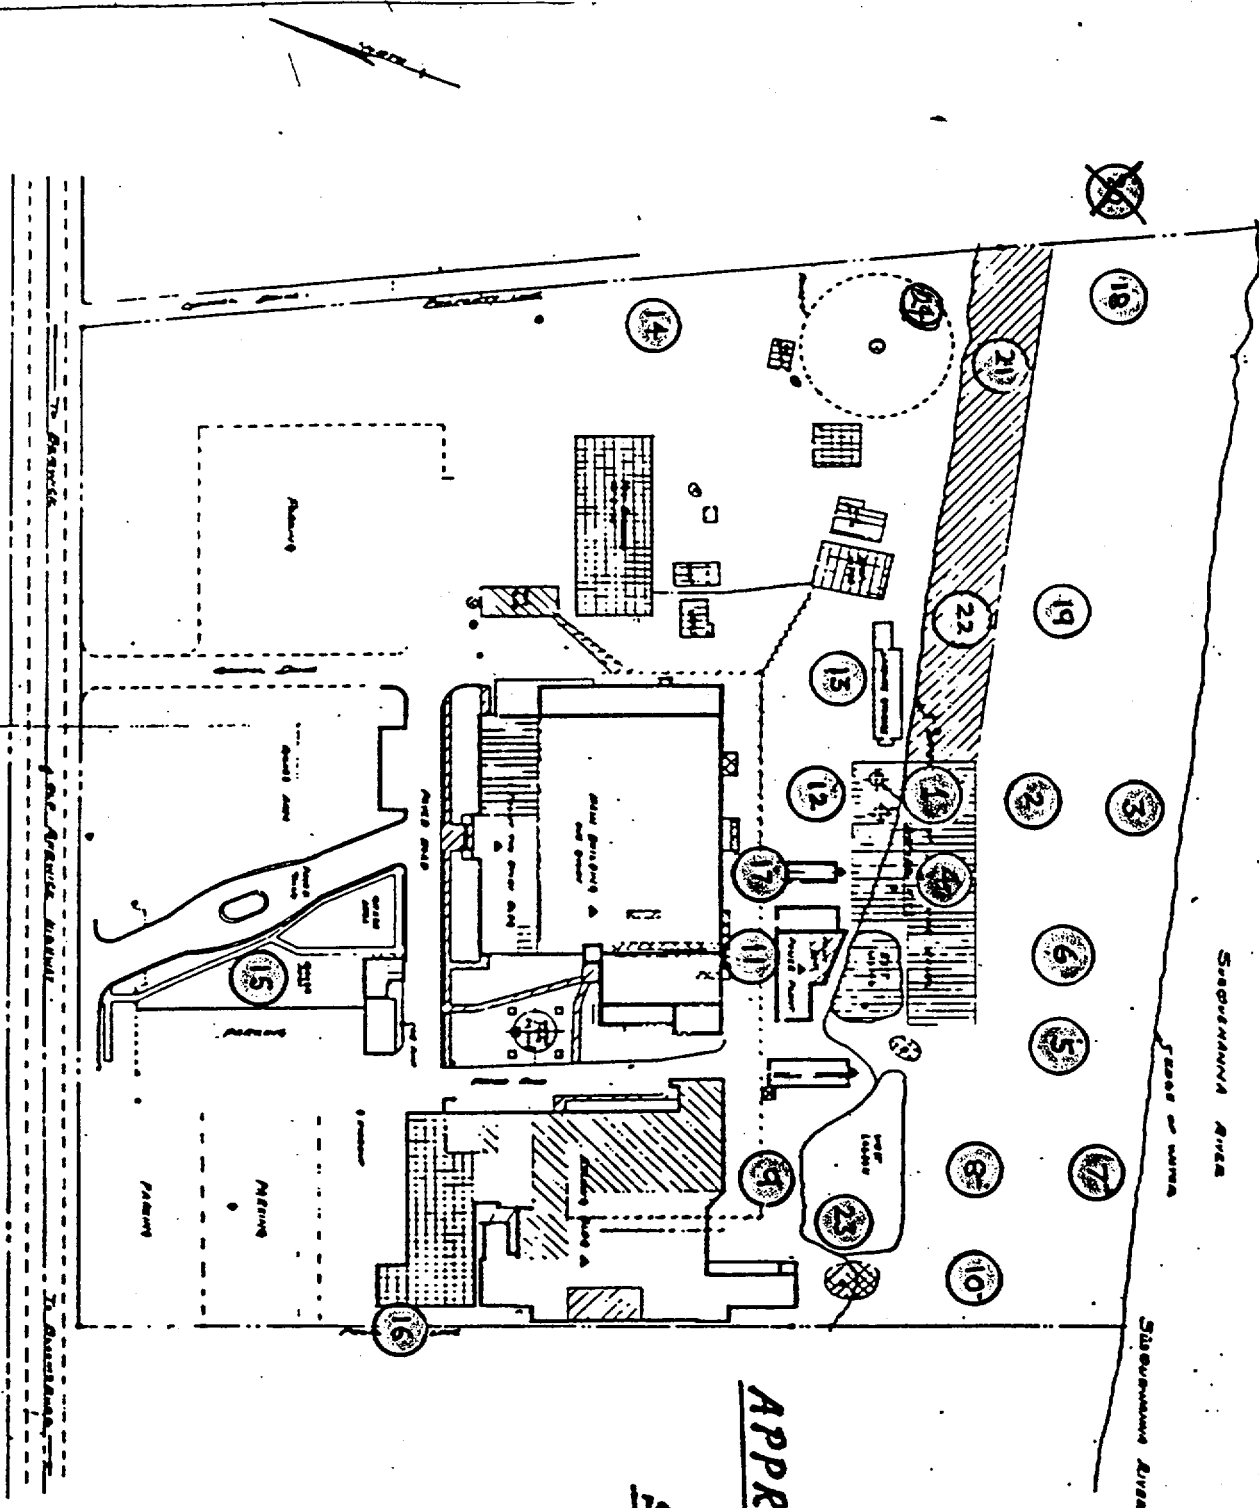
Locations of Onsite Bore Holes

The most recent results of the licensee's analysis of subsurface water samples are included in Attachment 1 to this report. The locations of these samples are indicated in the map in Attachment 2 to this report. The results of these analyses indicate that there are a number of onsite samples which exceed NRC limits for water released to unrestricted areas and a larger number of samples which exceed the EPA drinking water samples. This analysis assumes that gross alpha activity is radium-226 and the gross beta activity is strontium-90.
