Subject: Special Inspection No. 89-001

Combined Inspection Nos. 030-05980/89-001, 030-05981/89-001, 030-05982/89-001  
030-08335/89-001 and 030-8444/89-001

Licensee: Safety Light Corporation  
4150-A Old Berwick Road  
Bloomsburg, Pennsylvania 17815

License Report on January 17, 1989 Tritium Release

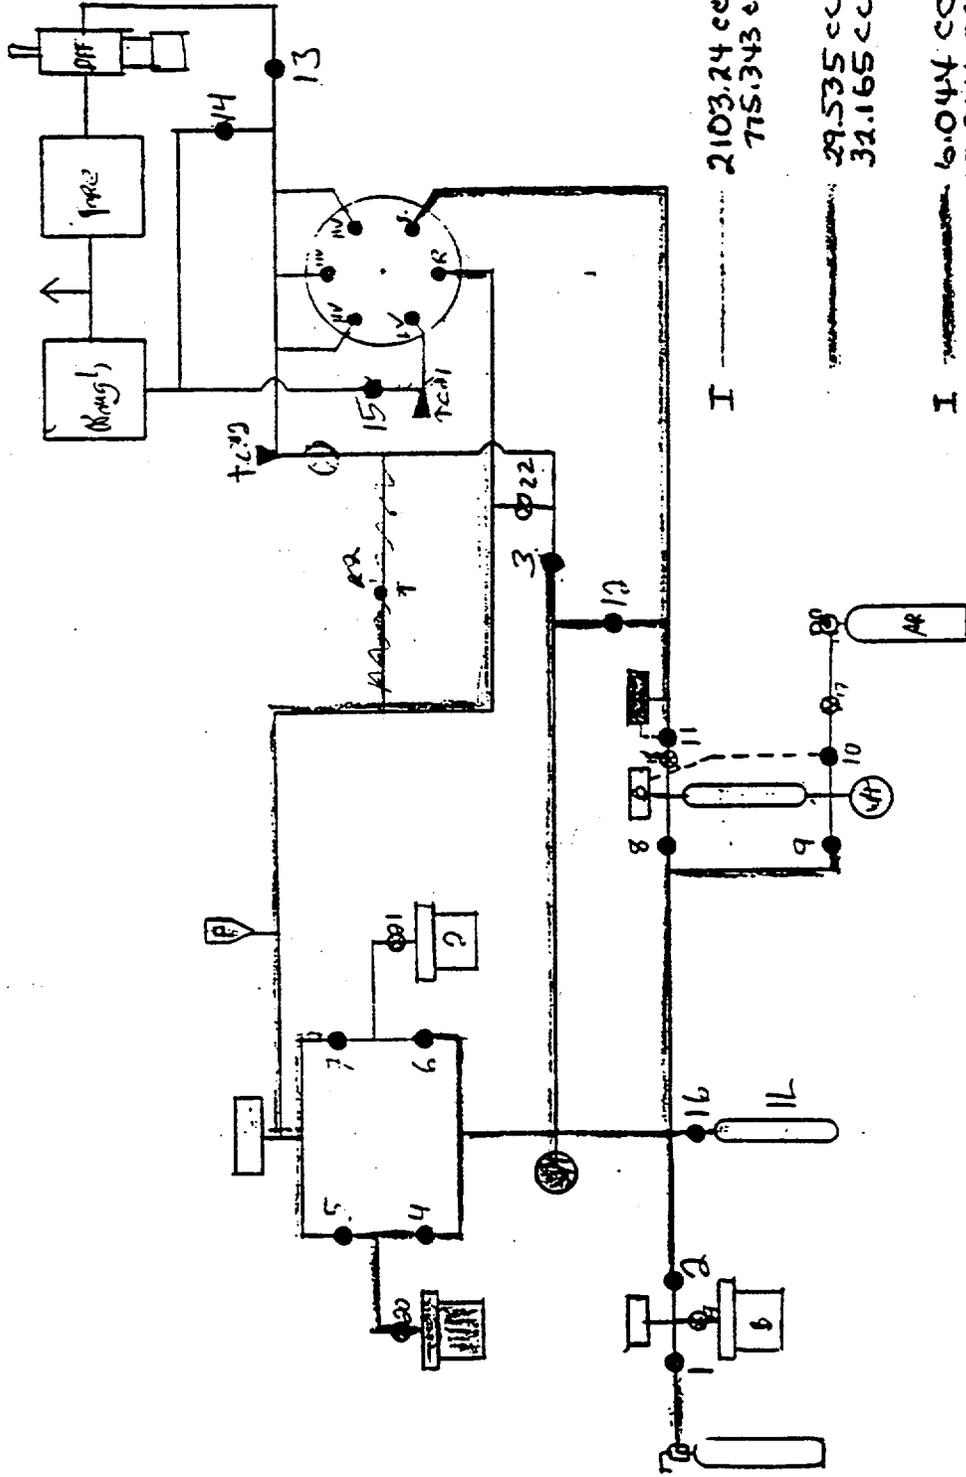
# ROTARY INDEX FILL MACHINE # 1

Overheat of ORNL pyro to 600 degrees C creating pressure in excess of capability of Bulk Storage pyro to absorb and resulting in tritium gas loss due to failure of system integrity somewhere upstream of valve #2, including possibility of extreme diffusion through walls of ORNL pyro.

Leak Detection - 1/19/89 - Entire rear side of system (ORNL, Bulk Storage, #1 and #2 pyros plus 1 L. cylinder) leak detected twice. No leak found. Just previous to shutdown of leak detector, a sharp reduction in vacuum appeared and a third leak detection was performed. A significant leak was discovered upstream of valve #1 at a VCO elbow. Two retaining nuts were found to be less than sufficiently drawn up.

Elbow removed and found to contain one deteriorated O-ring, and one O-ring in good shape. Both O-rings replaced and piping re-connected. Monitor probe showed tritium in excess of 10,000  $\mu\text{Ci}/\text{cu.m}$  and took quite a while to return to normal ranges, indicating tritium oxide was released. Fill rig monitor remained on  $10^2$  (max 1000  $\mu\text{Ci}/\text{cu.m}$ ) scale indicating that shielding was insufficient to prevent outgassing of VCO elbow from exiting work area, however no greater degree of shielding would have permitted room enough to perform work required.

1. Install double pole, single throw relays in Rotary I and Rotary II ORNL pyro heater controllers (will involve rebuilding of both controller boxes).
2. Investigate possibility of replacing sections of line in Rotary I that contain VCO connectors/fittings.
3. Discuss addition of overtemp. alarms on all heater controllers.
4. Re-emphasize to operators importance of observing results of actions with respect to any type of operation on gas handling rigs.
5. Evaluate our rig maintenance programs to determine if they are adequate and that they are being followed properly.
