UNITED STATES  
NUCLEAR REGULATORY COMMISSION  
OFFICE OF NUCLEAR REACTOR REGULATION  
WASHINGTON, D.C. 20555-0001

January 17, 1995

NRC INFORMATION NOTICE 95-02: PROBLEMS WITH GENERAL ELECTRIC CR2940 CONTACT  
BLOCKS IN MEDIUM-VOLTAGE CIRCUIT BREAKERS

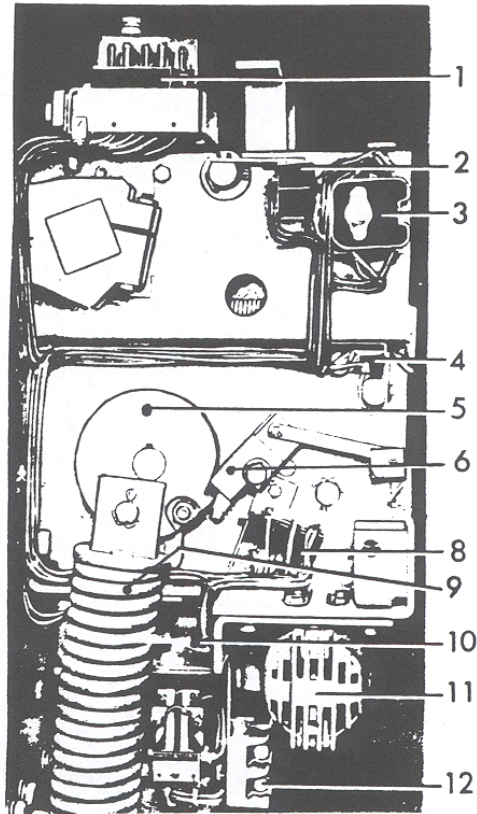
FIG. 2 - LEFT SIDE VIEW  
 ML-13 OPERATING MECHANISM

(they can also be closed in the test position). The contact block or switch containing 52IS contacts 1 and 2 (in series with the breaker closing spring charging motor circuit) is mounted on the bottom of a small bracket at the top of the left side of the operating mechanism frame by means of two special machine screws. The heads of these screws are to be drilled and tapped with female threads to accept the male threads of the mounting screws of the other 52IS contact block (containing contacts 3 and 4 in the breaker closing circuit) that is designed to be mounted onto the bottom of the first contact block. A lever of the breaker cubicle interlock mechanism operates the plunger of the upper (charging motor interlock) contact block. Simultaneously, the moving contact carrier assembly inside the upper switch operates the plunger of the lower (closing interlock) contact block that protrudes into the case of the upper contact block. The lack of female threads being cut into the hole drilled in the head of one of the two special mounting screws in the upper contact block prevented the use of one screw in mounting the lower contact block properly. As a result, during subsequent operations of the breaker, the lower block became loose such that its plunger could not be depressed to close it by the moving contact carrier of the upper contact block. The breaker closing circuit therefore did not function.
