Virginia Electric And Power Company
Surry Power Station
5570 Hog Island Road
Surry, Virginia 23883

Report No. 50-280, 50-281/2003-006-00

LICENSEE EVENT REPORT (LER)

TITLE (4)
Steam Generator AFW Isolation Unanalyzed Condition from Original Design

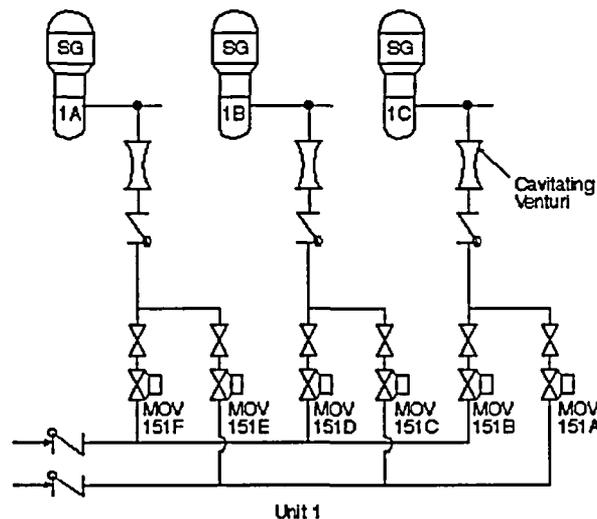
Complete Fig. 1 LER228

The Surry AFW system has three AFW pumps feeding two headers, which in turn supply three steam generators. There are six motor operated valves (MOV) inside containment, two for each SG, which are used to control flow from the two AFW headers. For each SG, one MOV is powered from the "H" emergency bus, and one MOV from the "J" emergency bus. The MOVs are normally maintained open (and receive an open signal concurrent with AFW pump start signals).

A review of this scenario determined that a ruptured steam generator condition was not bounded by the accident analyses, and therefore was an unanalyzed condition. Under steam generator tube rupture (SGTR) accident conditions with either the "H" or "J" emergency bus de-energized, the three MOVs powered from the de-energized emergency bus cannot be repositioned closed unless a containment entry is made. Therefore, only one of the two MOVs to the ruptured SG could be closed by operating the MOVs remotely while the intact SGs are being filled to meet heat sink requirements. Operation of one motor driven AFW pump and the turbine driven AFW pump will provide more flow to the intact SGs and some flow is directed towards the ruptured SG. Since there are no check valves in each header downstream of the MOV prior to the headers joining together, flow from the energized train of piping will flow back through the de-energized open MOVs into the deenergized train of piping, and into the ruptured SG.

The current AFW configuration has existed since original construction. No documentation was found that indicated the AFW MOVs have ever been required to be in a special alignment to account for this condition. The root cause for this condition is design configuration/ analysis, in that the unanalyzed condition was not considered during initial plant design.

Engineering provided technical information to return the Units to an analyzed condition by closing 4 of the 6 AFW MOVs. The Station Nuclear Safety and Operating Committee (SNSOC) approved the recommended actions and 4 of the 6 AFW MOVs were closed. With the units within the assumptions for the accident analysis, the AFW system was declared operable and the 6-hour clock to HSD was exited at 1341 hours on December 12, 2003.

A design change package will be developed to install stop check valves downstream of each of the AFW steam generator isolation MOV, prior to where the two headers join together. These modifications will be performed during the refueling outages on both Units, and will allow exit from the JCO.
