FirstEnergy Nuclear Operating Company

Subject: Supplemental Information regarding License Amendment Application to Revise  
Technical Specification 3/4.4.5, "Reactor Coolant System - Steam Generators," to  
Permit One-Time Extension of Steam Generator Tube Inservice Inspection Interval  
(TAC No. MC1573)

SUPPLEMENTAL INFORMATION REGARDING LICENSE AMENDMENT  
APPLICATION TO REVISE TECHNICAL SPECIFICATION 3/4.4.5,  
"REACTOR COOLANT SYSTEM - STEAM GENERATORS," TO PERMIT  
ONE-TIME EXTENSION OF STEAM GENERATOR TUBE INSERVICE  
INSPECTION INTERVAL

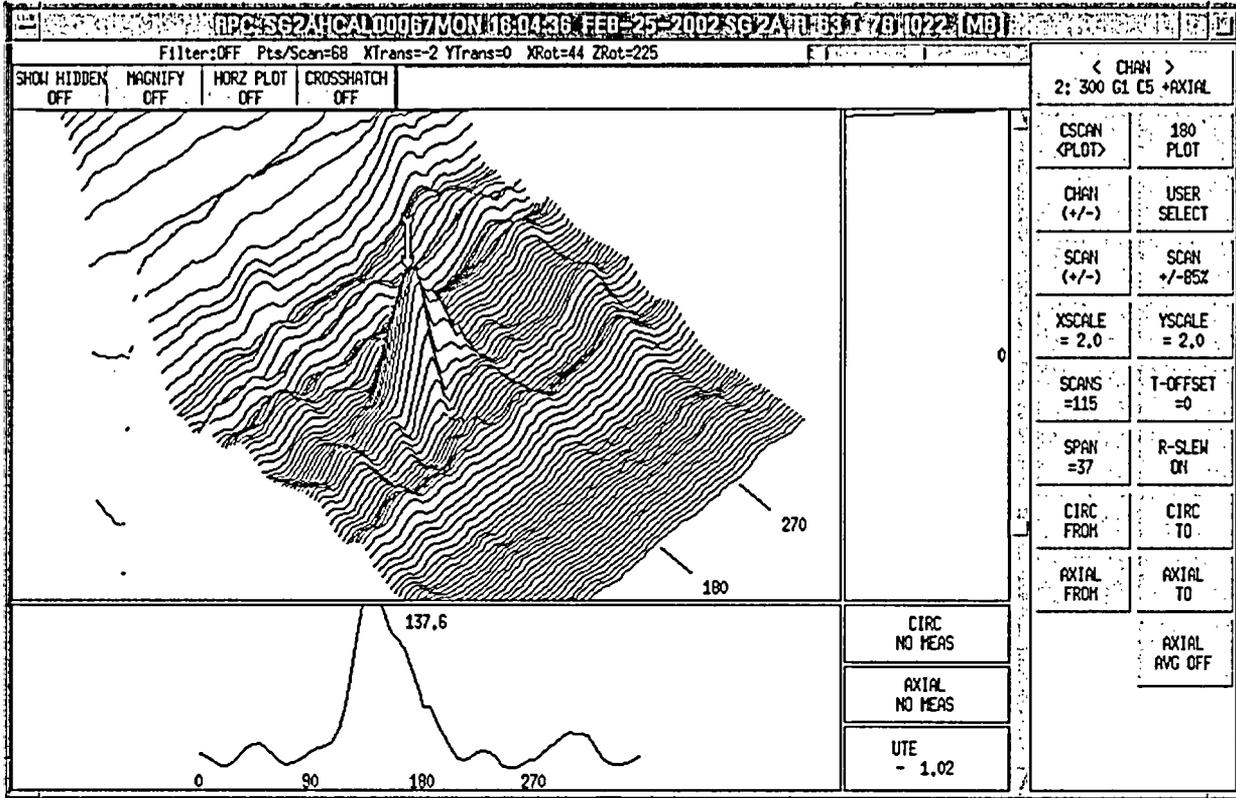
Figure 1 – C-scan of R63T78 in 13RFO

During inservice inspection of the Davis-Besse Nuclear Power Station (DBNPS) once-through steam generators (OTSGs) during the thirteenth refueling outage (13RFO), an axial crack was identified in OTSG tube 2A-Row 63 Tube 78. The axial crack in OTSG tube 2A-Row 63 Tube 78 was in the roll expanded region of the tube, in the upper roll, but not in the roll transition region itself. This particular crack is not characteristic (length, depth, voltage) of what has historically been observed in once-through steam generators at the roll transition area. Roll transition cracking in the OTSGs is typically <1 volt Plus-point, confined within the transition (<0.25"), and with average depths much less than 90% through-wall (TW). Because of its location within the roll joint and above the transition, this indication had no impact on the DBNPS structural or leakage integrity at end-of-cycle (EOC).<sup>13</sup> Figure 1 provides the Plus-point C-scan plot of this indication/region. The thirteenth refueling outage (13RFO) inspection was the first inspection of this tube in this region after 15.8 effective full power years (EFPY) of operation at DBNPS with an eddy current technique that is capable of reliably detecting indications of this degradation type/location. The fact that the profile of the indication is >90%TW for almost its entire length is not totally unexpected (Figure 2). Upper 95<sup>th</sup> percentile growth rates for these indications in OTSGs is approximately 13%TW/EFPY and 0.2"/EFPY, indicating approximately 4-5 cycles of growth for this particular indication. The bobbin coil data for this tube was also reviewed from both the 13RFO and 12RFO inspections and indicated the presence of a signal that can be matched to that of the Single Axial Indication (SAI) reported in 13RFO from the Plus-point inspection (Figures 3 and 4). This data also indicates that the growth did not occur over a single cycle and is consistent with the historical growth rates of this degradation.

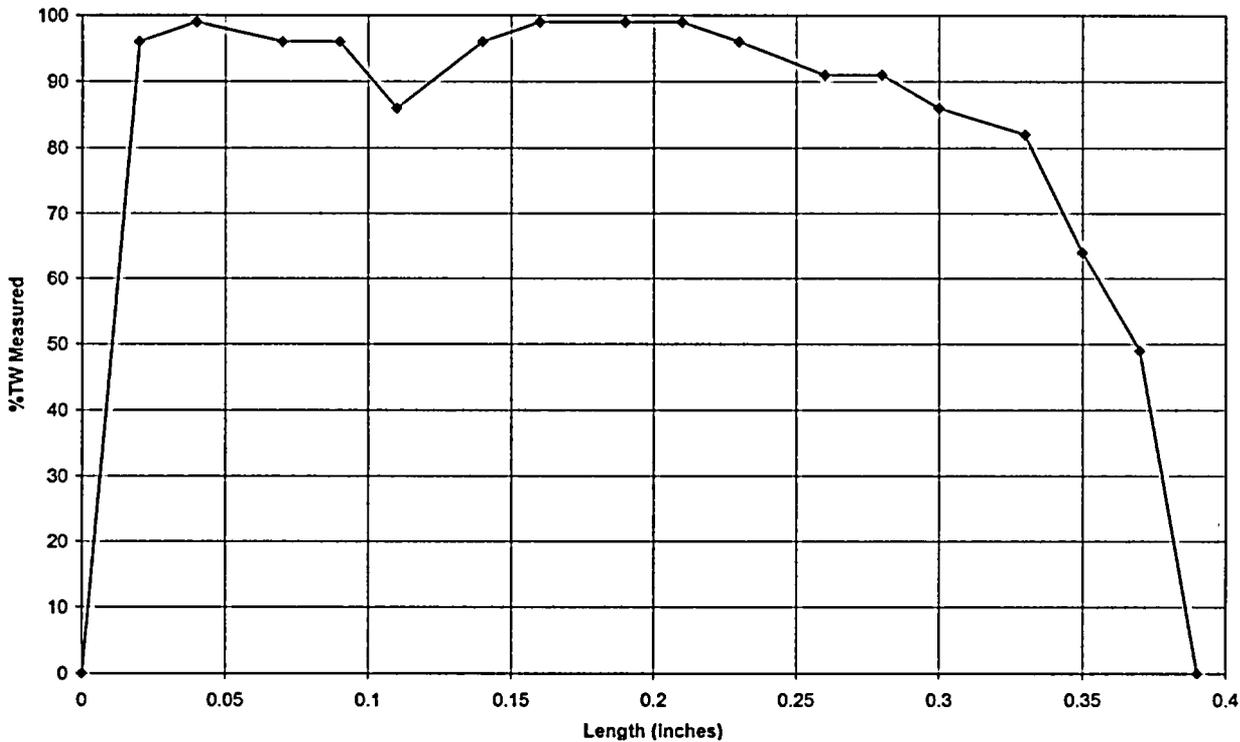
Figure 2 – NDE Profile of R63T78

Profile of SAI in Tube 2A-63-78
