Davis-Besse Reactor Vessel Head Damage NRC UPDATE

August 2003

This is the twelfth periodic update on the NRC response to the reactor vessel head damage at the Davis-Besse Nuclear Power Station. The updates will be available at public meetings of the NRC Davis-Besse Oversight Panel which is coordinating the agency's activities related to the damage. Each update will include background information to assist the reader in understanding issues associated with the corrosion damage.

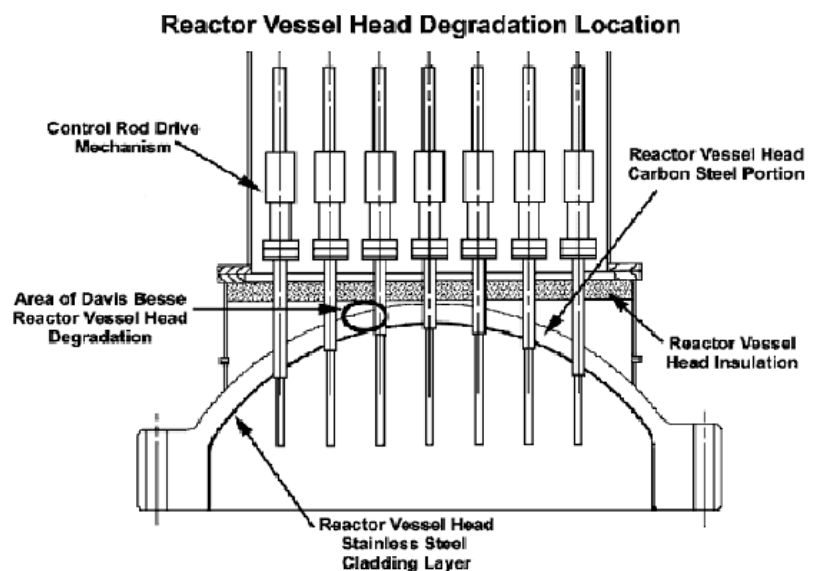
Corrosion, caused by the boric acid, damaged the vessel head next to Nozzle No. 3, creating an irregular cavity about 4 inches by 5 inches and approximately 6 inches deep. The cavity penetrated the carbon steel portion of the vessel head, leaving only the stainless steel lining. The liner thickness varies somewhat with a minimum design thickness of 1/8 inch. Subsequent examination by Framatome, FirstEnergy's contractor, found evidence of a series of cracks in the liner, none of which was entirely through the liner wall.
