SEQUOYAH NUCLEAR PLANT (SQN) - UNIT 2 - RESPONSE TO REQUEST FOR INFORMATION REGARDING STEAM GENERATOR (SG) INSPECTION REPORTS FROM UNIT 2 CYCLE 11

SEQUOYAH NUCLEAR PLANT

NRC QUESTIONS AND TVA RESPONSES

UNIT 2 CYCLE 11 STEAM GENERATOR INSPECTIONS

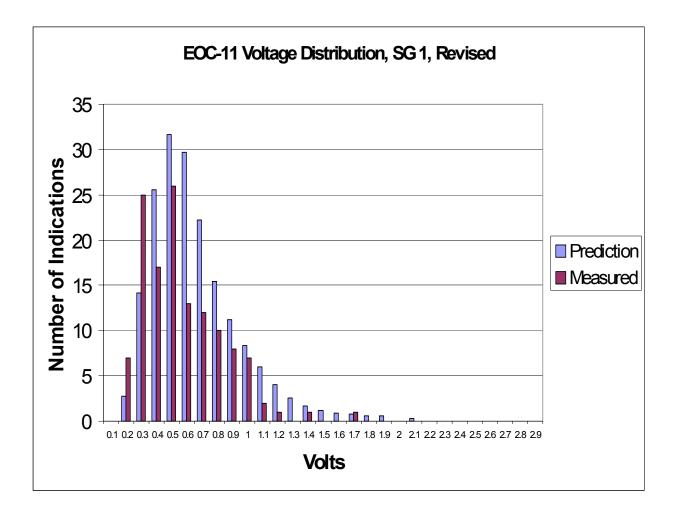
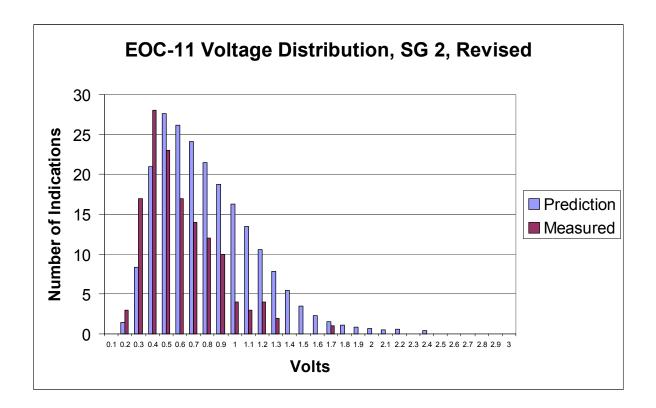
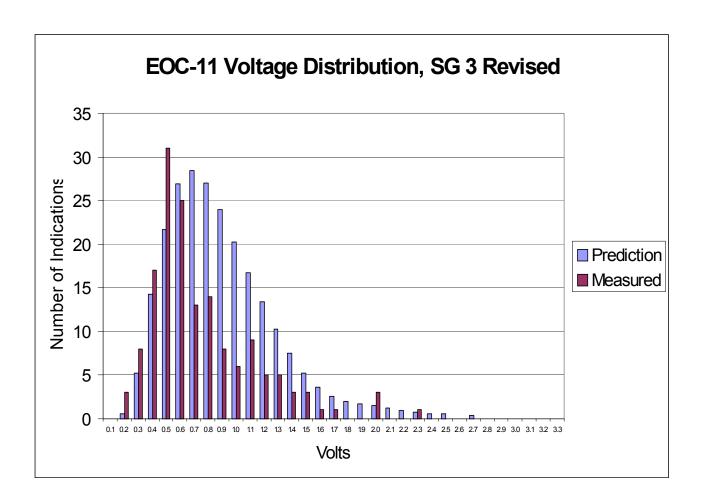
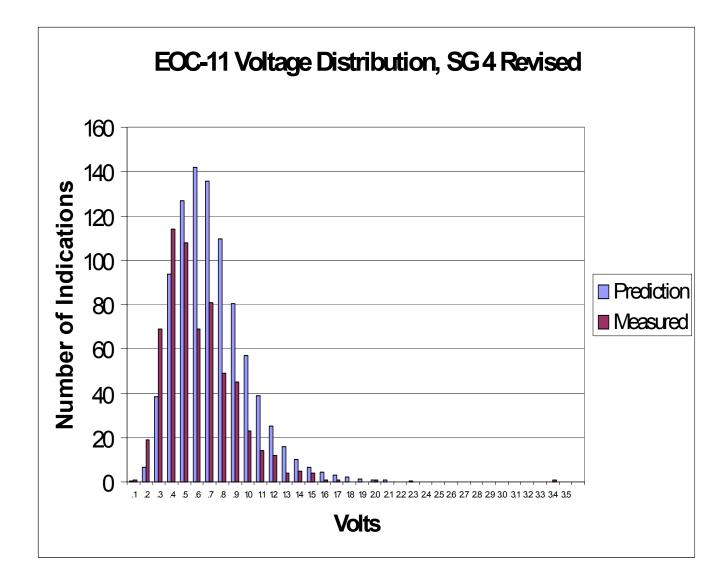
The EOC-11 voltage distribution predictions identified in Figures 4.1 - 4.4 of the July 29, 2002 report appear to be different than the EOC-11 voltage distribution predictions identified in Figures 7.1 - 7.4 of the January 30, 2001 report submitted to the NRC. Explain this apparent discrepancy. If errors are present in one or both sets of figures, clarify if correction of the errors changes any of the details (e.g., results or comparisons) in either of the two reports.

A clerical error was made by the author in the preparation of the final figures of the 2002 report. All comparisons were made with the correct data. This error resulted from a final "clean-up" of the figures. We regret the error and have corrected the figures via TVA's Corrective Action Program (Reference SQN PER 04-770190). The following corrected figures are provided.
