DATE: 7/31/01 TIME:
TO: Russ Bywater PHONE: 3113
Kathy Weaver FAX:
FROM: Woody Walker PHONE: 4923
FAX:
RE: Fire Protection related questions
cc:

Questions from NRC resident inspectors related to walkdown of Unit 1 Auxiliary building, elevations 354' and 335'.

Title: EVALUATE FIRE PROTECTION REQUIREMENTS IN FIRE ZONE 79-U

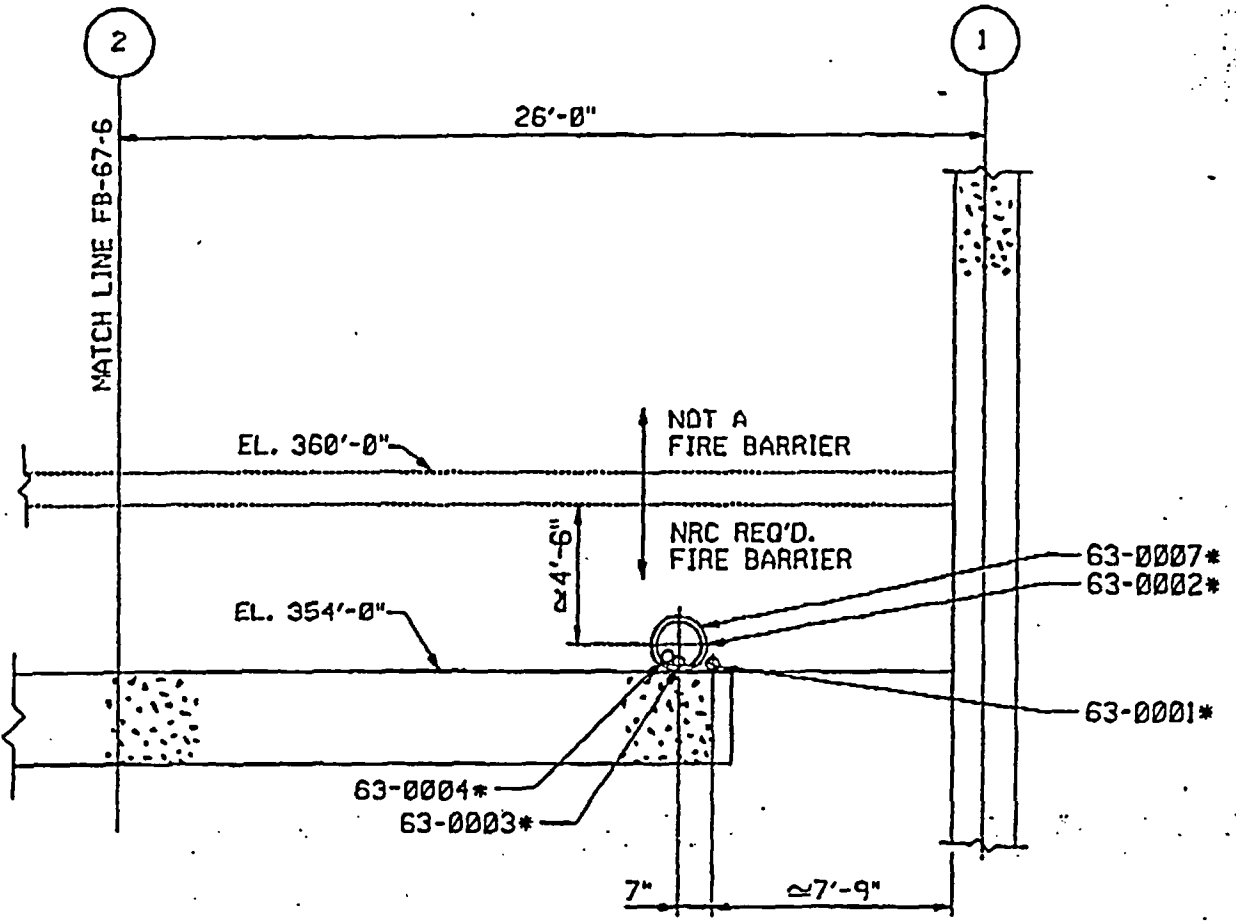
LOOKING SOUTH
WALL 4-S-28

*green
train*

*not wrapped green
CWHOS*

*red
1405*
