March 5, 2004

NRC Information Notice 2003-20: Derating Whiting Cranes Purchased Before 1980

NRC Information Notice 2004-01: Auxiliary Feedwater Pump Recirculation Line Orifice Fouling - Potential Common Cause Failure

NRC INFORMATION NOTICE 2004-01: AUXILIARY FEEDWATER PUMP
 RECIRCULATION LINE ORIFICE FOULING -
 POTENTIAL COMMON CAUSE FAILURE

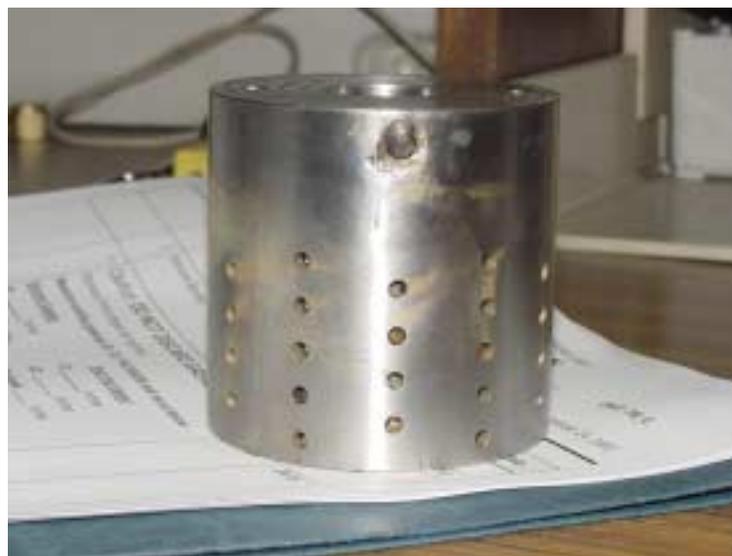
Figure 2. Recirculation Flow Restricting Orifice

The RO used a multi-stage, anti-cavitation trim package installed in the body of a globe valve to limit flow. This style of orifice or flow restrictor was installed in the AFW recirculation lines at PBNP in the past few years to eliminate cavitation caused by the old orifices. This type of flow restrictor used very small channels and holes in each stage combined with a tortuous path to limit flow and prevent cavitation.

After removal of the orifice internals, partial blockage was observed in 24 of the 54 holes in the outermost sleeve. No particles were found on any of the inner sleeves. Samples of the particles removed from the orifice were retained for analysis. A boroscope inspection of the recirculation piping at the orifice location revealed no evidence of debris. Following cleaning and reassembly, the orifice was reinstalled and the P38A AFW pump was successfully retested. Testing was successfully completed on the other three AFW pumps to verify acceptable recirculation flow by October 25, 2002.

Also, in January and February 2003, a specially fabricated orifice was tested at a contractor laboratory in an effort to determine a plugging probability with service water. Definitive testing occurred on February 21 when a debris mixture of sand, silt, and zebra mussel shells, representative of what would exist in the Point Beach SW system, was injected into a closed loop configuration of piping, an orifice, and a centrifugal pump. The orifice plugged in much less than one minute after the mixture was injected into the loop. These results were contrary to those of a previously performed computational particle fouling model analysis that indicated that plugging was unlikely because of the particle size distribution of debris in SW and the shear forces in the holes and channels of the orifices developed with the minimum flow required through the orifice for pump cooling.
