March 5, 2004

NRC INFORMATION NOTICE 2003-20: DERATING WHITING CRANES PURCHASED  
BEFORE 1980

NRC Information Notice 2004-01: Auxiliary Feedwater Pump Recirculation Line Orifice Fouling - Potential Common Cause Failure

NRC INFORMATION NOTICE 2004-01: AUXILIARY FEEDWATER PUMP  
RECIRCULATION LINE ORIFICE FOULING -  
POTENTIAL COMMON CAUSE FAILURE

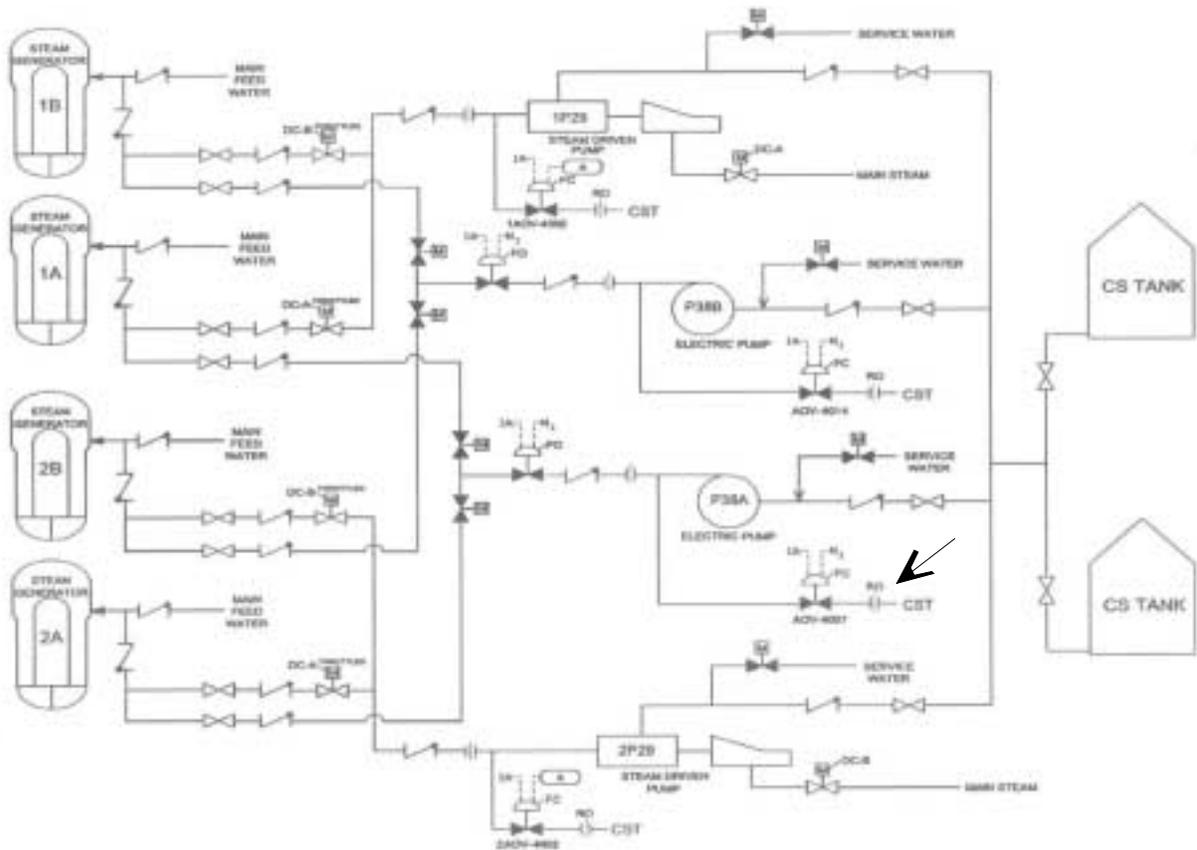
Figure 1. AFW System - Major Flow Paths

Point Beach Nuclear Plant (PBNP) is a two unit site. Each unit has a turbine-driven AFW pump (pumps 1P29 and 2P29) which can supply water to both steam generators. Additionally, the plant has two motor-driven AFW pumps (pumps P38A and P38B) each of which can be aligned to a steam generator in each unit. Each pump has a recirculation line back to the condensate storage tanks (CSTs) to ensure minimum flow to prevent hydraulic instabilities and dissipate pump heat. The recirculation line contained a pressure reducing, flow restricting orifice. An arrow is pointing to the recirculation flow restricting orifice (RO) in the major flow path AFW diagram provided in Figure 1 and a picture of the RO is provided in Figure 2.

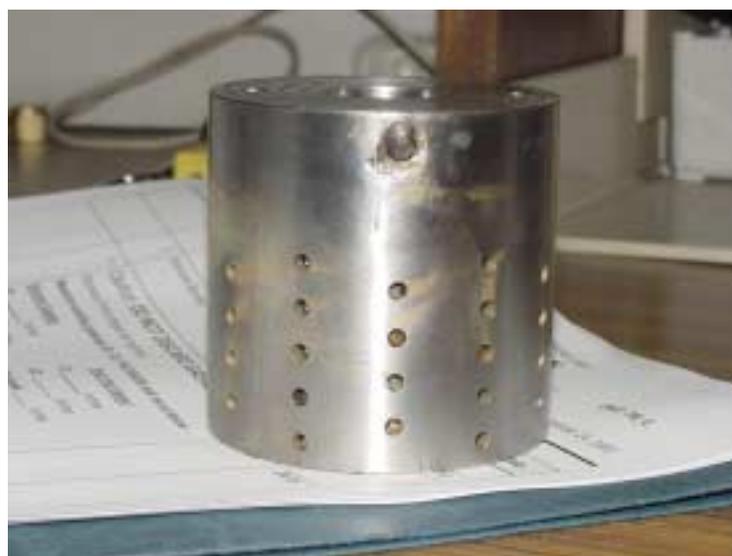
Figure 2. Recirculation Flow Restricting Orifice

The RO used a multi-stage, anti-cavitation trim package installed in the body of a globe valve to limit flow. This style of orifice or flow restrictor was installed in the AFW recirculation lines at PBNP in the past few years to eliminate cavitation caused by the old orifices. This type of flow restrictor used very small channels and holes in each stage combined with a tortuous path to limit flow and prevent cavitation.

After removal of the orifice internals, partial blockage was observed in 24 of the 54 holes in the outermost sleeve. No particles were found on any of the inner sleeves. Samples of the particles removed from the orifice were retained for analysis. A boroscope inspection of the recirculation piping at the orifice location revealed no evidence of debris. Following cleaning and reassembly, the orifice was reinstalled and the P38A AFW pump was successfully retested. Testing was successfully completed on the other three AFW pumps to verify acceptable recirculation flow by October 25, 2002.

A PBNP multi-discipline event resolution team was formed to identify and resolve the issues associated with the discovery of this condition. Activities included initiation of a root cause evaluation (RCE) to determine the root and contributing causes for the postulated common-mode failure that would render all AFW pump recirculation lines with restricted flow rates. The RCE concluded that this event had a direct root cause and an organizational root cause. The direct root cause was the failure by design engineering to properly evaluate the potential for orifice plugging within the design process. Instead of revisiting the design for adequacy and evaluating the potential for plugging of the proposed orifices within the rigor of the design process, the 10 CFR 50.59 safety evaluation was revised to justify the proposed design. The organizational root cause was less than adequate management oversight of the design modification process.
