South Texas Project
Unit 2
Docket No. STN 50-499
Errata Sheet

South Texas Project
Unit 2
Docket No. STN 50-499
Licensee Event Report 2-03-003
Standby Diesel Generator 22 Failure

1. FACILITY NAME South Texas Unit 2				2. DOCKET NUMBER 05000 499				3. PAGE 1 OF 7			
4. TITLE Standby Diesel Generator 22 Failure											
5. EVENT DATE			6. LER NUMBER			7. REPORT DATE			8. OTHER FACILITIES INVOLVED		
MONTH	DAY	YEAR	YEAR	SEQUENTIAL NUMBER	REV NO	MO	DAY	YEAR	FACILITY NAME	DOCKET NUMBER	
12	09	2003	2003	03	00	2	05	2004	FACILITY NAME	DOCKET NUMBER	
									05000		
									05000

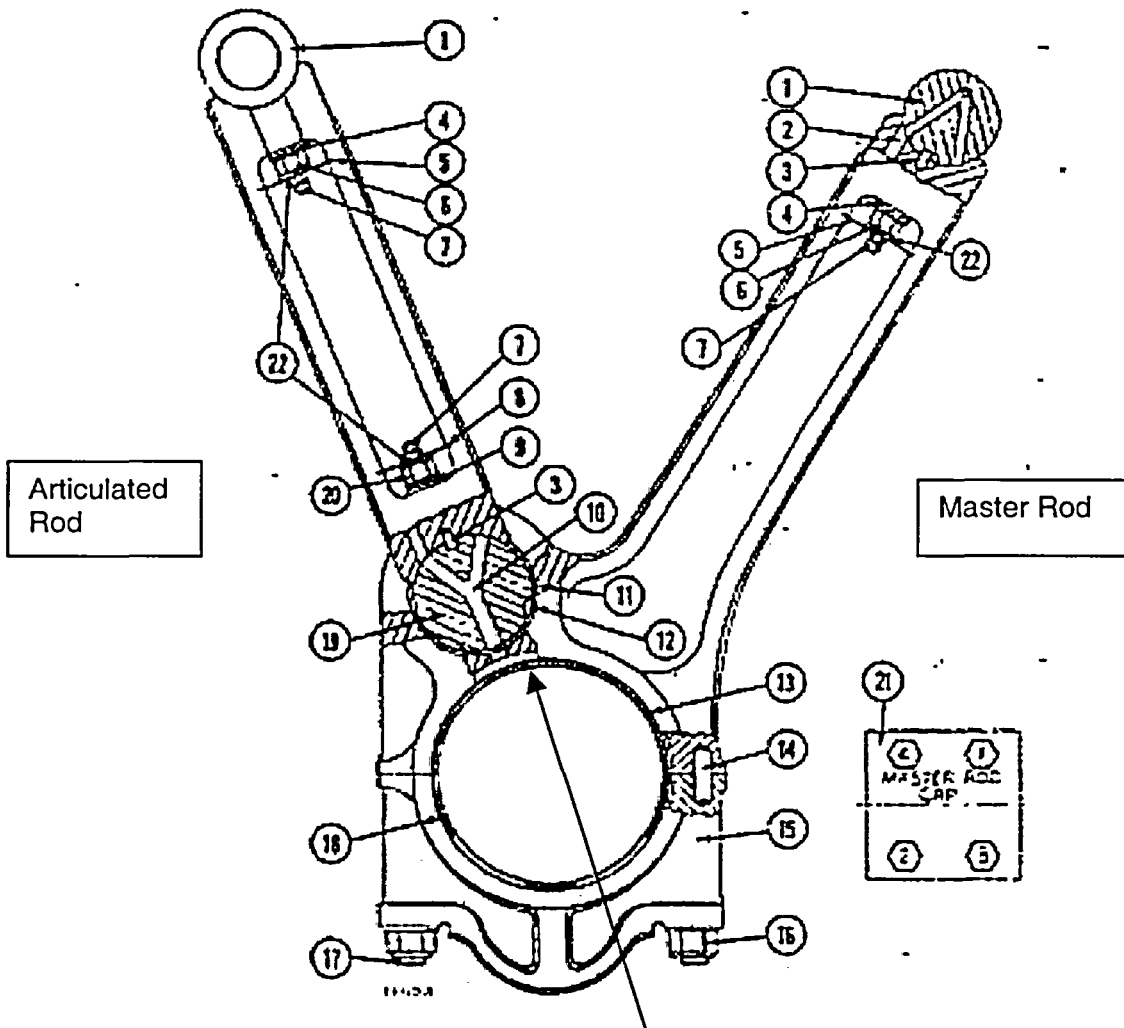
Attachment 1 Diagram of Connecting Rods

The crack initiated on the master connecting rod in the area (ligament) between the crankshaft

bearing bore and the articulating rod bushing bore. The crack propagated through the section thickness (approximately 1") and then propagated across the width of the bore. One side of the fracture essentially extended across the width of the fracture face with only a small corner section showing overload. The other side of the fracture extended approximately 3.5" angled toward the articulating rod bushing surface, followed by failure due to overload.

Visible "beach marks", which indicate that a crack was propagated by cyclic stresses, were found on a fracture surface on the position 9 master rod at the common ligament area between the master rod crankshaft bearing bore and the articulated rod pin bore. The articulated rod, a piece of the master rod, and several other damaged pieces were sent to a metallurgical lab for analysis. Lab results confirmed that there was a high cycle fatigue crack on the master connecting rod.

The root cause of the diesel engine failure was microcracks created on the position 9 master connecting rod during the manufacturing process. The microcracks propagated due to high cycle fatigue until the master connecting rod failed.

Site of crack initiation (on the master rod under the bearing shell)

1. Repair Standby Diesel Generator 22 and associated damaged equipment.
2. Phased array ultrasonic testing of all standby diesel generator master connecting rods in Unit 1 and Unit 2 has been completed. Similar areas of cracking have not been found.
