Donald C. Cook Nuclear Plant Units 1 and 2
2003 ANNUAL OPERATING REPORT

2003 Annual Operating Report

3.0 STEAM GENERATOR INSPECTIONS

3.1. 2003 SG In-Service Inspection

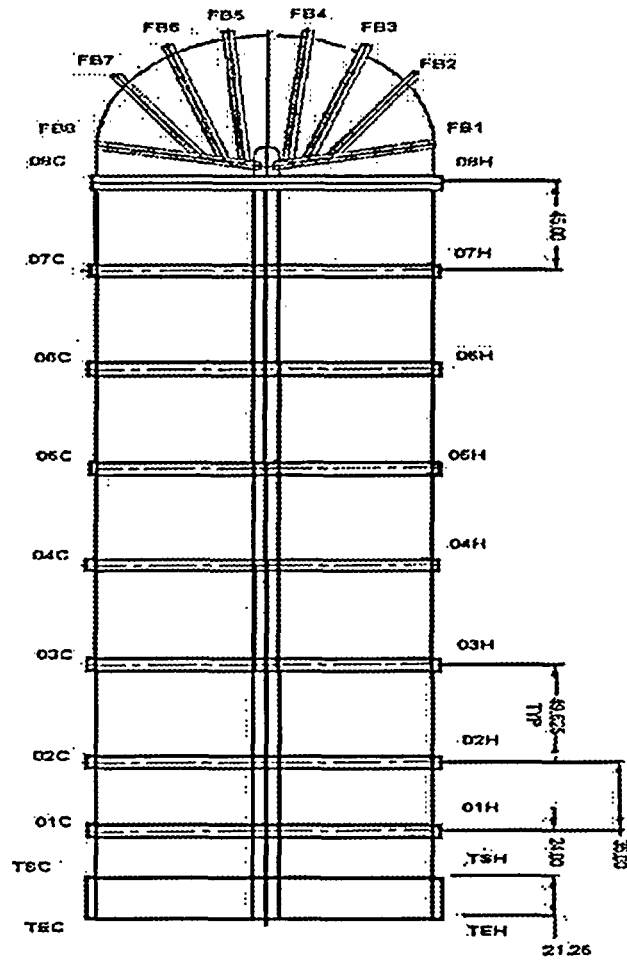
Figure 1
Steam Generator Support Structure Numbering Scheme

Tube	Location * (Figure 1)	Voltage
R49/C57	FB2 + 12.63"	2.51
R56/C38	FB5 + 14.50"	3.23
R61/C33	2C + 19.43"	2.29
R85/C57	TSC + 1.71"	4.88

*Note: The convention used to locate indications is to reference from the center of the tube supports, top-of-tubesheet or tube end as appropriate. All indication locations are measured in a positive direction from the closest lower structure (including tube end), except as follows:

- Indications located within 2.0 inches of the top of tubesheet or the center of a support shall be reported from the centerline in a positive or negative direction, as applicable.
- A tubesheet minus measurement (i.e. tubesheet hot - 5.50") may be reported in cases where no tube end was recorded.
