KEWAUNEE NUCLEAR POWER PLANT
DOCKET 50-305
LICENSE No. DPR-43

RESPONSE TO REQUEST FOR ADDITIONAL INFORMATION RELATED TO
LICENSE AMENDMENT REQUEST 199 TO THE KEWAUNEE NUCLEAR POWER
PLANT TECHNICAL SPECIFICATIONS

RESPONSE TO
REQUEST FOR ADDITIONAL INFORMATION
STEAM GENERATOR EDDY CURRENT INSPECTION FREQUENCY EXTENSION
TAC MC1049

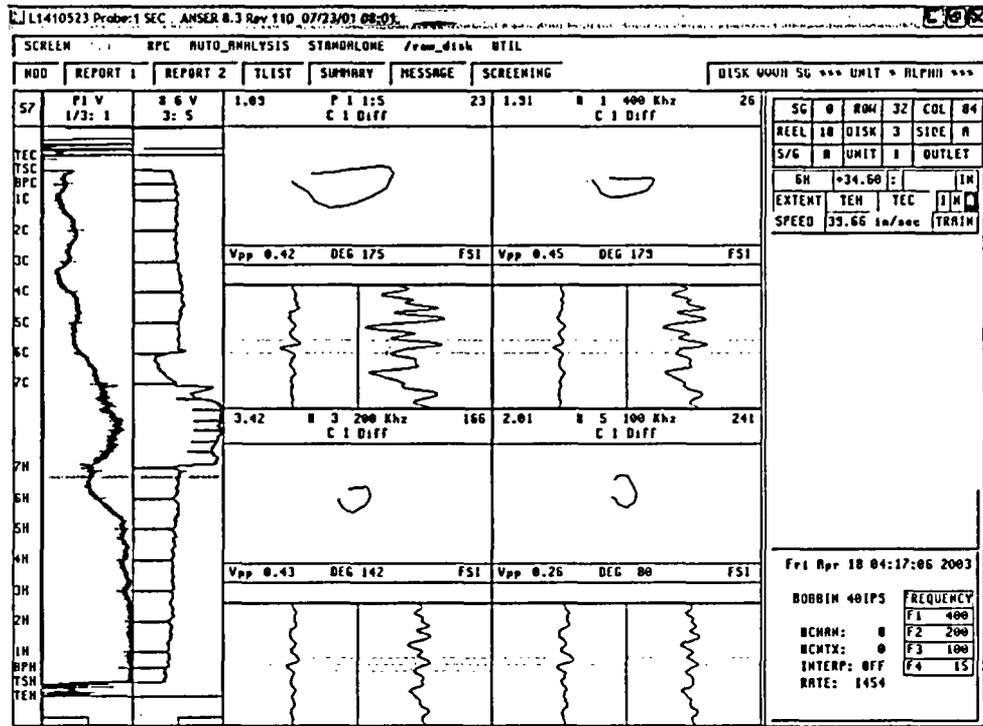
The two freespan indications (FSI) reported during the inservice inspection are shown in Figures 1 and 2. Both of these indications exhibit a change from the pre-service inspection (PSI) condition. The PSI results are shown in Figures 3 and 4. The PSI data for both of these locations exhibit low level geometric discontinuities which PSI are below the typical recording threshold. The amplitude of the FSI signals reported during the 2003 inservice inspection is commensurate with that of the discontinuities as is demonstrated by Figures 2 and 4. Also, note that the U-bend offset observable in the in-service data is not present in the pre-service data. The rotating probe inspections showed no detectable degradation (Figures 5 and 6). These signals are similar to those observed in Alloy 600 thermally treated (TT) tubing.

These signals observed during the in-service inspection are considered to be benign in nature. Based upon Alloy 600 TT operating experience, no such indications have exhibited corrosion related degradation and represent no apparent increase in the susceptibility to corrosion over the base material surrounding the indication. They do not affect the integrity of the tube.

Figure 1
 SG – A Row 32 Col 84, FSI reported in 1R26.

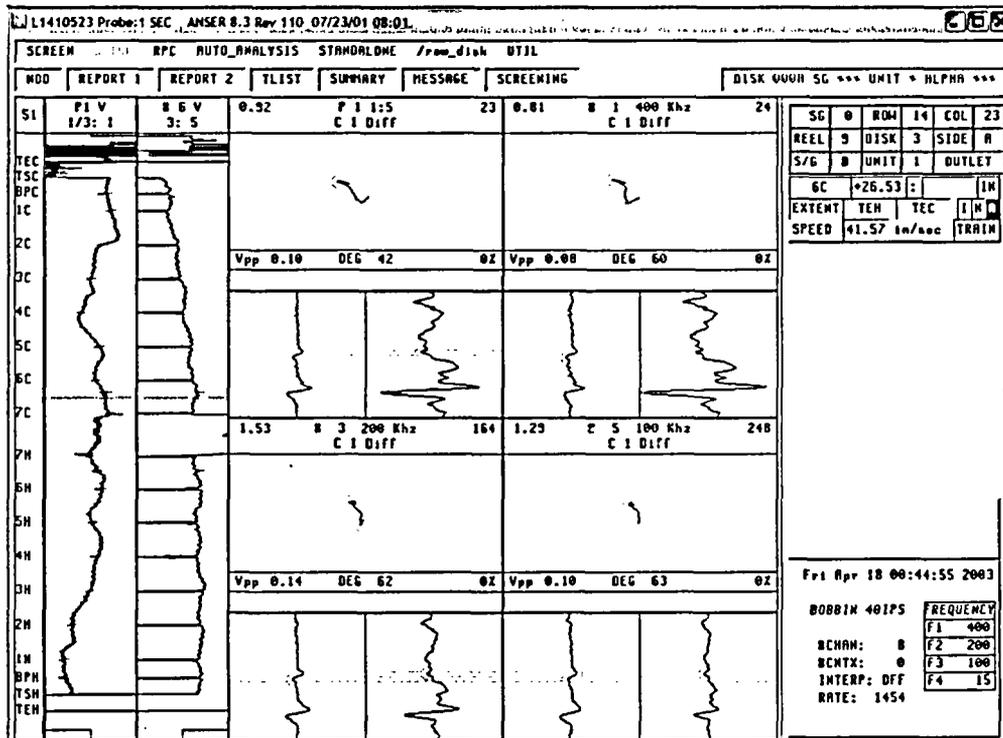
Figure 2
 SG – B Row 14 Col 23, FSI reported in 1R26.

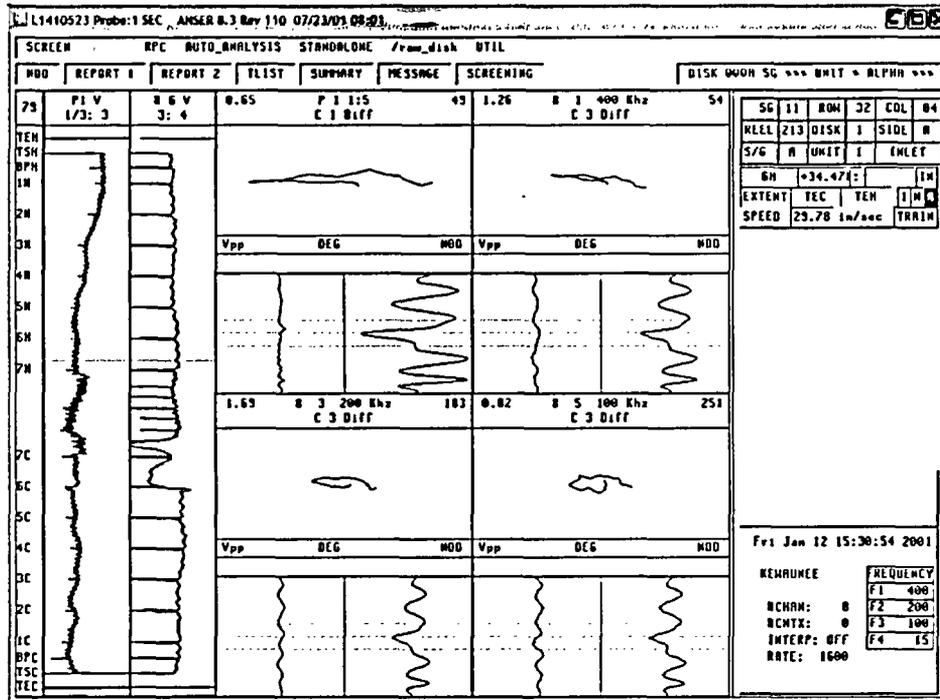
Figure 3

SG – A Row 32 Col 84, PSI data for FSI location. A small anomaly in the normal probe motion pattern is indicative of a small, localized geometric discontinuity.

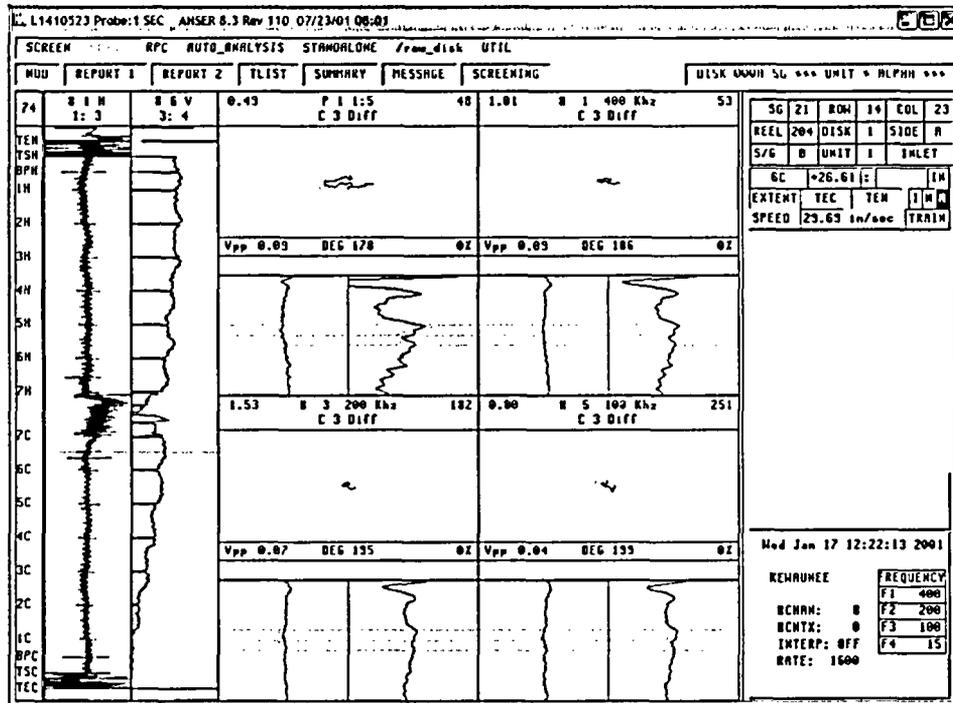
Figure 4

SG – B Row 14 Col 23, PSI data for FSI location. A small anomaly in the normal probe motion pattern is indicative of a small, localized geometric discontinuity.

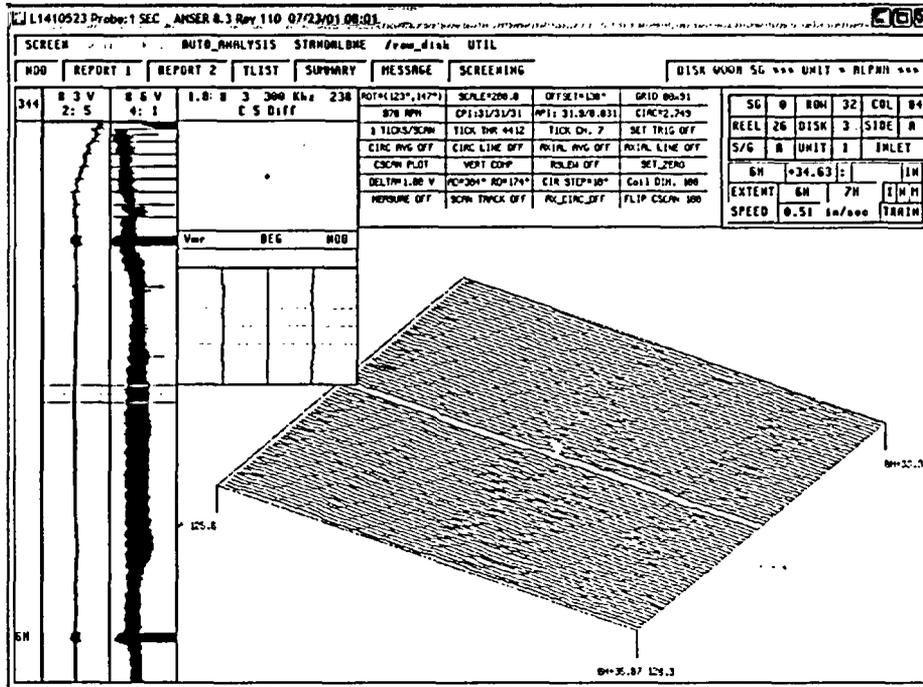
Figure 5
 SG – A Row 32 Col 84, +Point™ data for FSI location.
 No degradation or discontinuity is detectable.

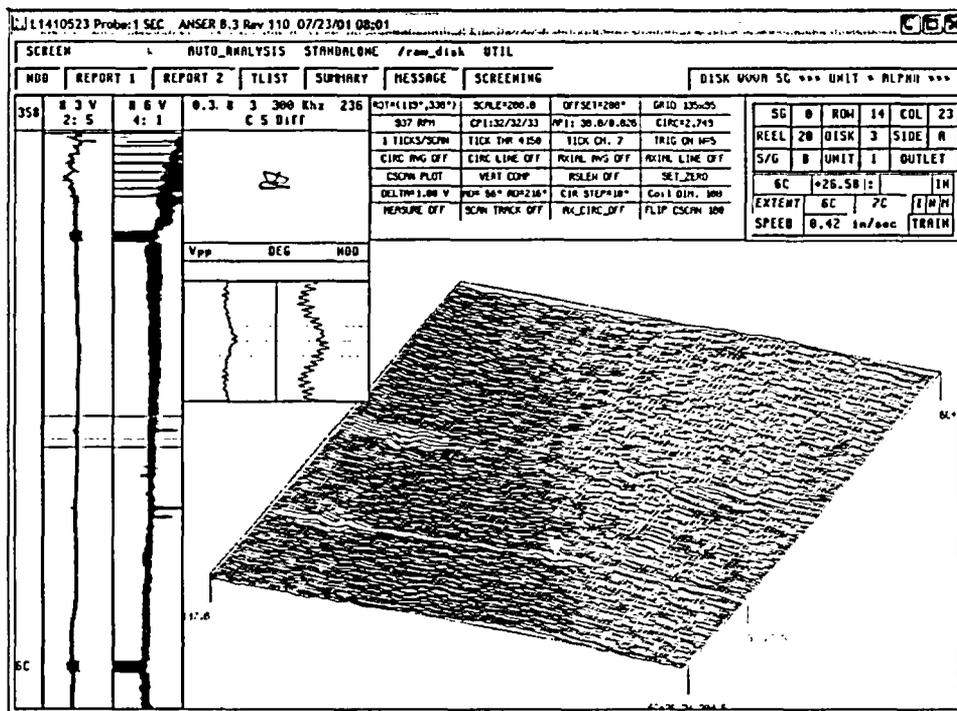
Figure 6
 SG – B Row 14 Col 23, +Point™ data for FSI location. No degradation is detectable, but a very small, localized geometric discontinuity can be observed.
