March 11, 2004

PERMIT TO MINE NO. 478

**RE: Irigaray Pond RB solution spill.**

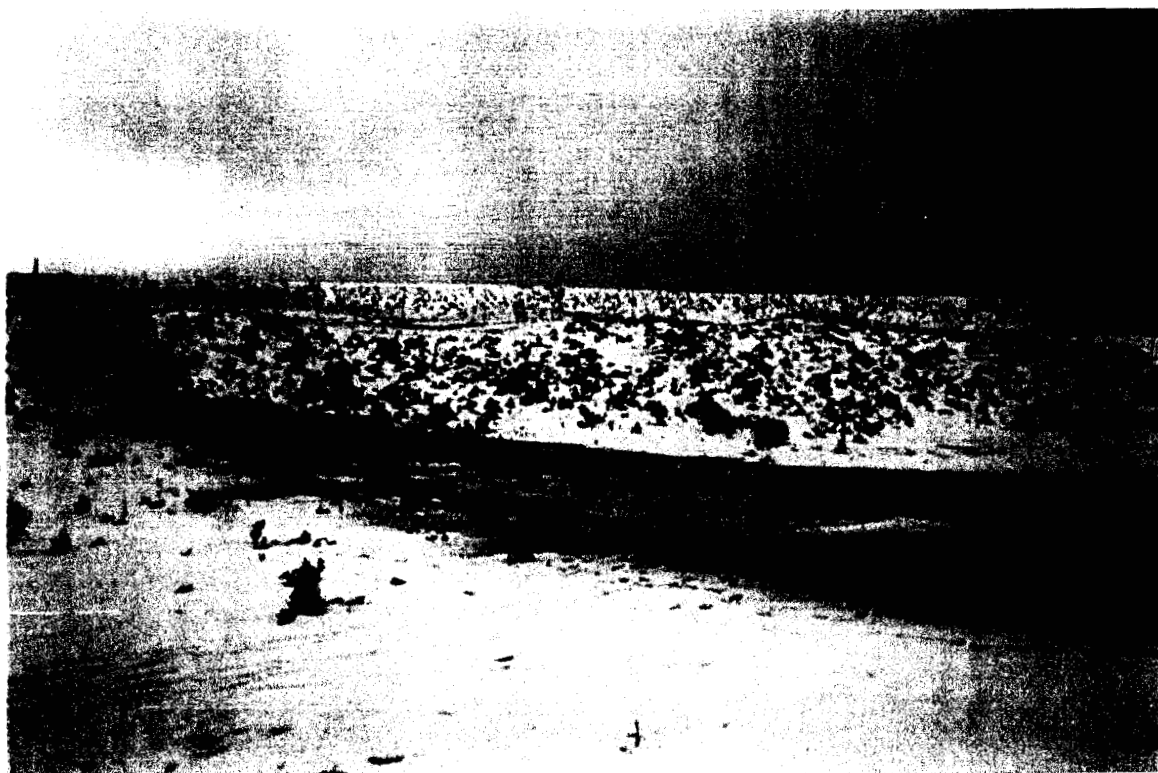
The event involved the loss of approximately 15,000 gallons of elution circuit rinse water on the afternoon of March 4, 2004. The spill occurred at our Irigaray (IR) waste ponds Sec 9, T.45 N., R.77 W. One of our plant operators was nearing completion of an eluted resin transfer for transport back to the Christensen Ranch (CR) Project. When he finished the final rinse cycle of the resin he discharged the spent rinse water to the Irigaray ponds as is typically the procedure. The water discharged was relatively clean fluid. A sample taken from the pond discharge line was tested at our CR lab with the following parameters observed:

The six inch polypipe that serves as the discharge line to the pond system had recently been relocated by our maintenance staff to the southeast corner of IR Restoration Pond B (Pond RB). The plant discharge lines have undergone several re-locations recently as part of procedures associated with the pond dewatering and decommissioning events taking place at the IR project site. According to Mr. Bill Geis our maintenance foreman, the pipe was secured at this location only by its own weight.

He indicated that this is standard procedure as trying to attach any weights to hold the line inside the pond causes it to rub holes in the pond liner as fluid flows through the line. Mr. Geis indicated that this is not the first time the line has shifted under temperature fluctuations that caused the end to move outside the pond embankment.

Mr. Geis, Mr. Larry Arbogast RST, and I visited the spill site as soon as the incident was reported. The spill area was denoted with flagging and a soil sample was taken for evaluation of uranium and radium 226 content. The spill fluid had obviously mixed with naturally occurring snow and ice build-up covering the terrace and soaked into about a ½ acre area along the west side of the IR road (see attached photos). No fluid was recoverable from the spill site.

Some minor erosion along the pond embankment was noted and will be reclaimed with the removal of the pond upon decommissioning. It was apparent that no fluid from this spill reached the confluence of this terrace with Willow Creek and certainly no wetlands of the state were endangered by the spill. The soil sample taken has been sent to Energy Labs in Casper, Wyoming for analysis. The site will be included in our spill investigation record for review and assessment of required clean-up during decommissioning operations at IR.

The incident was reviewed at a staff meeting held at CR on 3/9/04. At this meeting it was suggested that to prevent the reoccurrence of this problem the discharge pipe will be anchored at the top of the pond (outside the liner) by chain and metal tee-posts. This should provide some measure of added safeguard against a repeat of the incident. In addition when the plant operators perform this procedure in the future they will advise the maintenance staff that a discharge is being sent to the ponds, or they will themselves check the discharge line to be sure it is properly placed in the pond area.
