VIRGINIA ELECTRIC AND POWER COMPANY
SURRY POWER STATION UNITS 1 AND 2
EVALUATION OF PRELIMINARY WHITE FINDING AND ASSOCIATED NRC RISK
ANALYSIS CONTAINED IN NRC INSPECTION REPORT NOS. 05000280/2003008
AND 05000281/2003008

**Evaluation of an NRC's Significance Determination Process Phase 3 Analysis for
an Appendix R Fire in the Unit 1 (or Unit 2) Emergency Switchgear Room**

Surry Power Station Units 1 and 2

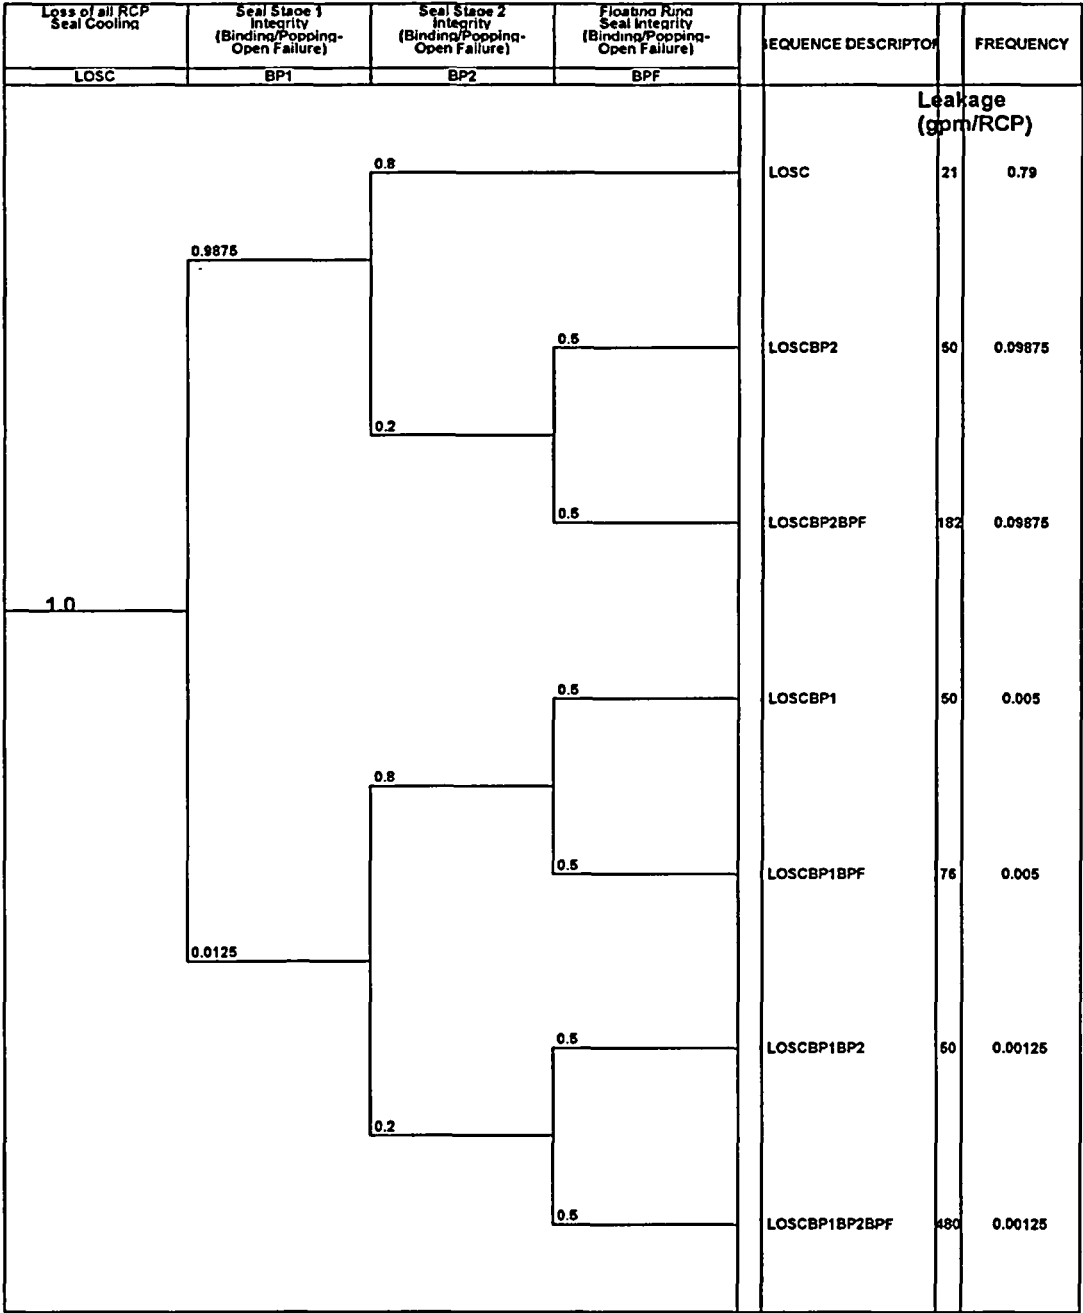
Figure 1
 Surry RCP Seal LOCA Model Reflecting Floating Ring Seals
 (50% Probability Floating Ring Seal Failure)

The conditional likelihood of RCP seal leakage events beyond 50 gpm per RCP was calculated from the modified RCP seal LOCA model event tree in Figure 1 for various floating ring seal failure probabilities between 0.1 and 0.5. These results were utilized in the sensitivity cases described below.

>50 gpm = 0.105
