A SURVEY OF WORLDWIDE EXPERIENCE WITH THE CRACKING
SUSCEPTIBILITY OF ALLOY 600 AND ASSOCIATED WELDS

W. H. Cullen, Jr., and T. S. Mintz
Office of Nuclear Regulatory Research
US Nuclear Regulatory Commission
Washington, DC 20555

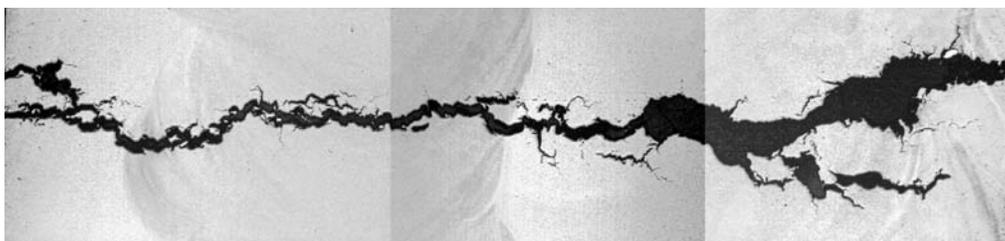
Figure 1. A metallograph showing the profile of a crack in the attachment weld of Nozzle #3 in the (now discarded) Davis-Besse reactor head (Ref. 2).

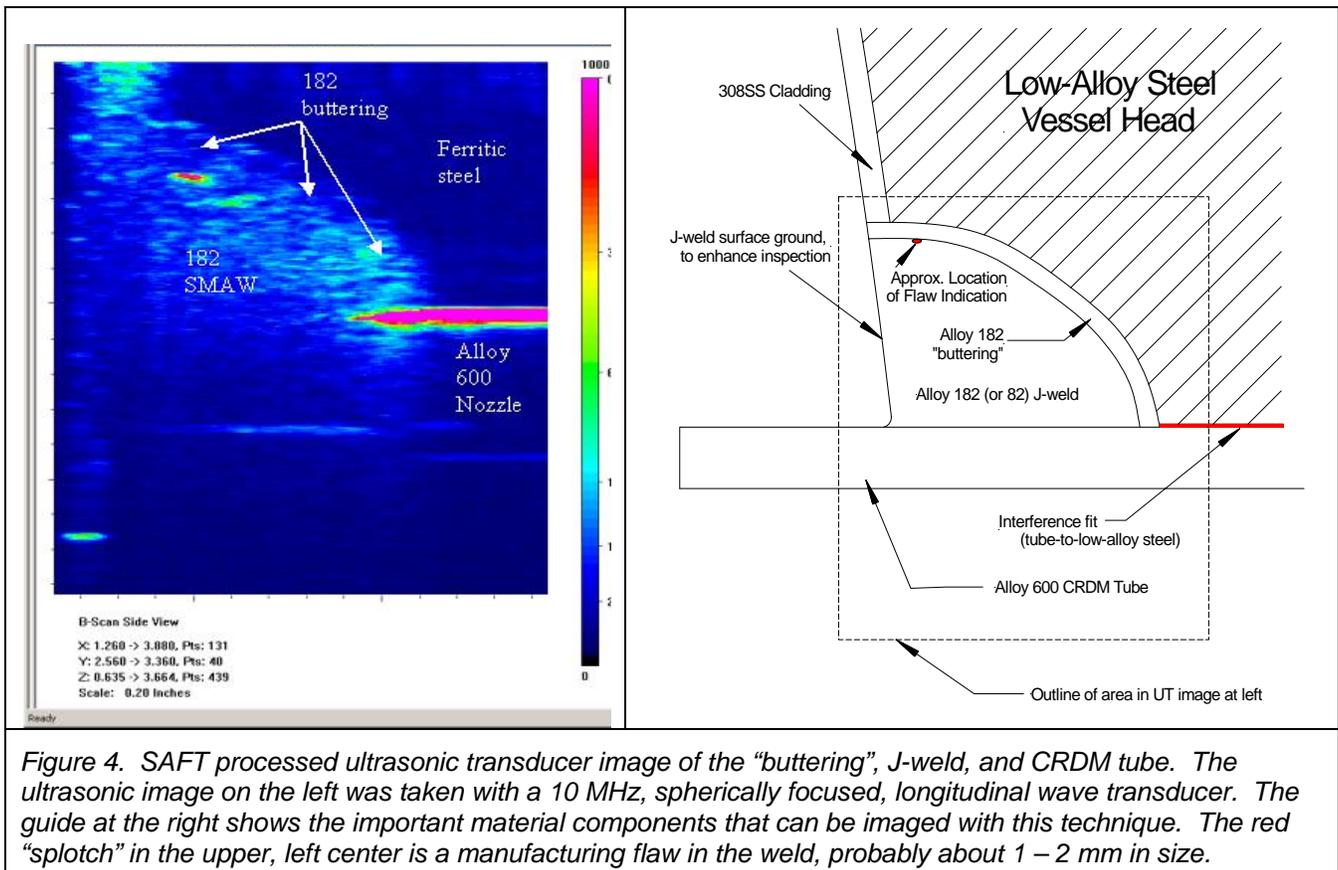
Figure 4. SAFT processed ultrasonic transducer image of the “buttering”, J-weld, and CRDM tube. The ultrasonic image on the left was taken with a 10 MHz, spherically focused, longitudinal wave transducer. The guide at the right shows the important material components that can be imaged with this technique. The red “splotch” in the upper, left center is a manufacturing flaw in the weld, probably about 1 – 2 mm in size.

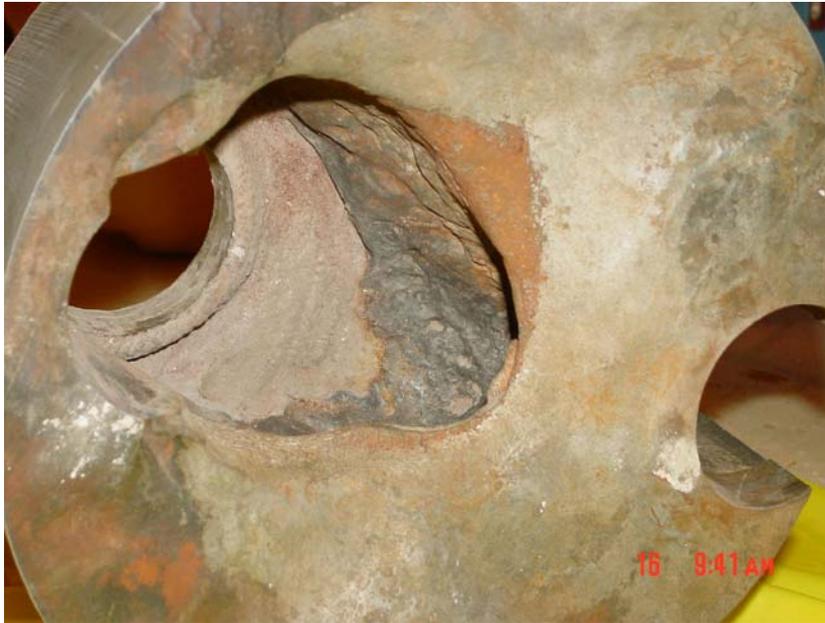
The extensive corrosion of the low-alloy steel vessel head found at Davis-Besse in March, 2002 created extensive interest in discovering the set of conditions that led to the wastage. The initial failure analysis of that corrosion was completed in June, 2003 (Ref. 2). Figure 1, and Figure 7, a photograph of the extensive corrosion loss experienced on the head at the Davis-Besse plant, were taken from that report. RES has initiated several programs addressing this issue. Pieces of the head were removed, and have been shipped to Pacific Northwest National Laboratory (PNNL), where they will be decontaminated, and the smaller corrosion cavity surrounding Nozzle #2 (the major corrosion was at Nozzle #3) will be examined in an attempt to discover the conditions of nascent head corrosion near a (relatively) younger CRDM leak. Other pieces of metal were removed from Nozzle #3, and the metal surrounding Nozzle #11, and sent to ANL, where crack growth rate tests are being conducted currently on the Alloy 600 and Alloy 182.

Figure 7. A photograph of the 18-inch diameter section of the discarded Davis-Besse head, containing the corrosion cavity created by leakage from the included nozzle (#3).
