A SURVEY OF WORLDWIDE EXPERIENCE WITH THE CRACKING
SUSCEPTIBILITY OF ALLOY 600 AND ASSOCIATED WELDS

W. H. Cullen, Jr., and T. S. Mintz
Office of Nuclear Regulatory Research
US Nuclear Regulatory Commission
Washington, DC 20555

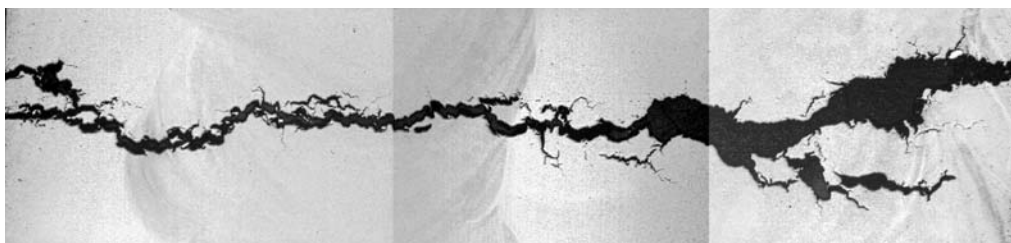
Figure 1. A metallograph showing the profile of a crack in the attachment weld of Nozzle #3 in the (now discarded) Davis-Besse reactor head (Ref. 2).

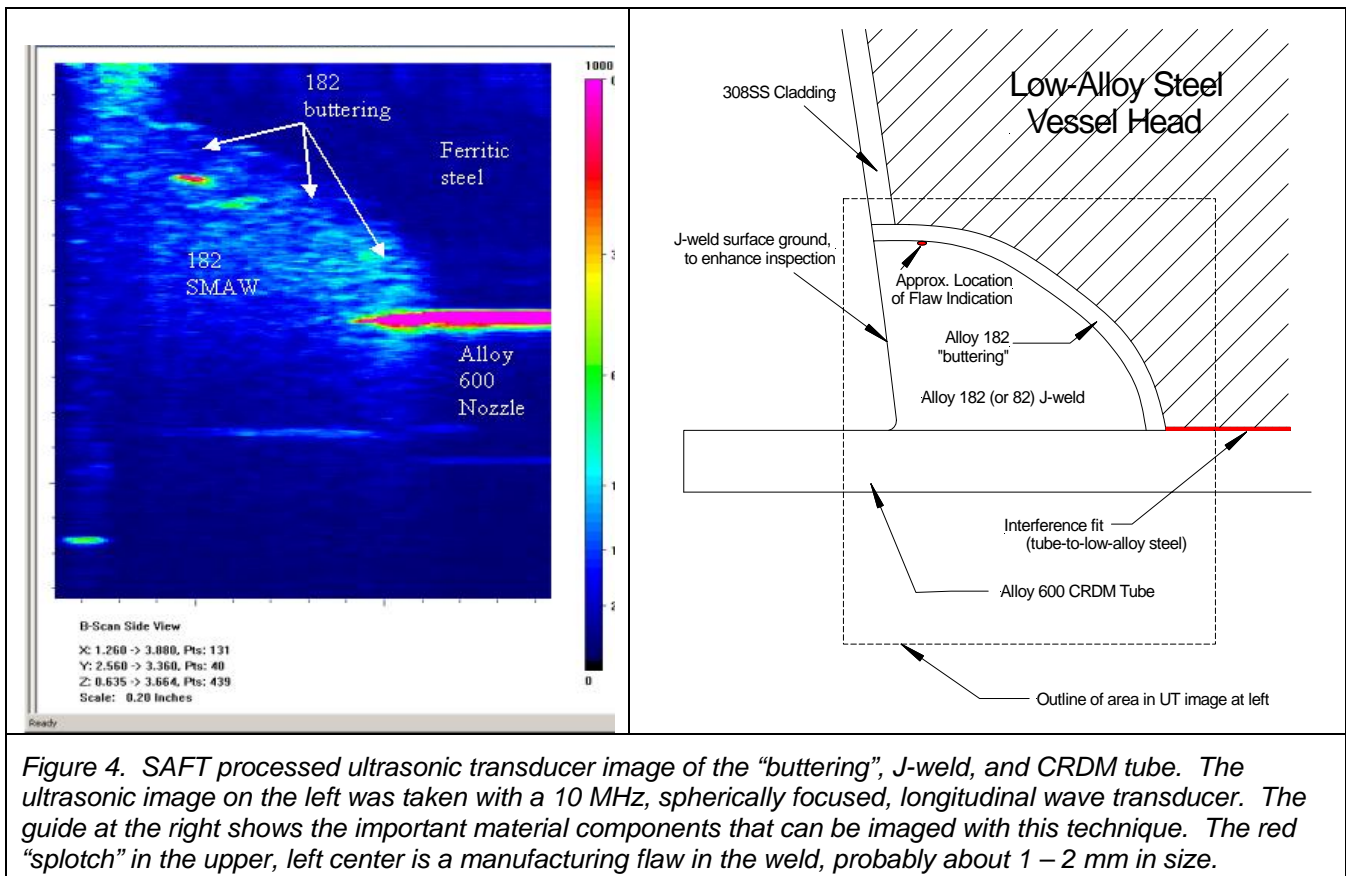
Figure 4. SAFT processed ultrasonic transducer image of the “buttering”, J-weld, and CRDM tube. The ultrasonic image on the left was taken with a 10 MHz, spherically focused, longitudinal wave transducer. The guide at the right shows the important material components that can be imaged with this technique. The red “splotch” in the upper, left center is a manufacturing flaw in the weld, probably about 1 – 2 mm in size.

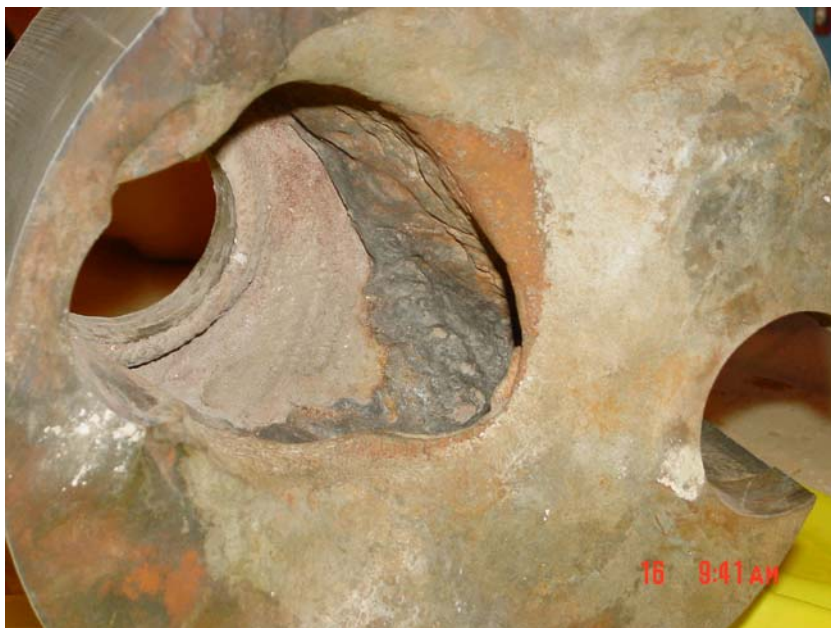
Figure 7. A photograph of the 18-inch diameter section of the discarded Davis-Besse head, containing the corrosion cavity created by leakage from the included nozzle (#3).
