CROW BUTTE RESOURCES, INC.

March 2, 2004

Subject: Injection Well I622-10 10-Year MIT Failure
Class III Underground Injection Control Permit NE0122611

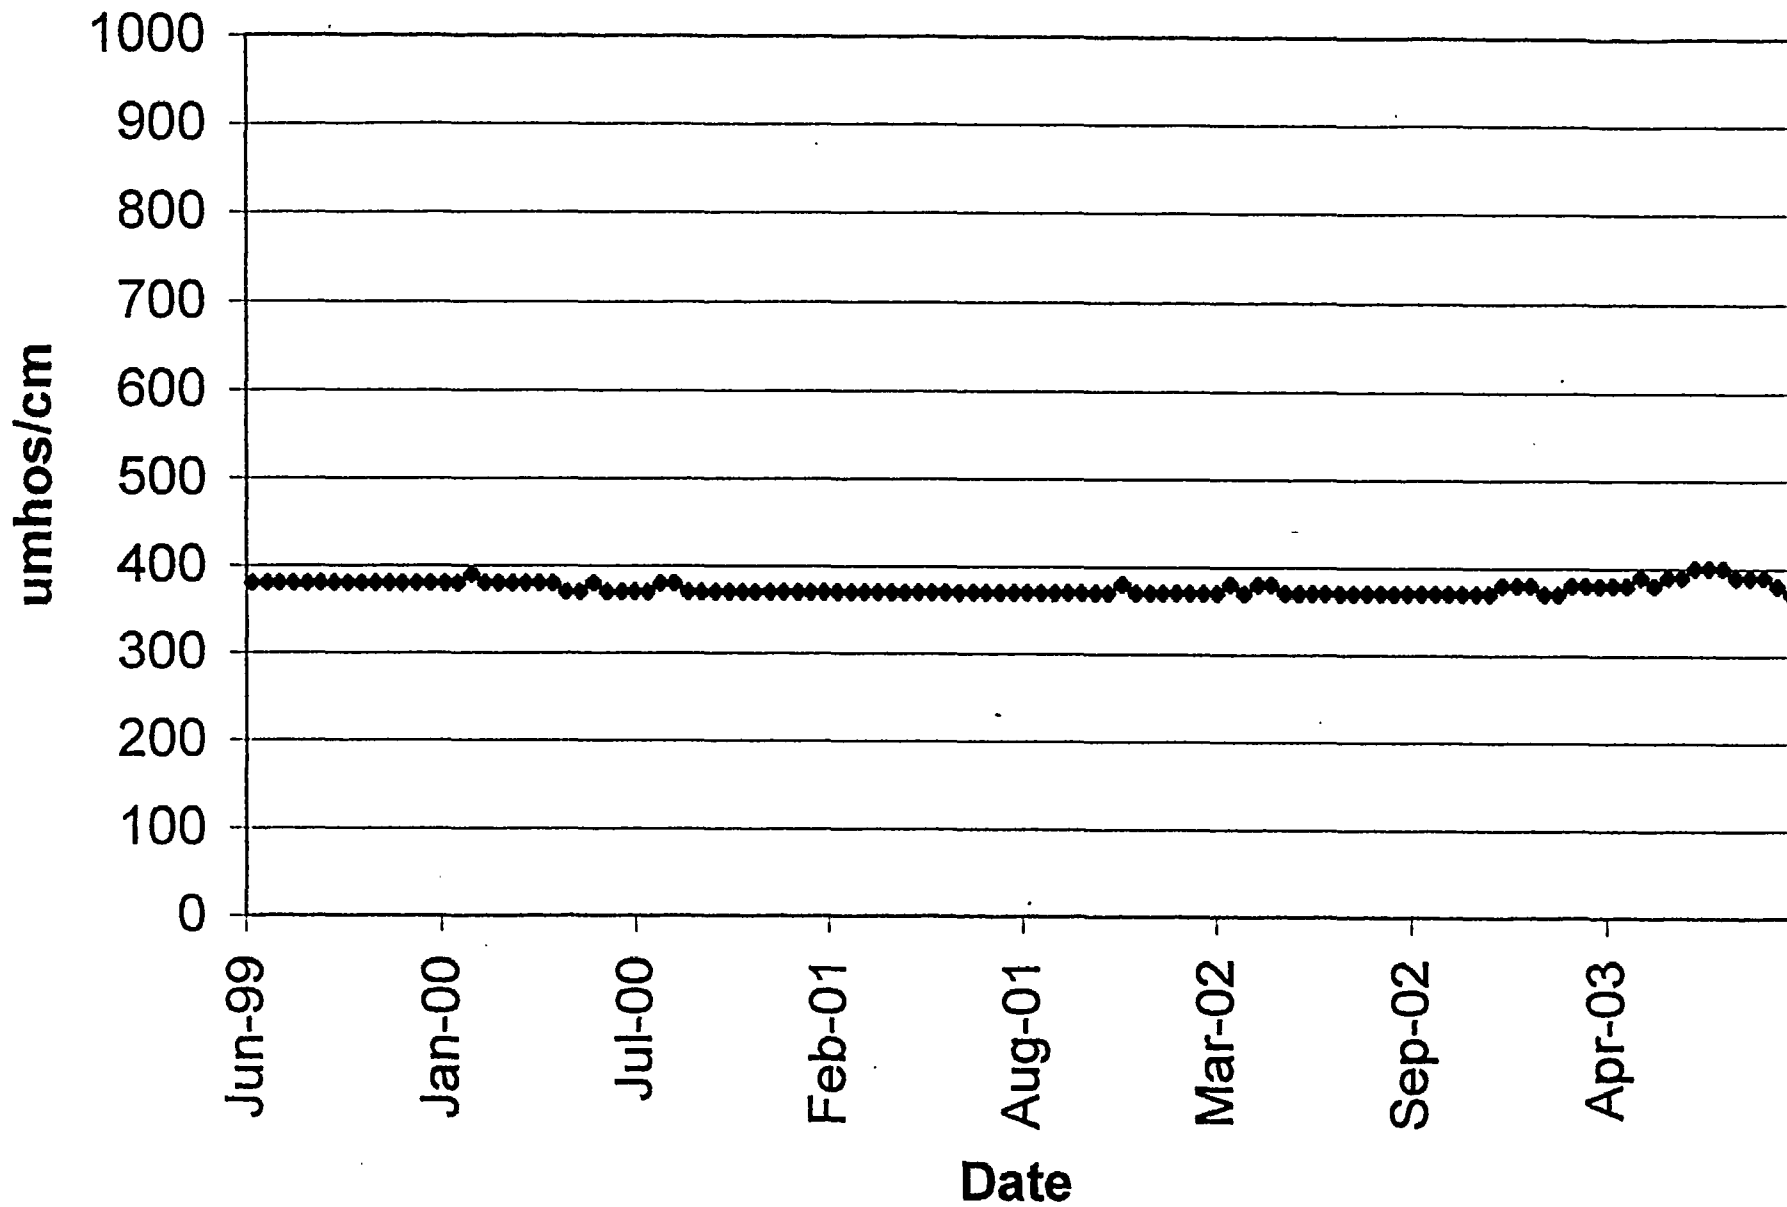
SM4-1 Conductivity

- Well SM4-1 is located approximately 120 feet west of I622-10. The well was cased to 260 feet and screened from 279 to 299 feet. The monitoring results for well SM4-1 are stable. A graph of the conductivity results for biweekly sampling since June 1999 is attached.
- Well SM4-2 is located approximately 200 feet southeast of I622-10. The well was cased to 290 feet and screened from 319 to 334 feet. The monitoring results for well SM4-2 are stable. A graph of the conductivity results for biweekly sampling since June 1999 is attached.
