**SUSQUEHANNA STEAM ELECTRIC STATION  
SUPPLEMENTAL INFORMATION FOR  
PROPOSED RELIEF REQUESTS NO. 29 AND 30 TO THE  
SECOND 10-YEAR INSERVICE INSPECTION PROGRAM  
FOR SUSQUEHANNA SES UNIT 1  
PLA-5743**

**SUPPLEMENTAL INFORMATION IN  
SUPPORT OF  
RELIEF REQUESTS NO. RR-29 AND 30**

**PPL SUSQUEHANNA, LLC  
SUSQUEHANNA SES UNIT 1  
SECOND 10-YEAR INTERVAL  
SUPPLEMENTAL INFORMATION  
IN SUPPORT OF RELIEF REQUEST NO. RR-29 AND 30**

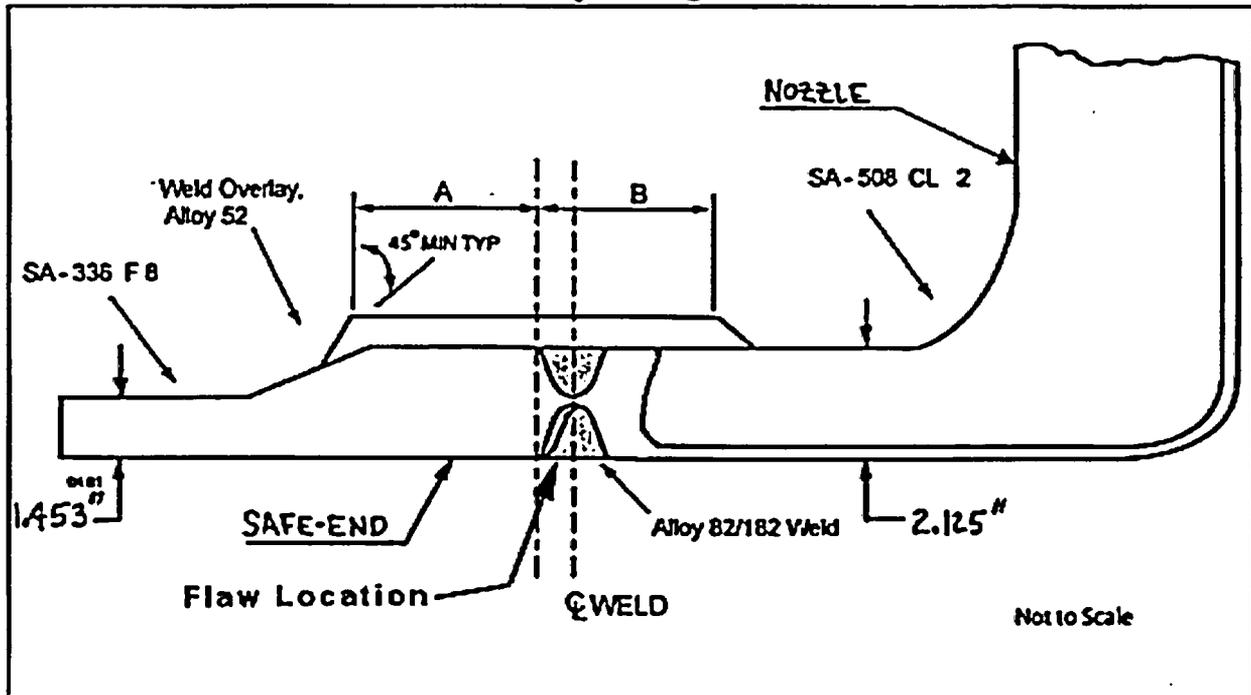
**Sketch #1**  
**N1B Nozzle and Weld**  
**Overlay Configurations**

WELD NUMBER	FLAW CHARACTERIZATION	Design Dimensions			COMMENTS
		t	A	B	
Recirculation Outlet Nozzle N1	Assumed 360° Circ. 100% throughwall flaw	0.74" min	2.5" min	4.2" min

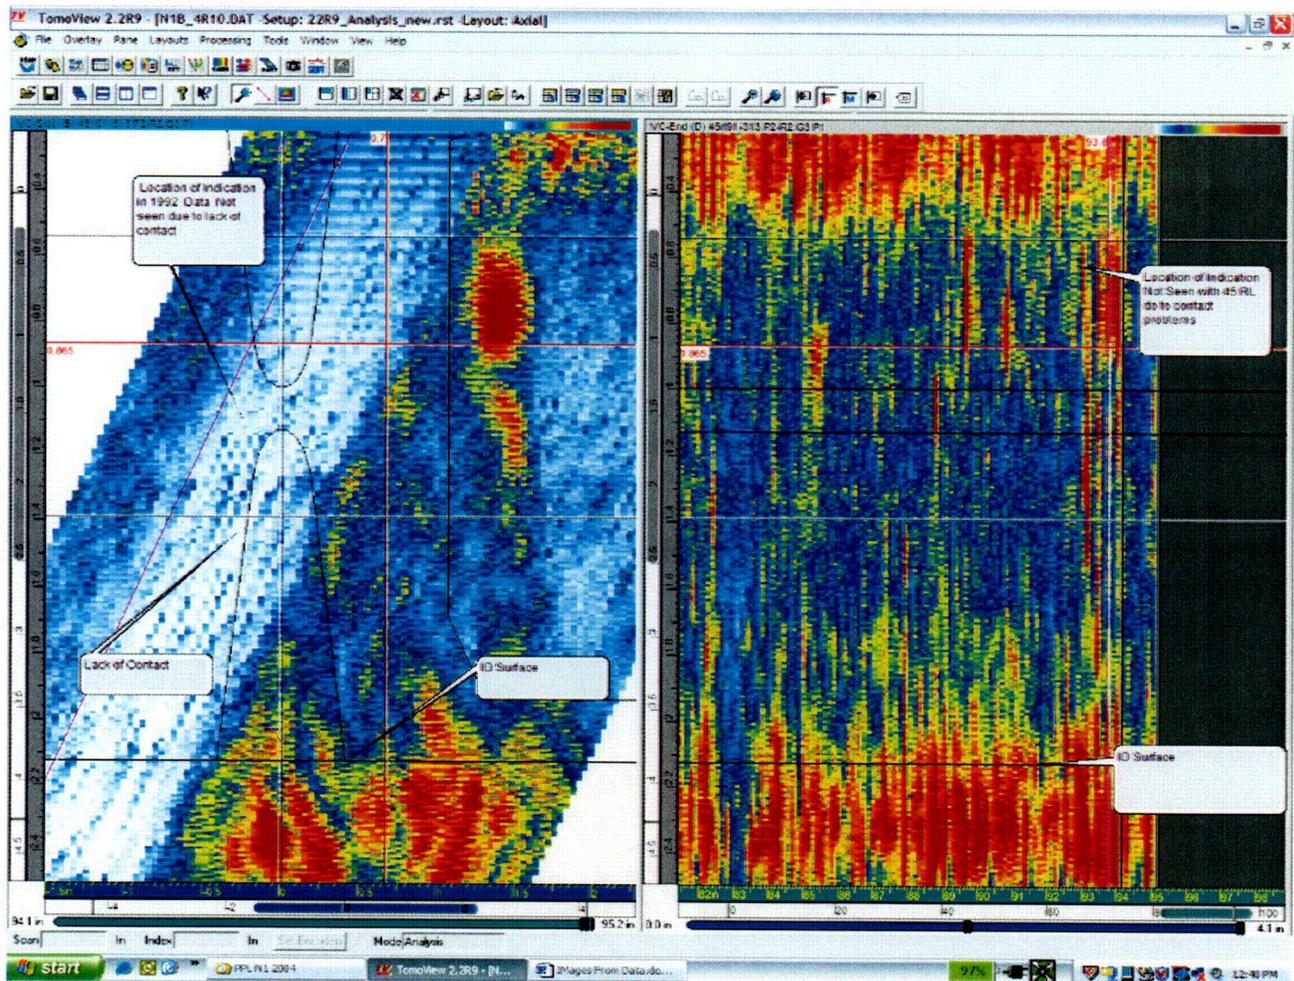
It is believe that the 45 degree data from the previous examinations did not have sufficient contact due to loss of couplant or incorrect pressure applied to the search unit to keep it coupled to the surface. This condition was not obvious to examiners when using the older data analysis software. When using the new data analysis software, this type of condition is easy to detect and thus easy to make appropriate adjustments to correct the condition. The data collected in the 2004 examination with the 45 RL search unit has very good contact.

**Figure 1**  
**45 Degree RL Data from 1992 (Prior to MSIP did not see indication due to lack of contact)**

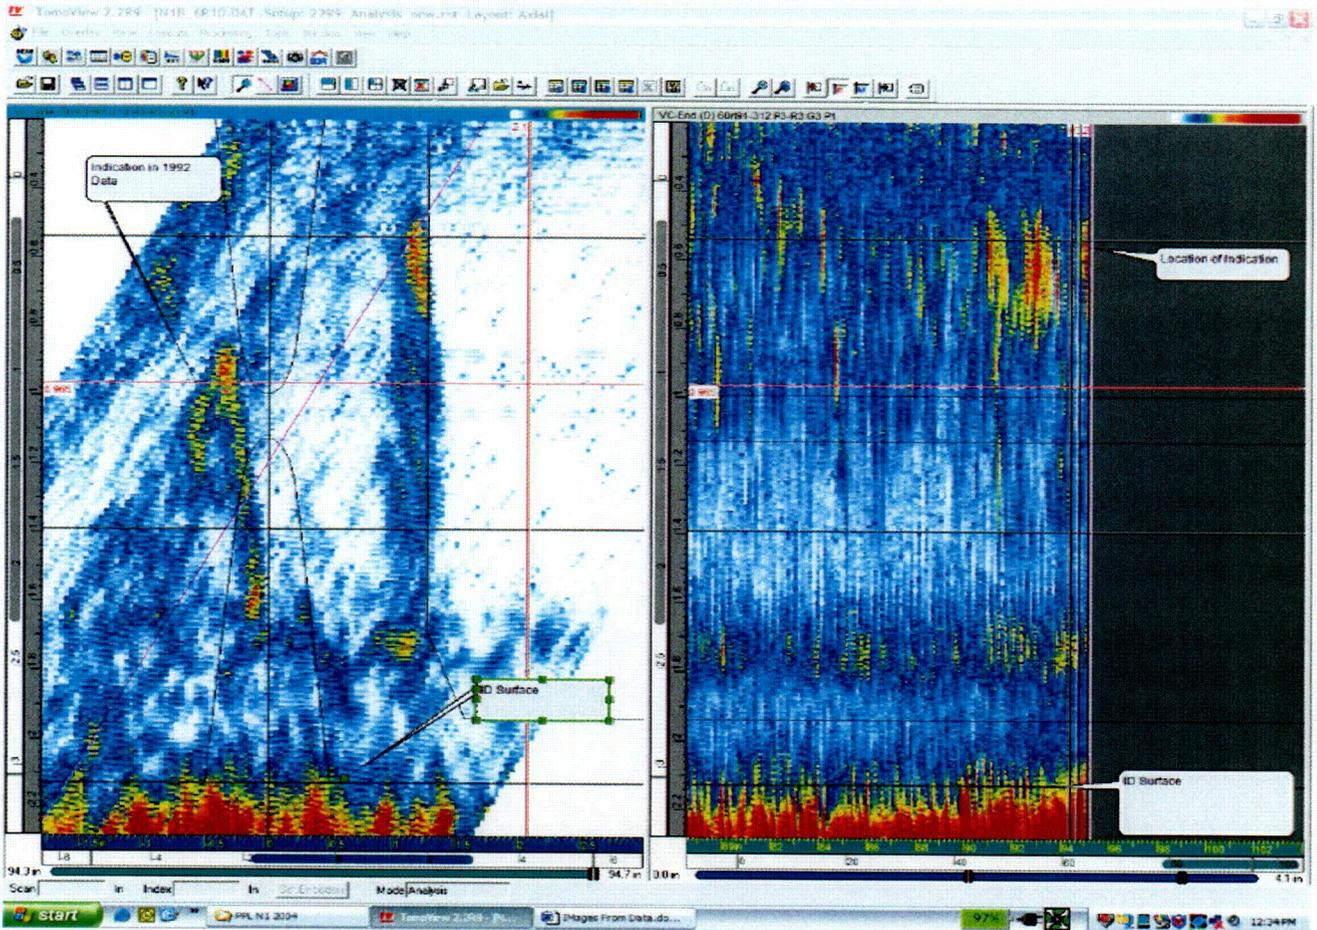
**Figure 2**  
**60-Degree RL Data From 1992 (Prior to MSIP)**

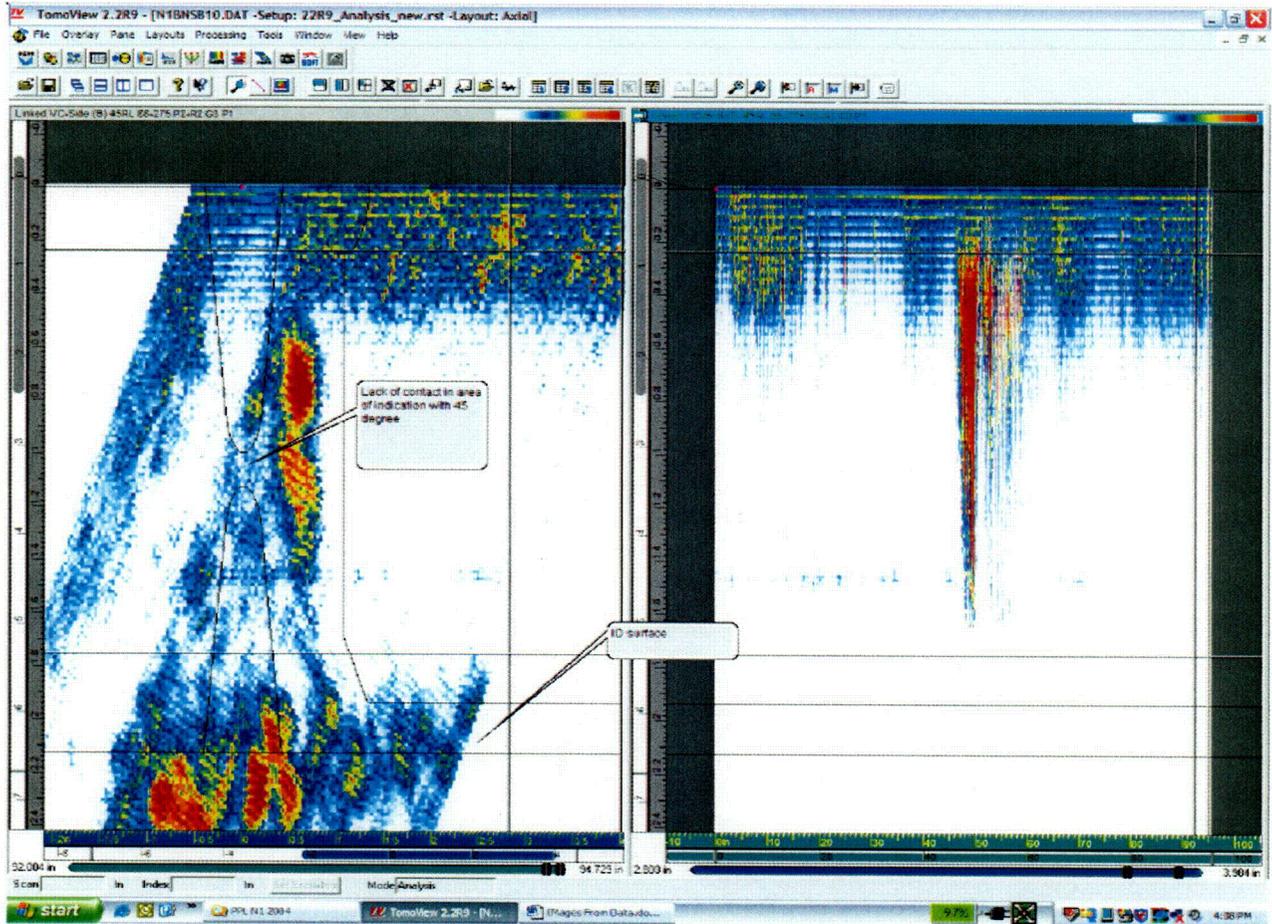
**Figure 3**  
**45-Degree RL Data from 1995 (Post MSIP)**

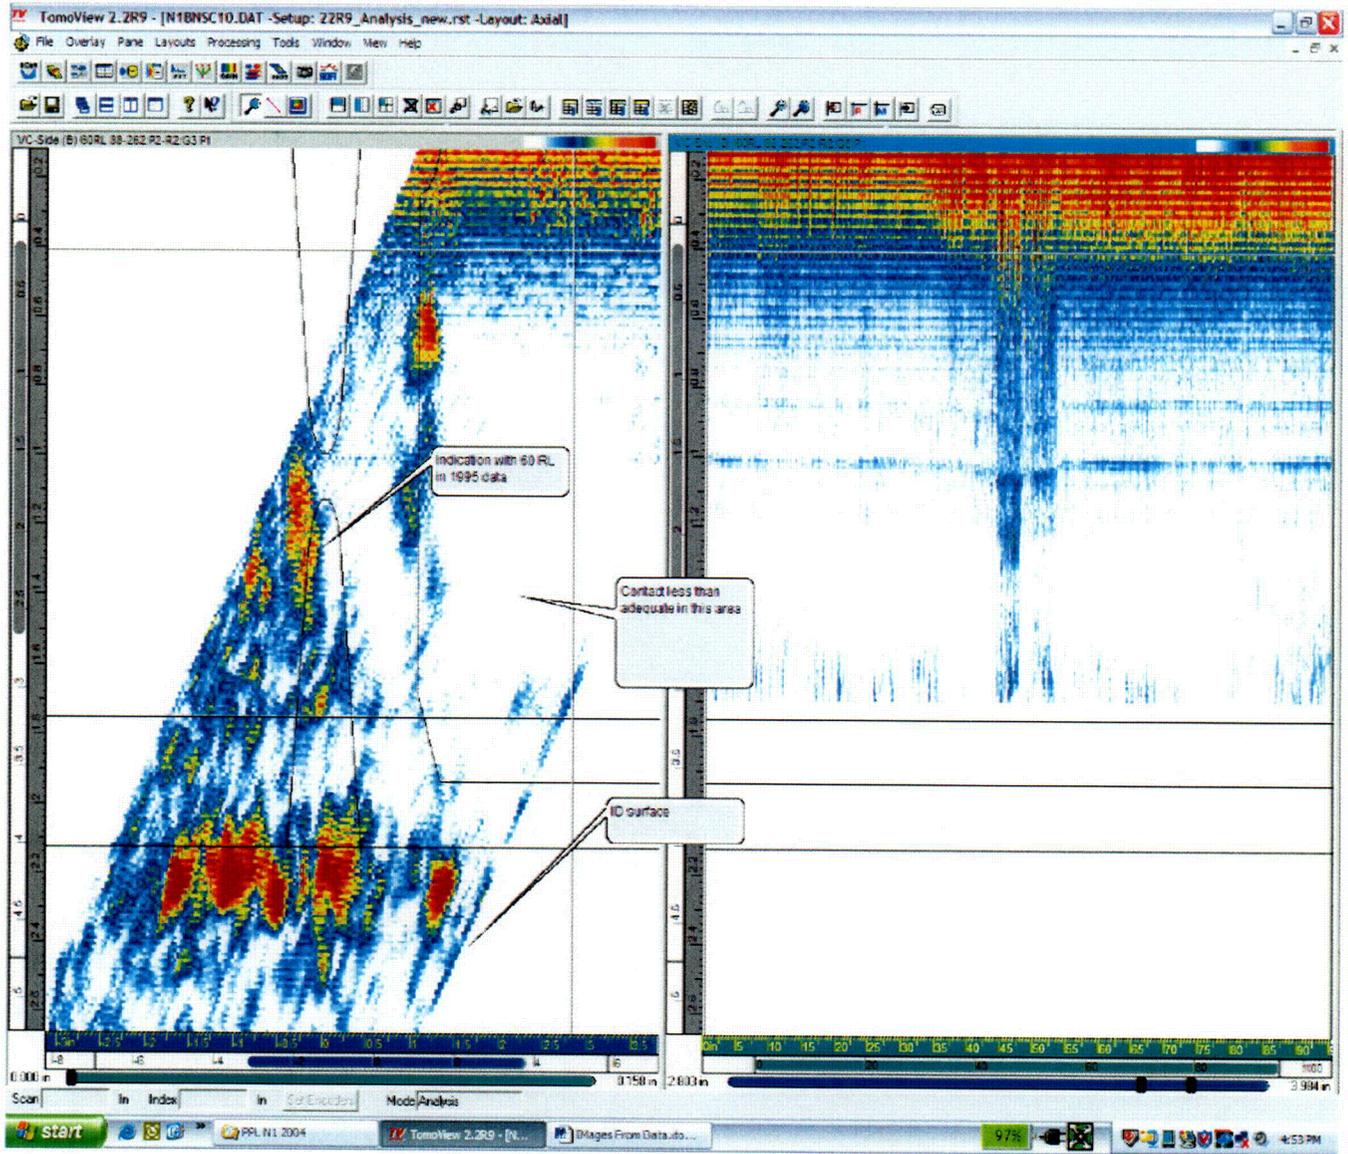
**Figure 4**  
**60 RL Data from 1995 (Post MSIP)**

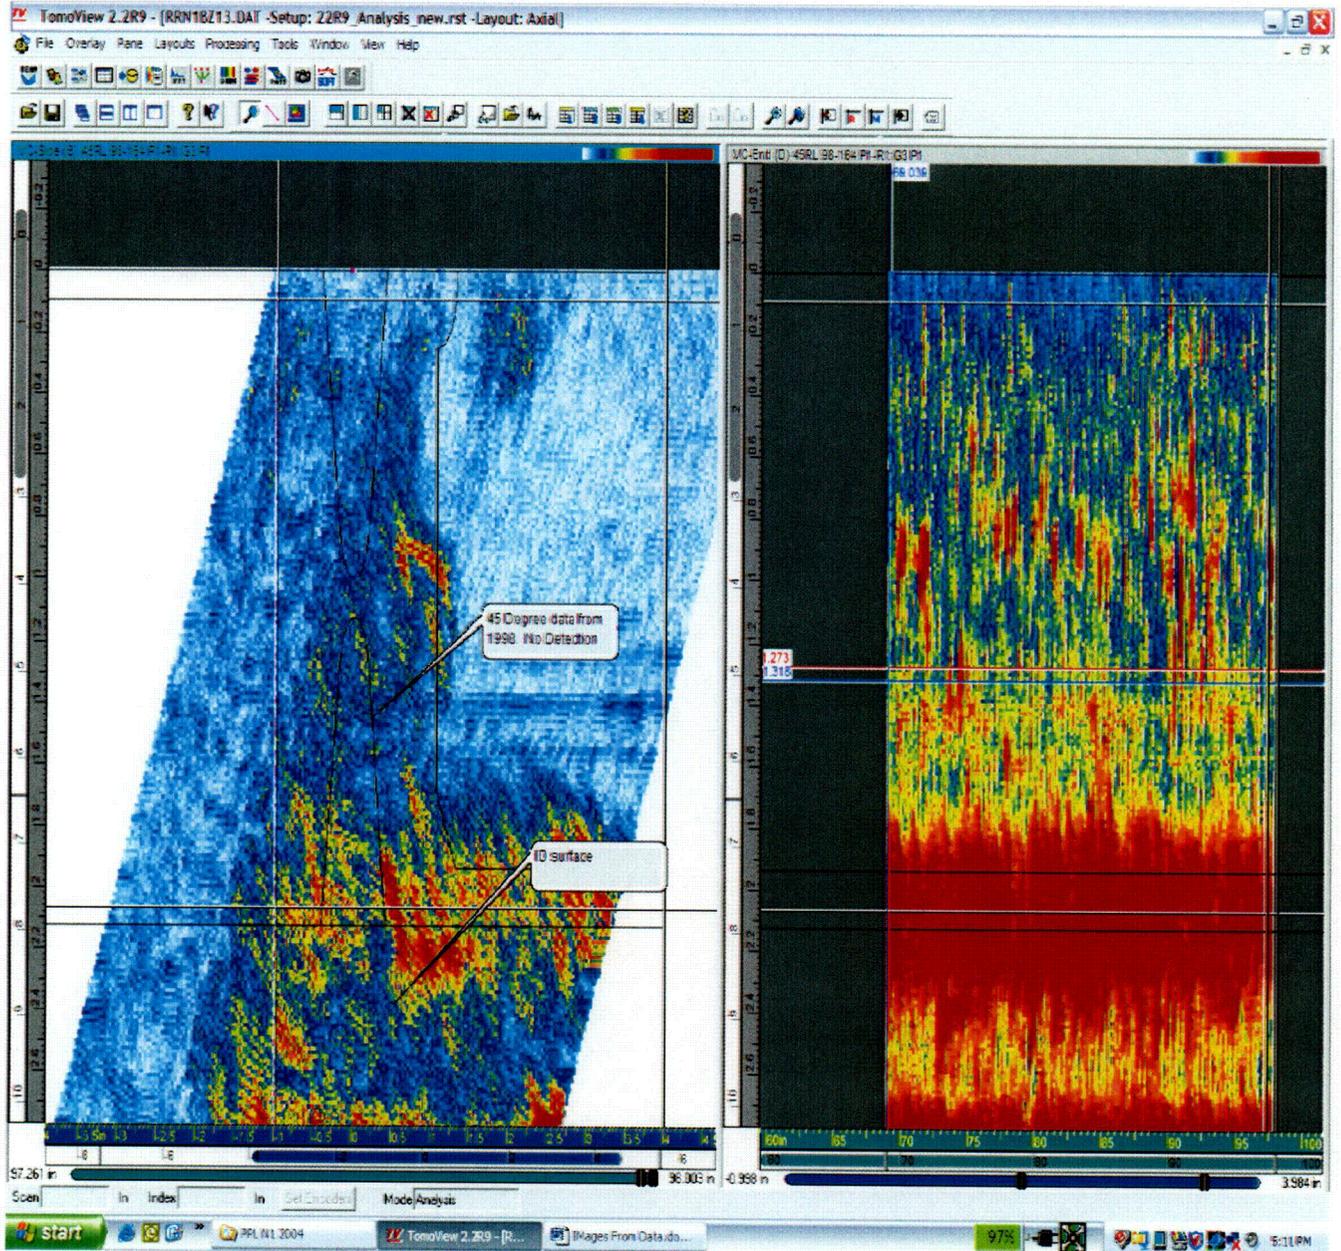
**Figure 5**  
**45 degree RL from 1998 data**

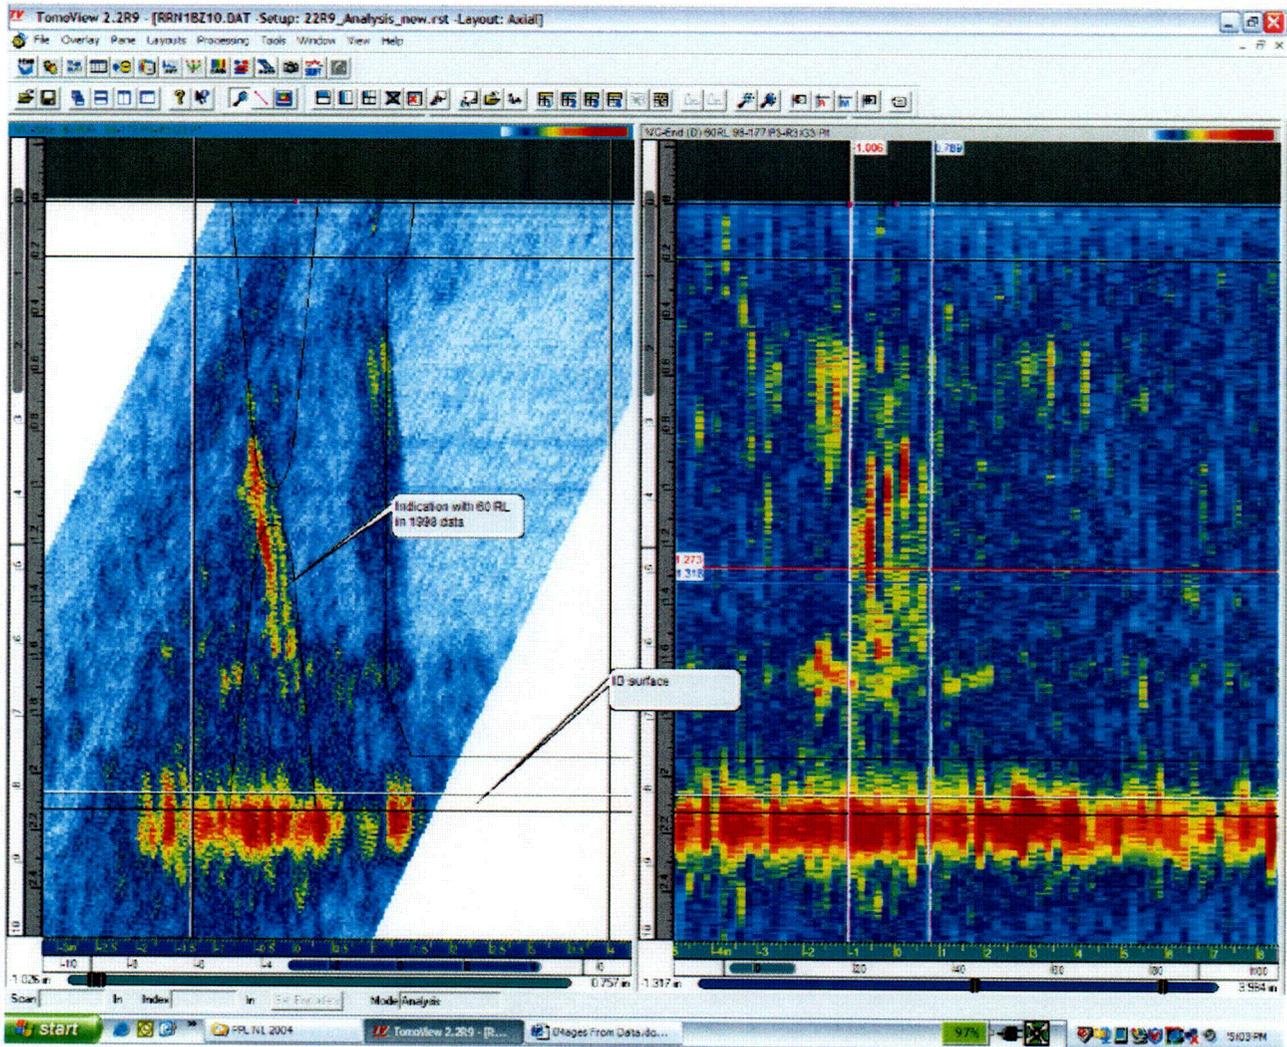
**Figure 6**  
**60 RL data from 1998 data**

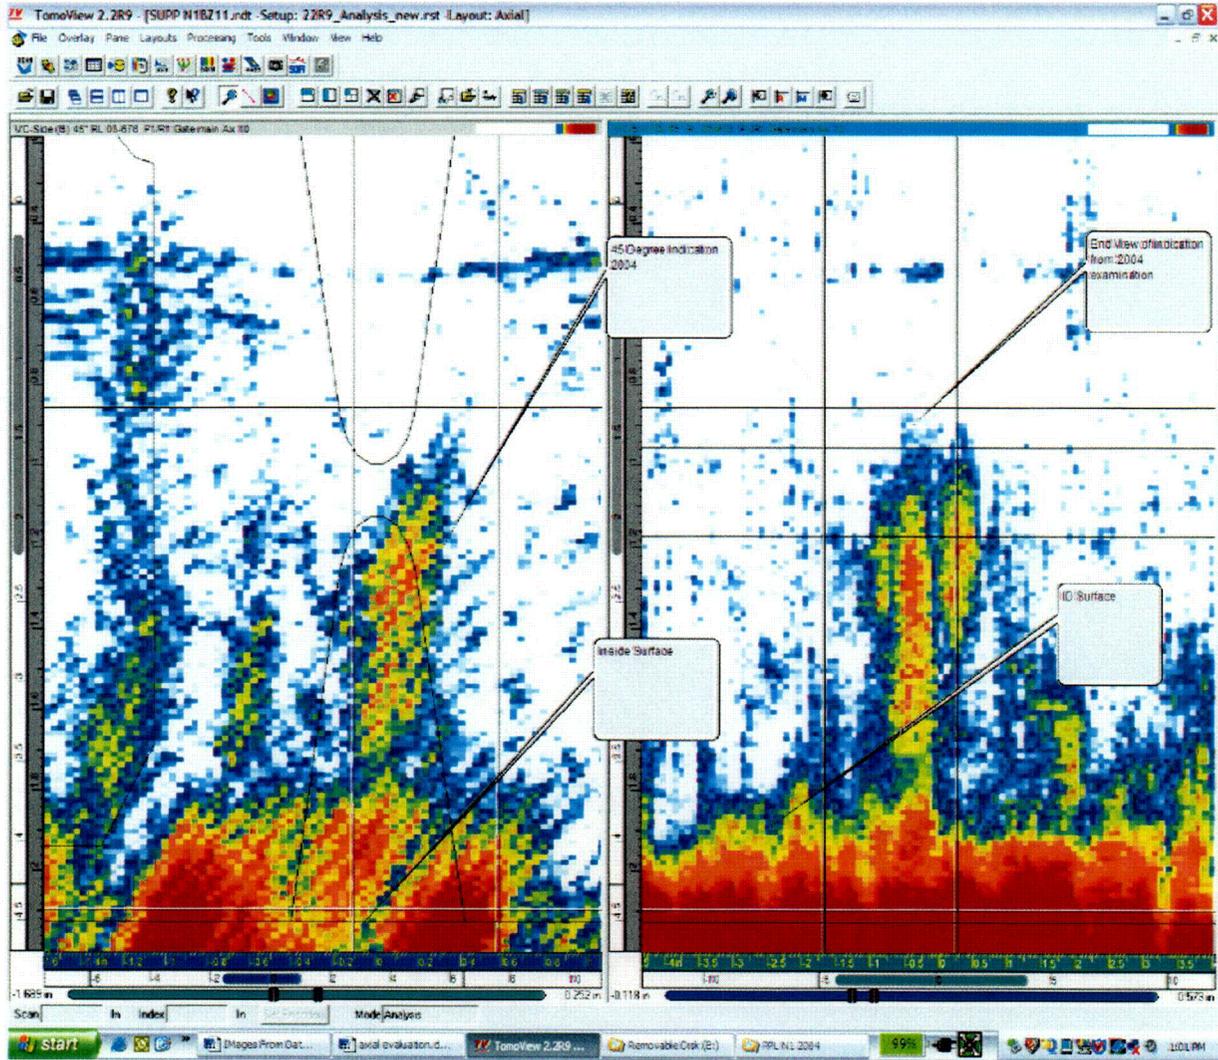
During the U1-13RI0 examination, the PDI qualified techniques were optimized for this configuration (thickness, diameter). The resultant ultrasonic data revealed a very defined indication, which was clearly connected to the inside surface. The responses from the higher angle search units imaged in a very clear profile of the length and through wall extent of the flaw.

**Figure 7**  
**45 Degree RL from 2004 data**

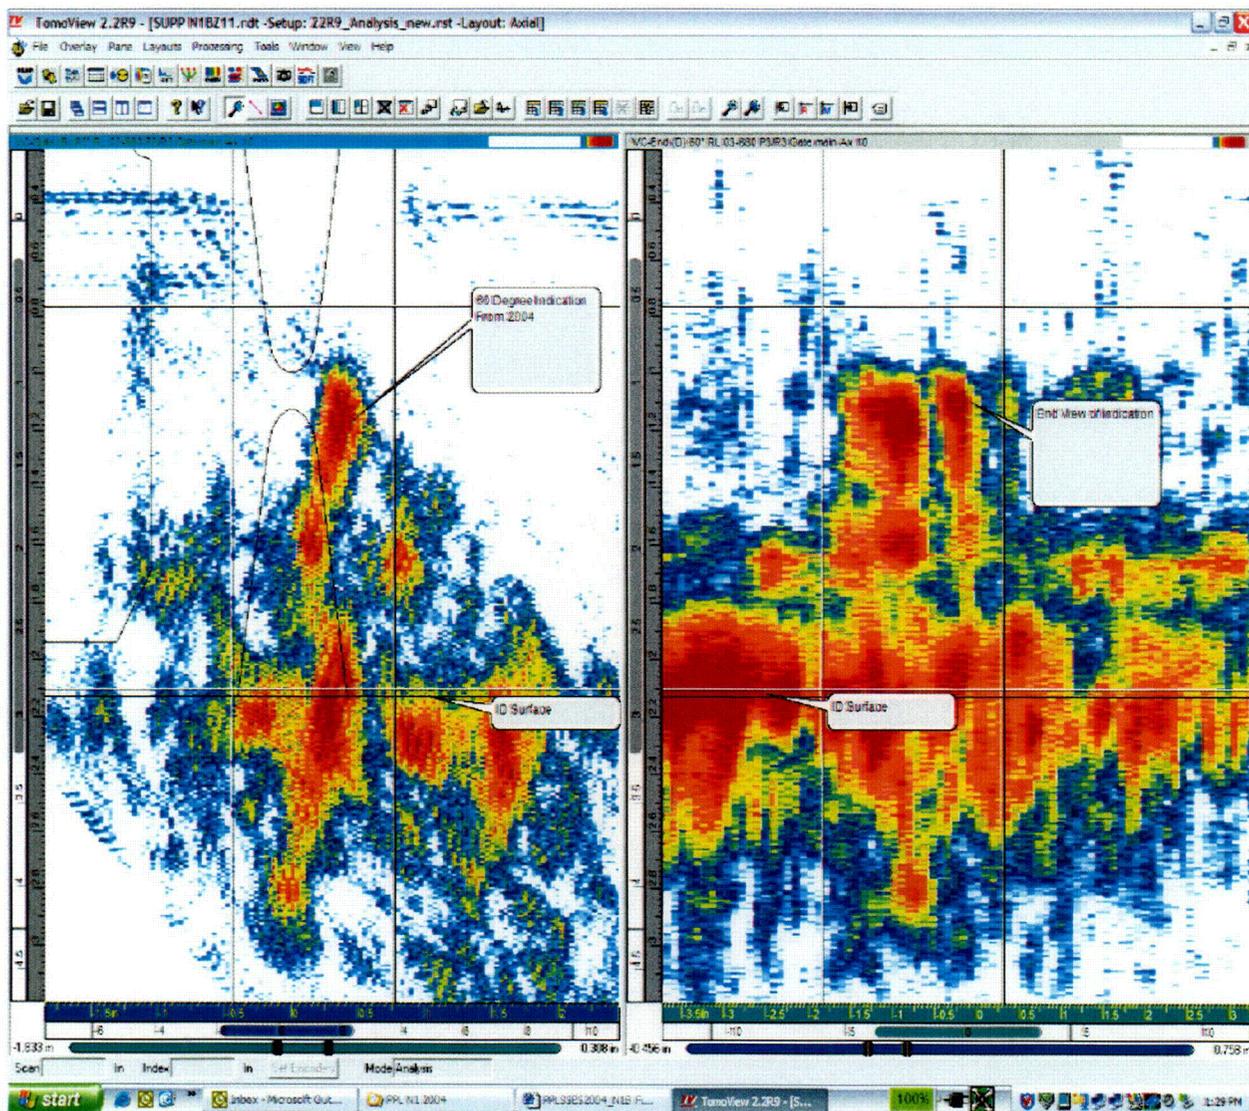
**Figure 8**  
**60 Degree RL from 2004 data**

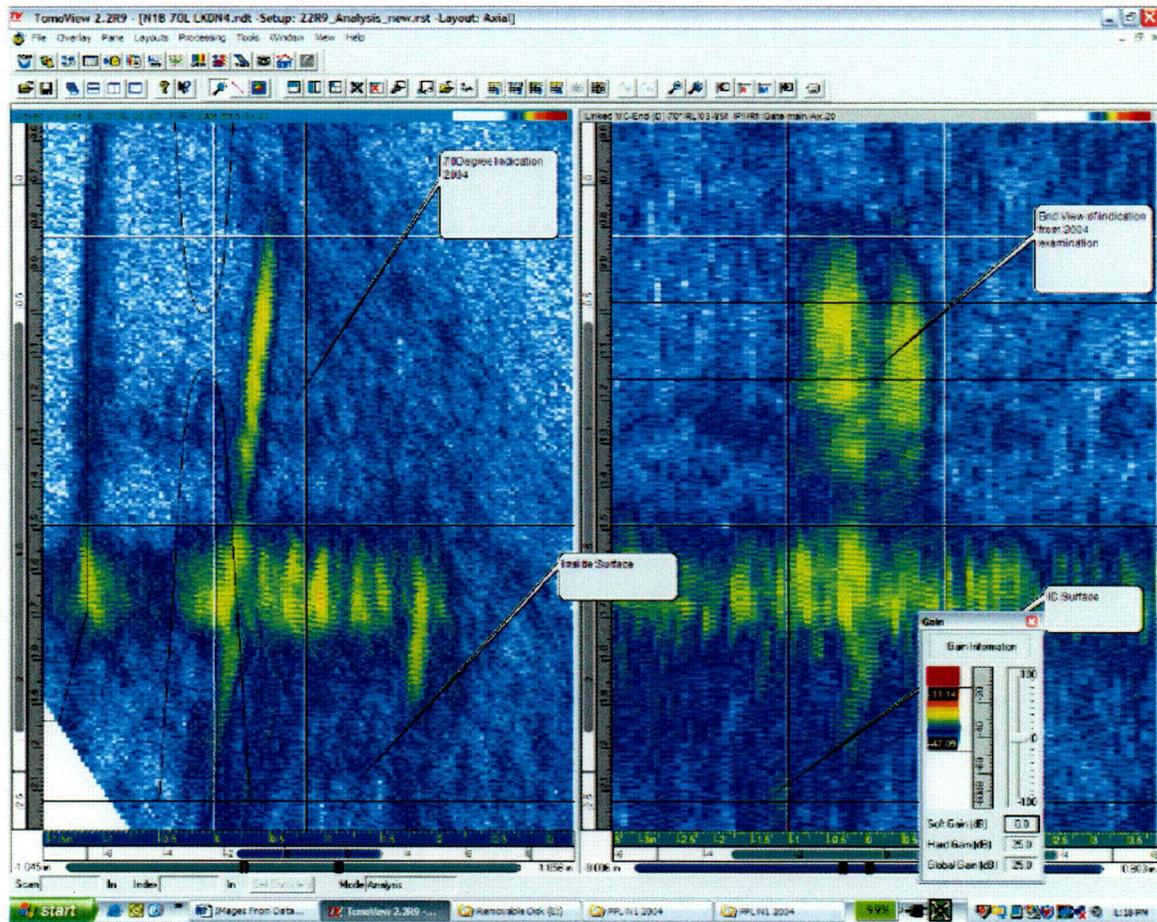
**Figure 9**  
**70 Degree RL from 2004 data**

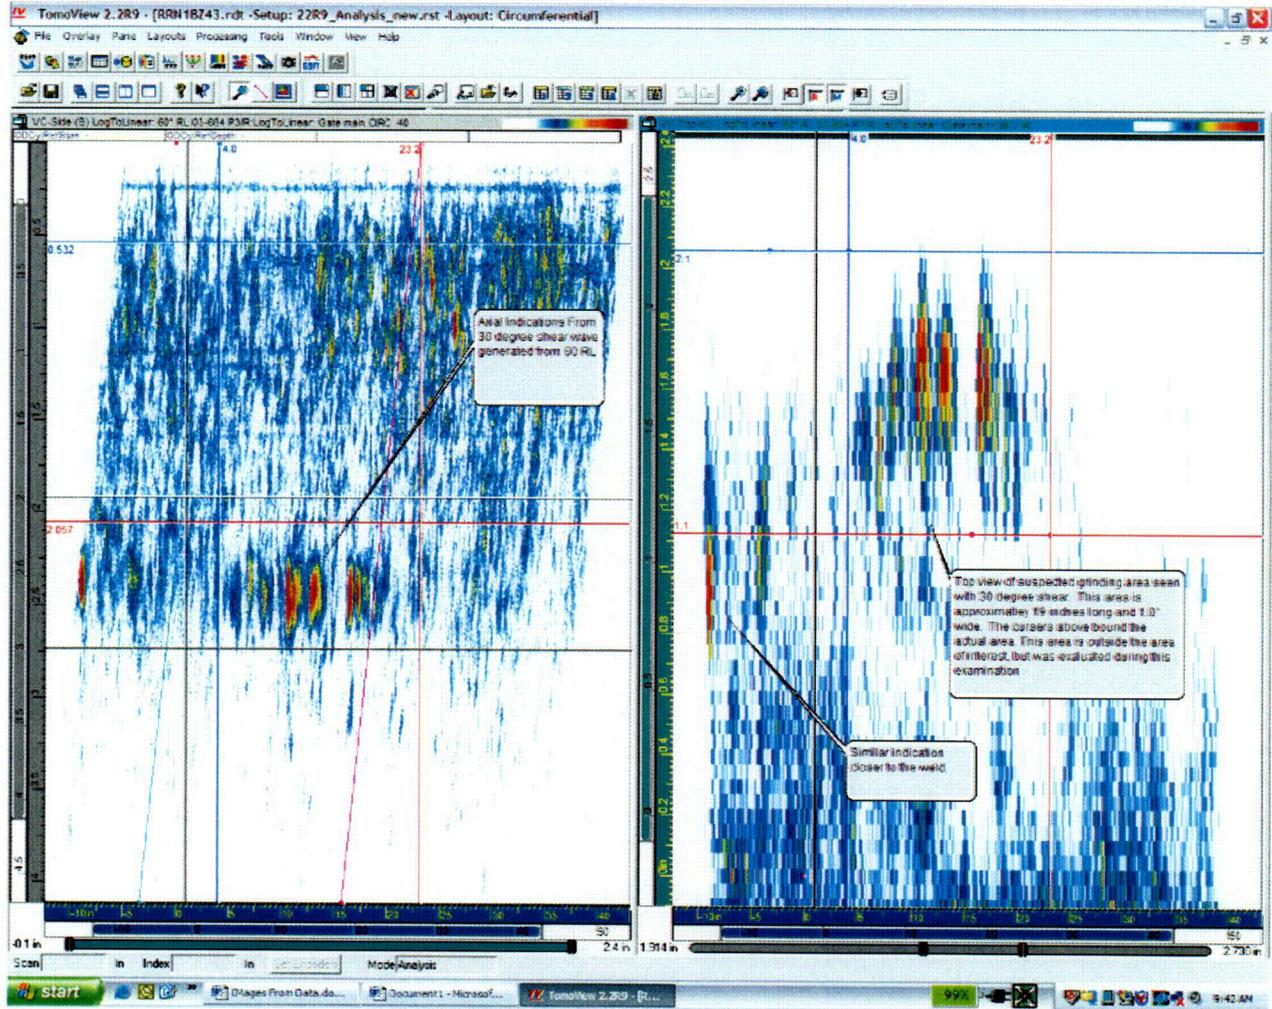
In addition to the evaluation of the circumferentially oriented flaw, axial reflectors were noted in the safe-end base material with the 30-degree shear wave that is generated from the 60 RL search unit. These indications had little or no echo-dynamic travel, and no measurable depth. The indications were barely detectable with the 45-degree RL and the 45-shear search units and also showed no through wall dimension. The majority of the indications were well outside of the required examination volume, but several of them fell just inside. The images below (Figures 10 –13) illustrate the location and response of the indications. Available fabrication records were reviewed and they required the inside surface to be ground or machined flush after completion of the welding of the butt weld. This grinding process is the likely cause of these indications. Previous automated data from 1998 was reviewed and, while compromised due to contact, this data also shows these indications were present.

**Figure 10**  
**Area of Suspected Grinding Marks seen with 30-shear wave component of 60**  
**RL search unit**

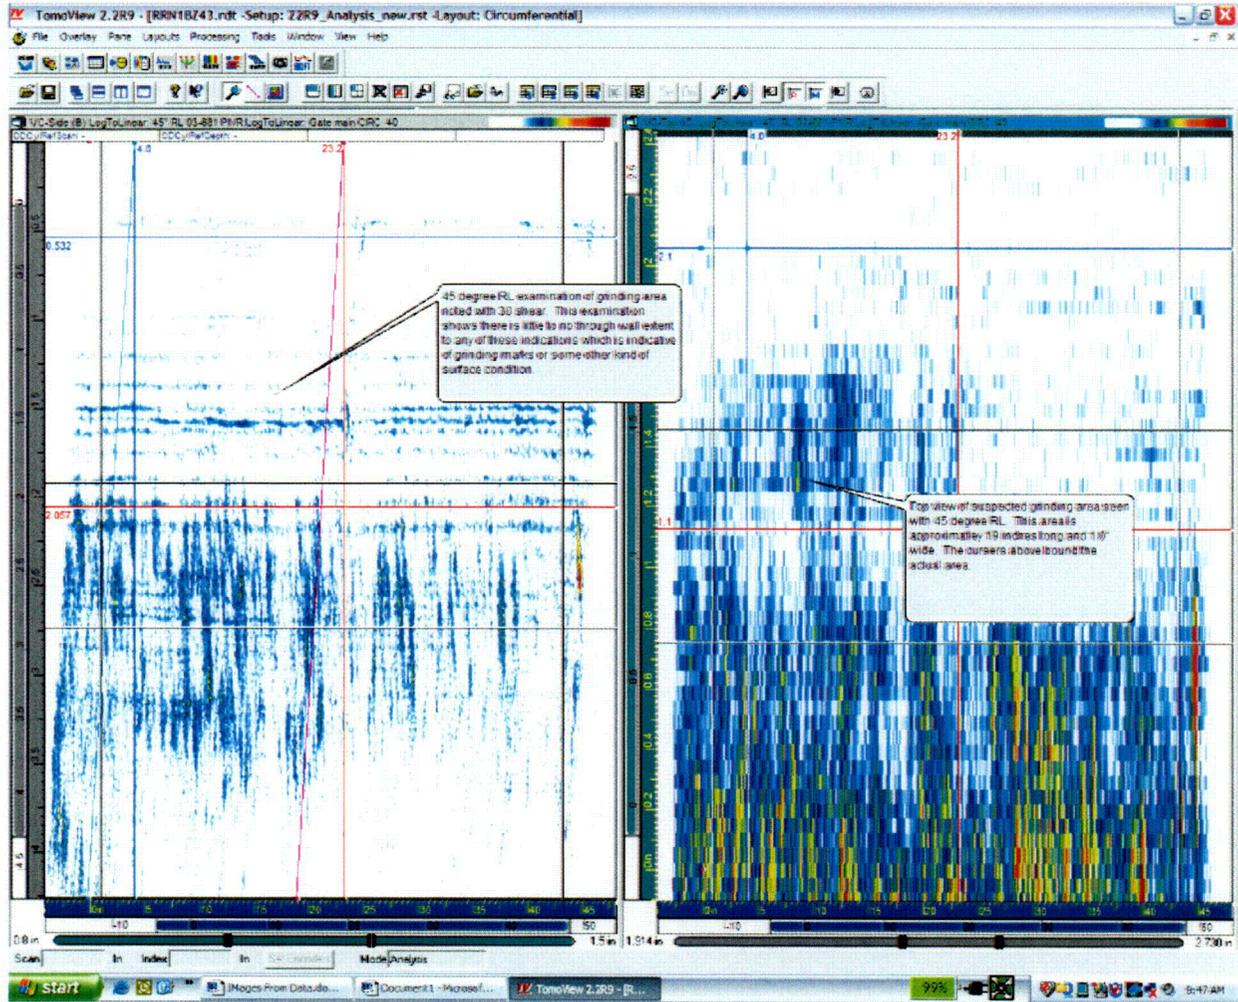
**Figure 11**  
**Area of Suspected Grinding Marks seen with 45 degree RL search unit**

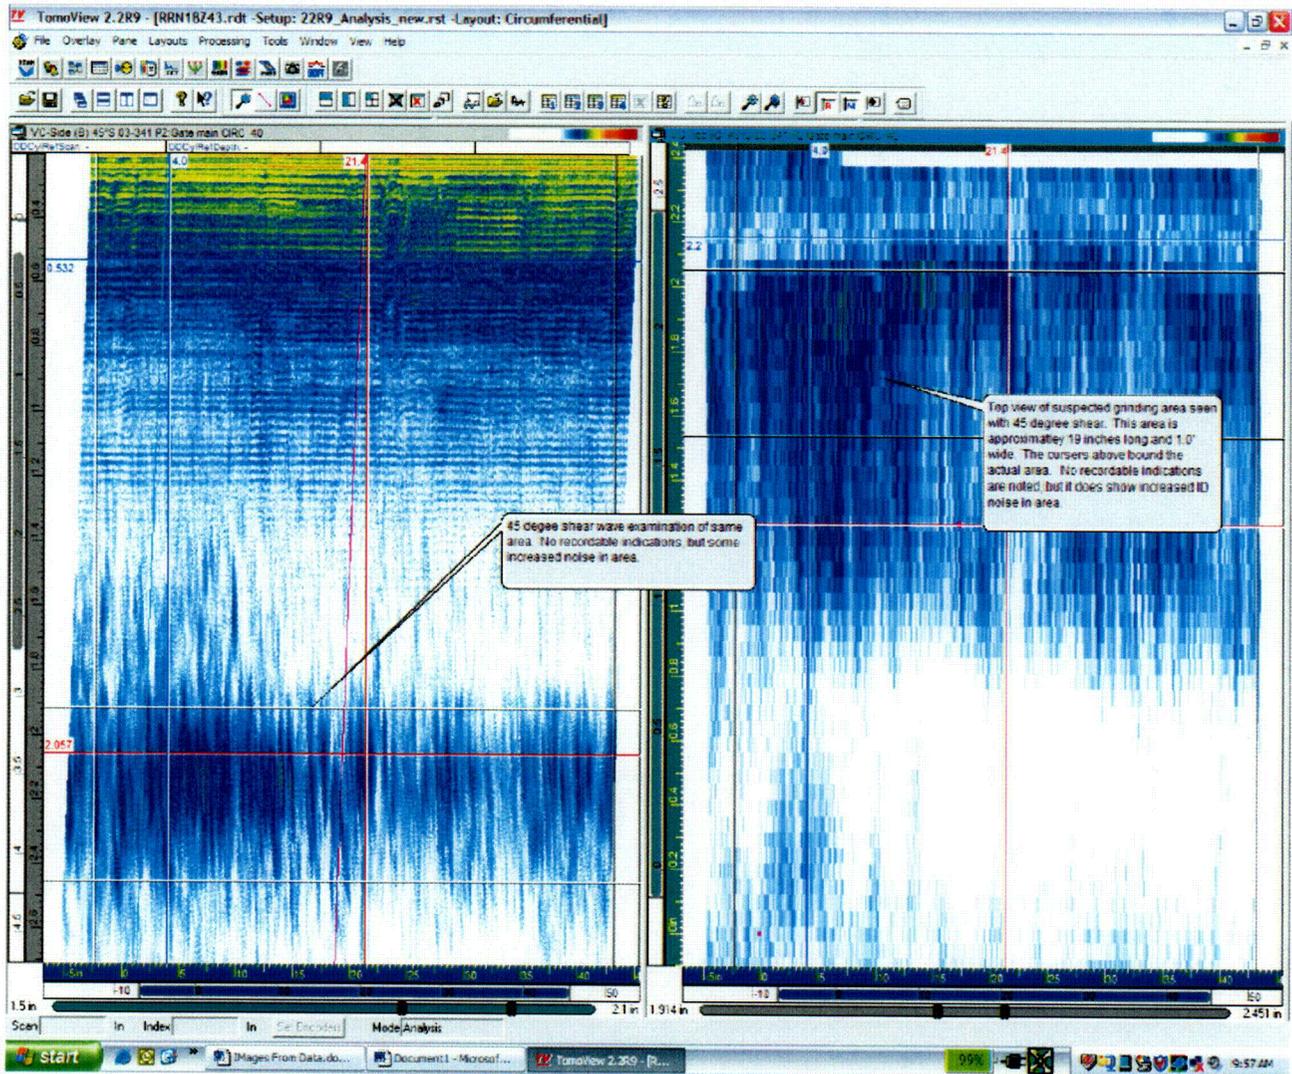
**Figure 12**  
**Area of Suspected Grinding Marks 45-Degree Shear Wave**

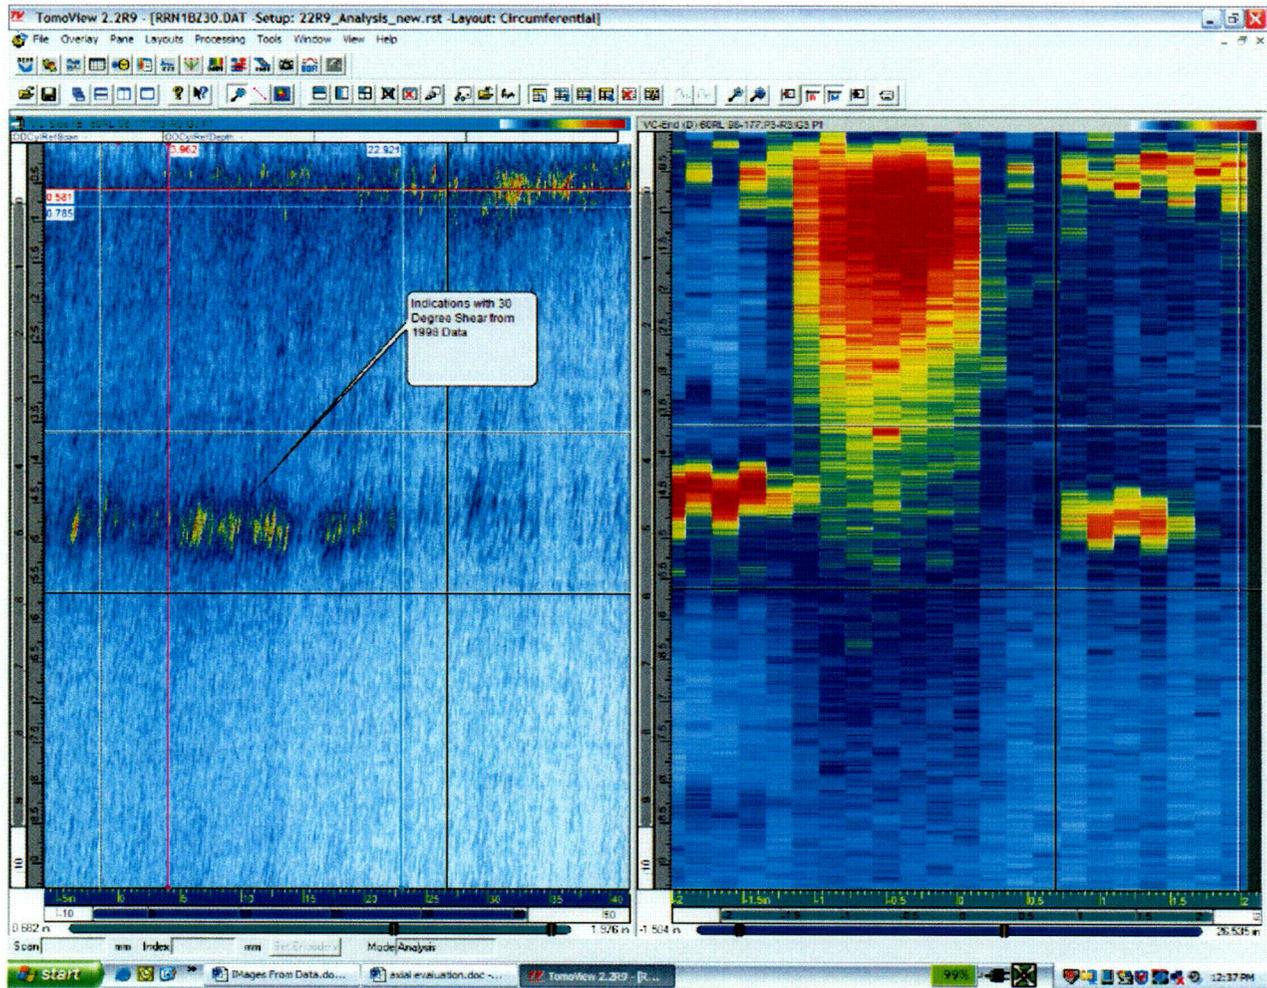
**Figure 13**  
**Similar indications from 1998 30-degree Shear Wave data**
