**SUSQUEHANNA STEAM ELECTRIC STATION
PROPOSED RELIEF REQUEST NO. 31 TO THE
SECOND 10-YEAR INSERVICE INSPECTION PROGRAM
FOR SUSQUEHANNA SES UNIT 1
PLA-5744**

**PPL SUSQUEHANNA, LLC
SUSQUEHANNA SES UNIT 1
SECOND 10-YEAR INTERVAL
RELIEF REQUEST NO. RR-31**

Susquehanna Steam Electric Station – Unit 1
Ultrasonic Examinations of N2J Nozzle to Safe End Weld
EPRI NDE Center
Summary Report
April 6, 2004

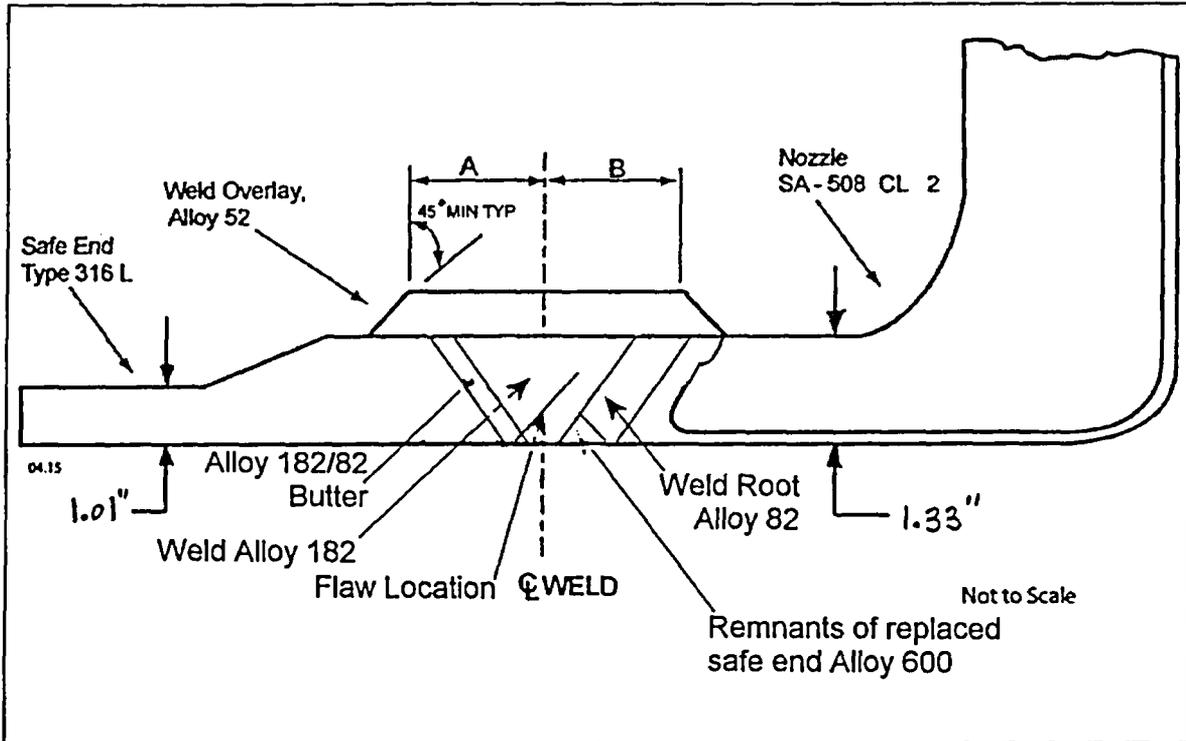
N2J Nozzle and Weld Overlay Configurations

The flaw associated with the N2J recirculation inlet nozzle is located in the weld between the nozzle and the safe-end. It originates in the butter on the safe end side of the nozzle to safe-end weld, and extends to a maximum depth of 0.94 inches from the inside diameter. The thickness of the safe-end at the flaw location is approximately 1.33 inches, and thus, the depth corresponds to approximately 71% through-wall penetration. The flaw runs approximately 12.1 inches in length around the circumference of the safe-end. Since the safe-end is approximately 14.25 inches in diameter at the location of the flaw, the "flaw length to pipe circumference" ratio is approximately 27%.

WELD NUMBER	FLAW CHARACTERIZATION	Design Dimensions			COMMENTS
		t	A	B	
Recirculation Inlet Nozzle N2J	Assumed 360° Circ. 100% throughwall flaw	0.44" min	2.3" min	2.3" min

The weld overlay will extend around the full circumference of the safe end to nozzle location in accordance with NUREG 0313 Rev. 2, Code Case N504-2, and Generic Letter 88-01. The overlay length will extend across the projected indication intersection with the outer pipe surface. The design thickness and length will be computed according to guidance provided in ASME Section XI, Code Case N-504-2 and ASME Section XI Paragraph IWB-3640, 1989 Edition with Appendix C (1989 Addenda). The overlay completely covers the defect location and other Alloy 182 susceptible material areas with the highly corrosion resistant Alloy 52 material. Ten (10) layers of weld material are planned to be applied. The final number of layers will be determined based on the number of layers needed to meet the thickness requirement of the overlay. A temper

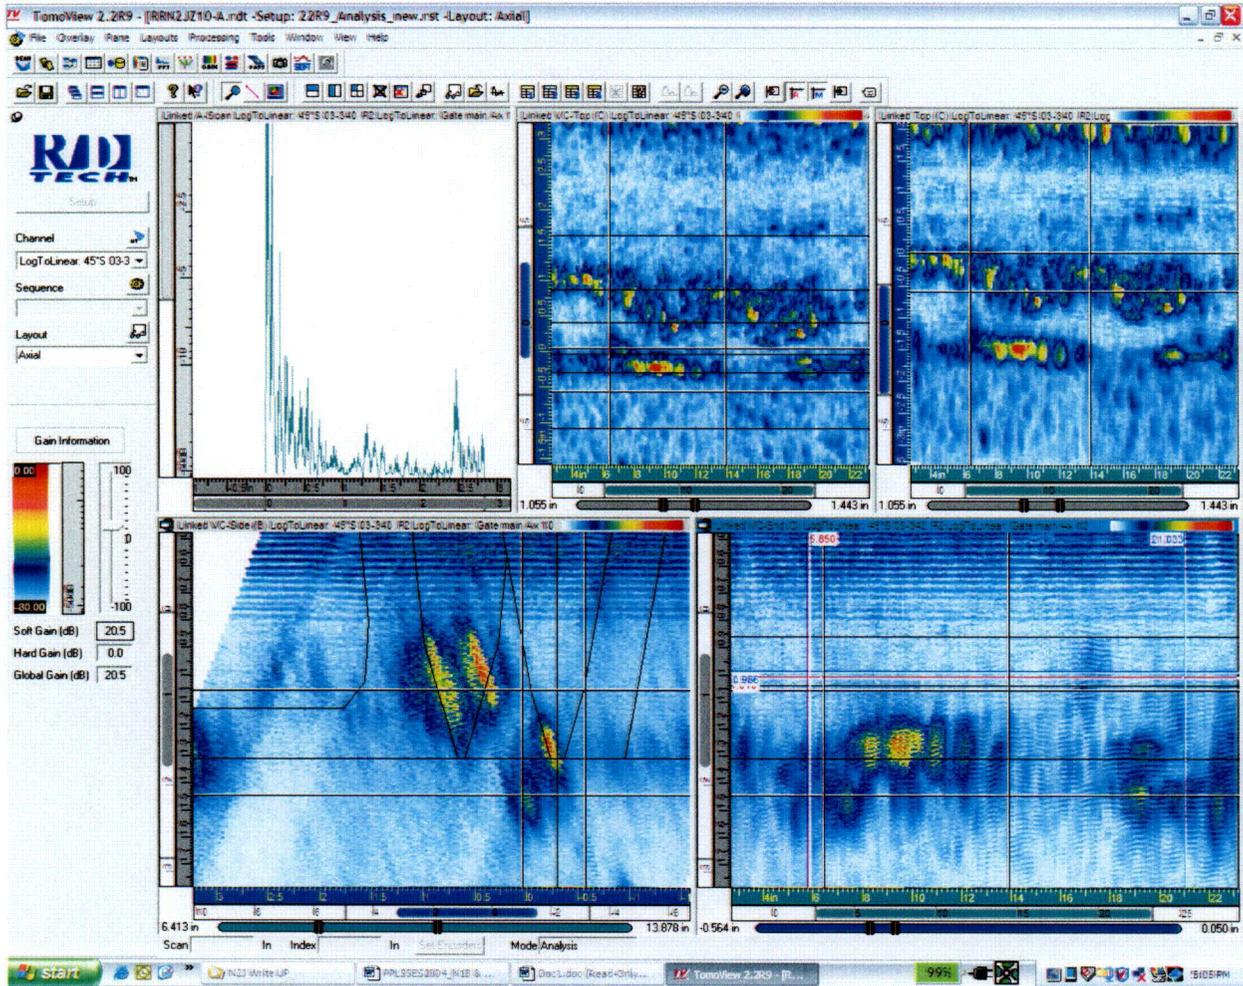
Figure 11
45 Degree Shear Data from 2004

Initial examination of this weld indicated a suspect indication in an area where it appeared the search unit was being compromised by weld crown. GENE requested that the surface condition of this weld be improved to eliminate the limitation. After removal of the weld crown restriction the examination was repeated and GENE reported a planar-type, circumferentially oriented indication located at approximately 45 degrees. The planar indication appeared to be contained in the weld material and connected to the inside surface. Evaluation of the qualified UT sizing data showed the flaw to be approximately 12.14 inches long with a through wall dimension of 0.94 inches.
