*Regulatory Conference*

*NRC Triennial Fire Protection  
Inspection Findings*

*Surry Power Station Units 1 and 2*

*April 1, 2004*

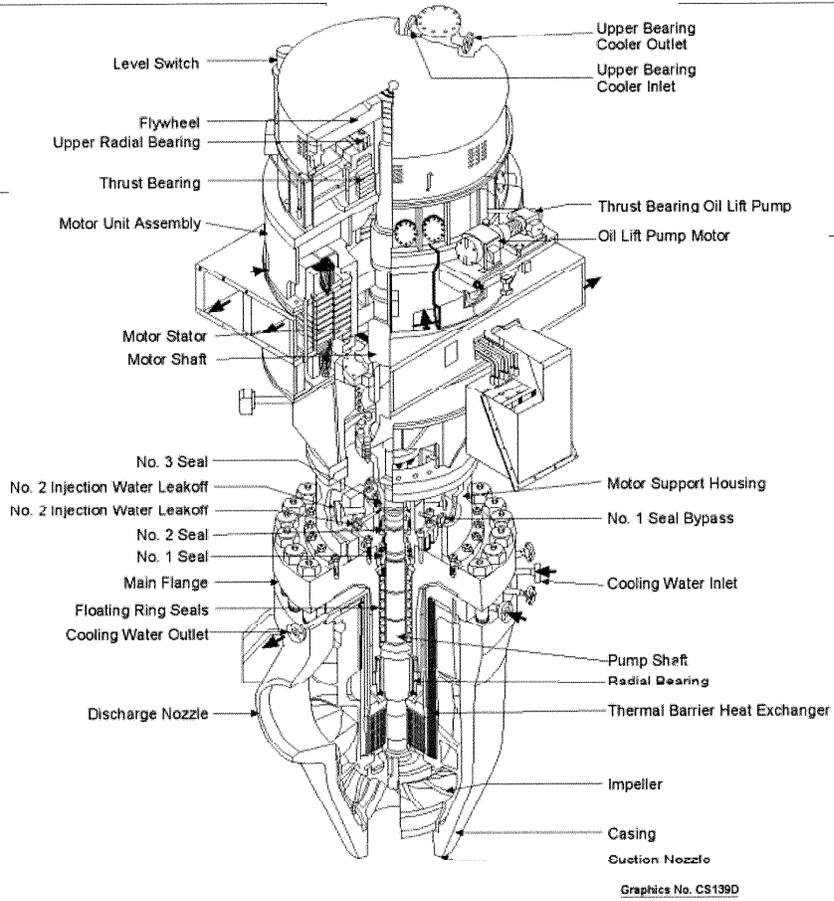
REACTOR COOLANT PUMP

- SDP used generic RCP seal LOCA model from WCAP-15603 Rev. 1-A
- Generic RCP seal LOCA model does not consider floating ring seals
- Surry, North Anna and few older Westinghouse plants still use them
- NRC credited floating ring seals in Haddam Neck Plant SER

- Floating ring seals
  - Designed to limit leakage to 50 gpm in seal package failures
  - Original floating ring seals in all Surry RCPs, no degradation
  - Floating ring seal clearances larger than other seals
  - No floating ring seal failure in Haddam Neck Plant event where all RCP seal cooling lost for 30 minutes and seal injection restored
- Should give at least 0.1 to 0.5 credit for floating ring seals in RCP seal LOCA model
- EdF test data supports no impact from restoration of injection to hot seals

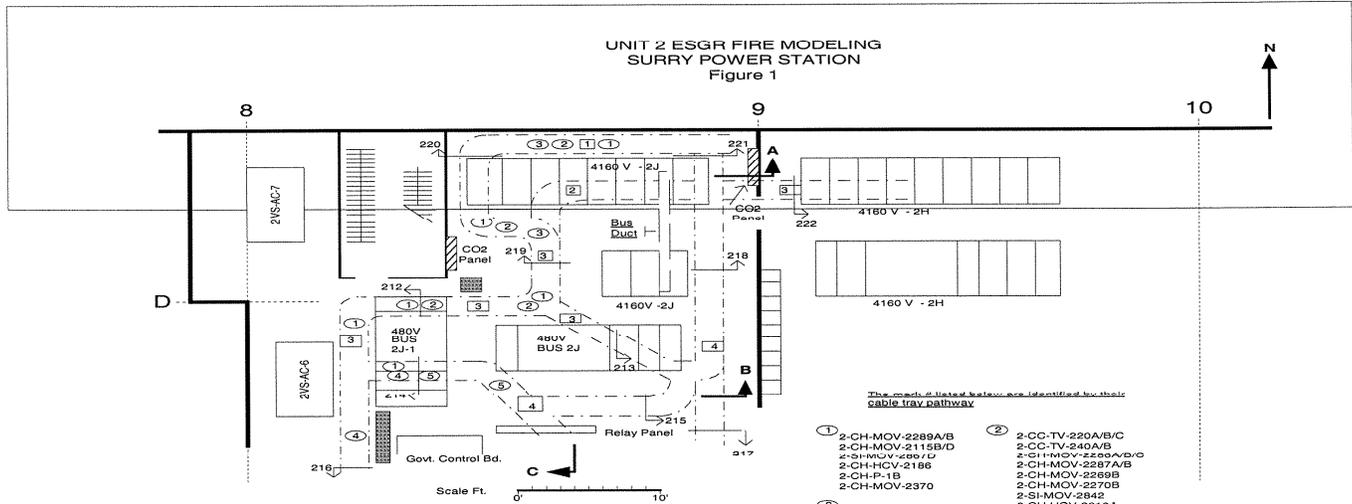
UNIT 2 ESGR FIRE MODELING  
 SURRY POWER STATION  
 Figure 1

- ESGR compartment sizes and equipment orientation similar
- Unit 1 and 2 ESGRs adjacent to each other
- Normally open sliding door between Unit 1 and 2  
(automatically closes on smoke detection or Halon actuation)
- Routing of critical RCP seal cooling cables in higher trays at Unit 2
  - All RCP seal cooling cables routed in 3rd or higher trays above electrical cabinets (versus trays 1 and 2 at Unit 1 ESGR)
  - Cables for Component Cooling to RCP thermal barrier coolers in 5th and 6th trays above 4160V switchgear

- Time to damage of critical RCP seal cooling cables longer at Unit 2
- More time available for manual suppression (portable and 150-lb wheeled carbon dioxide extinguishers)
- Core damage risk lower for Unit 2 ESGR (i.e., Green)
