Tennessee Valley Authority, Post Office Box 2000, Soddy-Daisy, Tennessee 37384-2000

April 12, 2004

SEQUOYAH NUCLEAR PLANT – DIFFUSER LINE MANHOLE BREACH

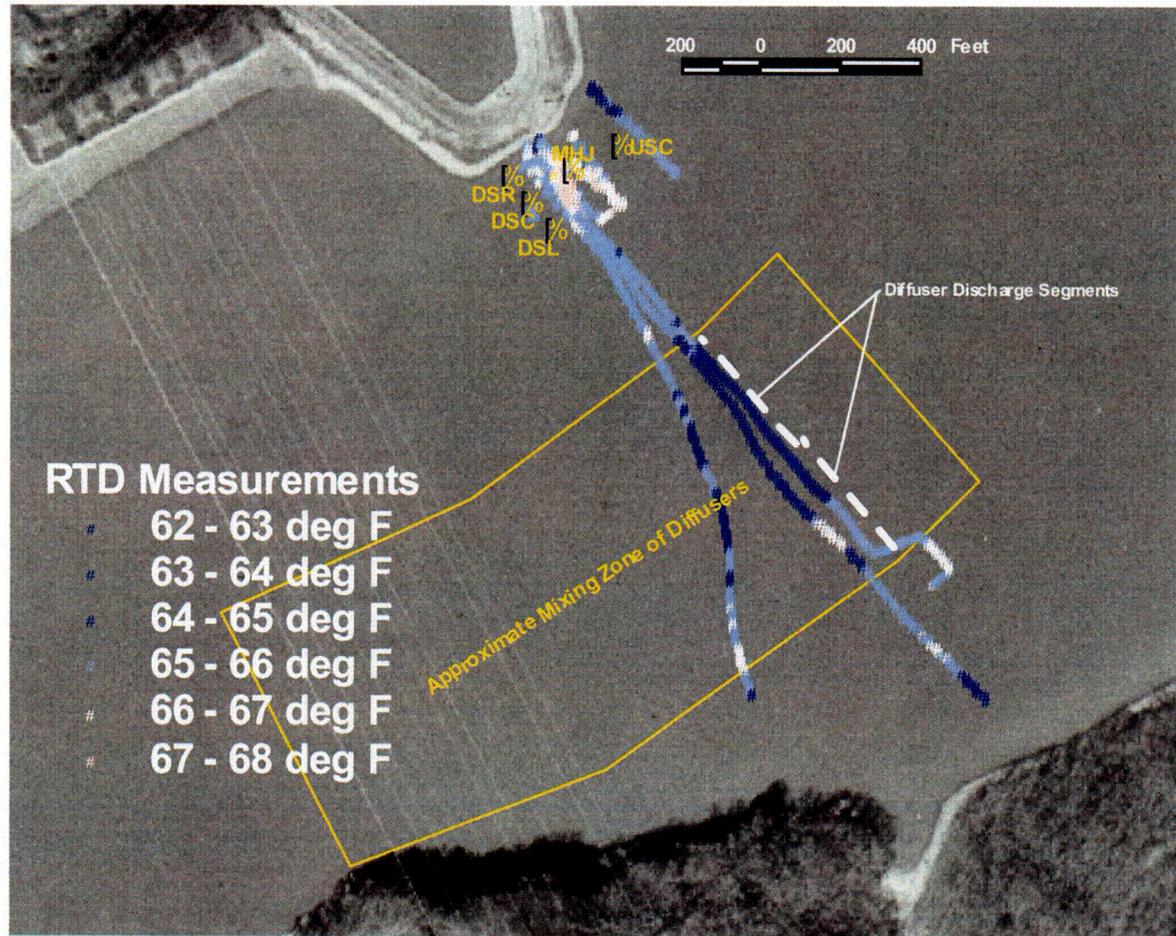
Figure 1. Location of manhole jet (MHJ) temperature assessment activities for April 7-9, 2004.

The manhole jet was centered at a location approximately 175 feet from the riverbank and estimated to be directly above the manhole of the diffuser pipe. Locations and distances specified herein refer to a local coordinate system centered on the manhole jet. The transverse axis is aligned with the main diffuser pipes and the longitudinal axis is perpendicular to the diffuser pipes. The downstream direction refers to the prevailing direction of the flow in the river (for example, the 24-hour average flow) along the longitudinal axis. Hydro peaking operations at Watts Bar and Chickamauga Dams can produce transient river flows in the upstream direction.

Surface temperature data collected with the trolled RTD array are shown in Figure 1. These data were collected from 1714 to 1832 CDT on April 7, 2004. These instantaneous temperature data ranged from a minimum of 62.1°F measured over the downstream diffuser discharge segment, while it was isolated, to a maximum of 70.6°F measured at the manhole jet while the Diffuser Pond gate #1 was partially open. Preliminary analyses of these data relative to the hourly intake temperature computed from Station 13 suggest that the instantaneous temperature rise above ambient drops below 5.4°F within 125 to 150 feet of the manhole jet for the period from 1714 to 1832 CDT on April 7, 2004.

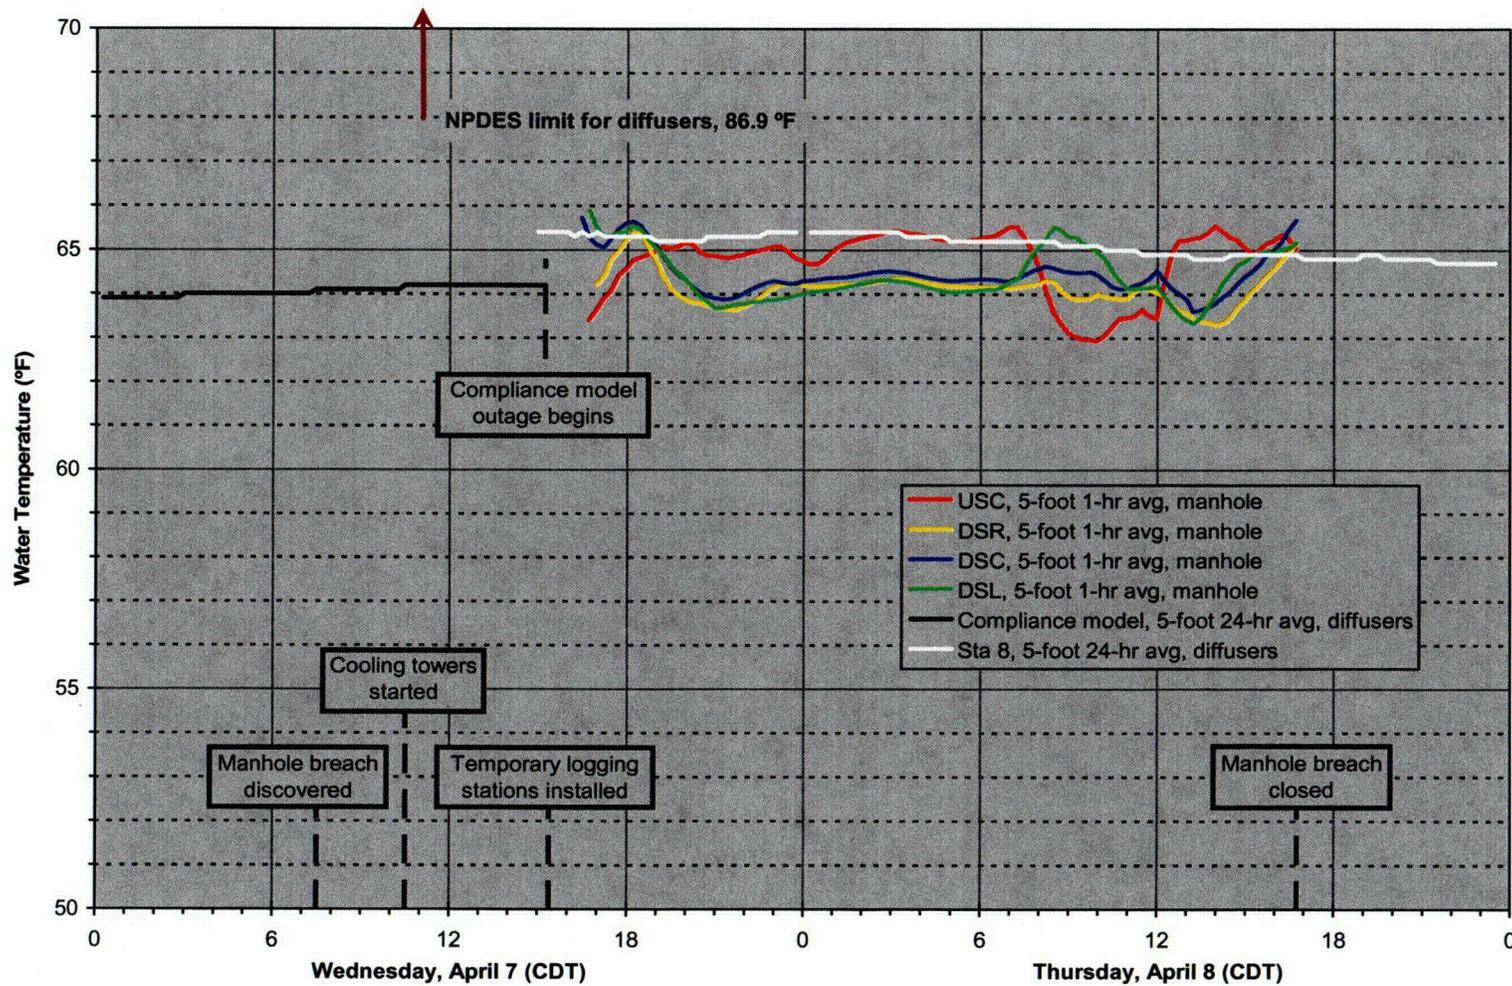
Figure 2. Variation of Downstream Temperatures

Time series data for April 7-8, 2004 from the permanent compliance monitoring systems and the temporary logging stations are shown in Figures 2, 3, and 4. The following comments are applicable to these figures:

- It is emphasized that the temperatures for the compliance model and Station 8 are for the end of the diffuser mixing zone, whereas those for the temporary logging stations are for the manhole jet.

Mixed temperature, temperature rise, and temperature rate of change measured at Station 8 are well below the NPDES limits of 86.9°F, 5.4°F, and $\pm 3.6^\circ\text{F/hr}$, respectively for the diffuser mixing zone. While the manhole jet does lie outside the diffuser mixing zone, it is relevant to observe that the mixed temperature, temperature rise, and temperature rate of change computed at the temporary logging station locations are also within the NPDES limits that apply to the diffuser mixing zone.

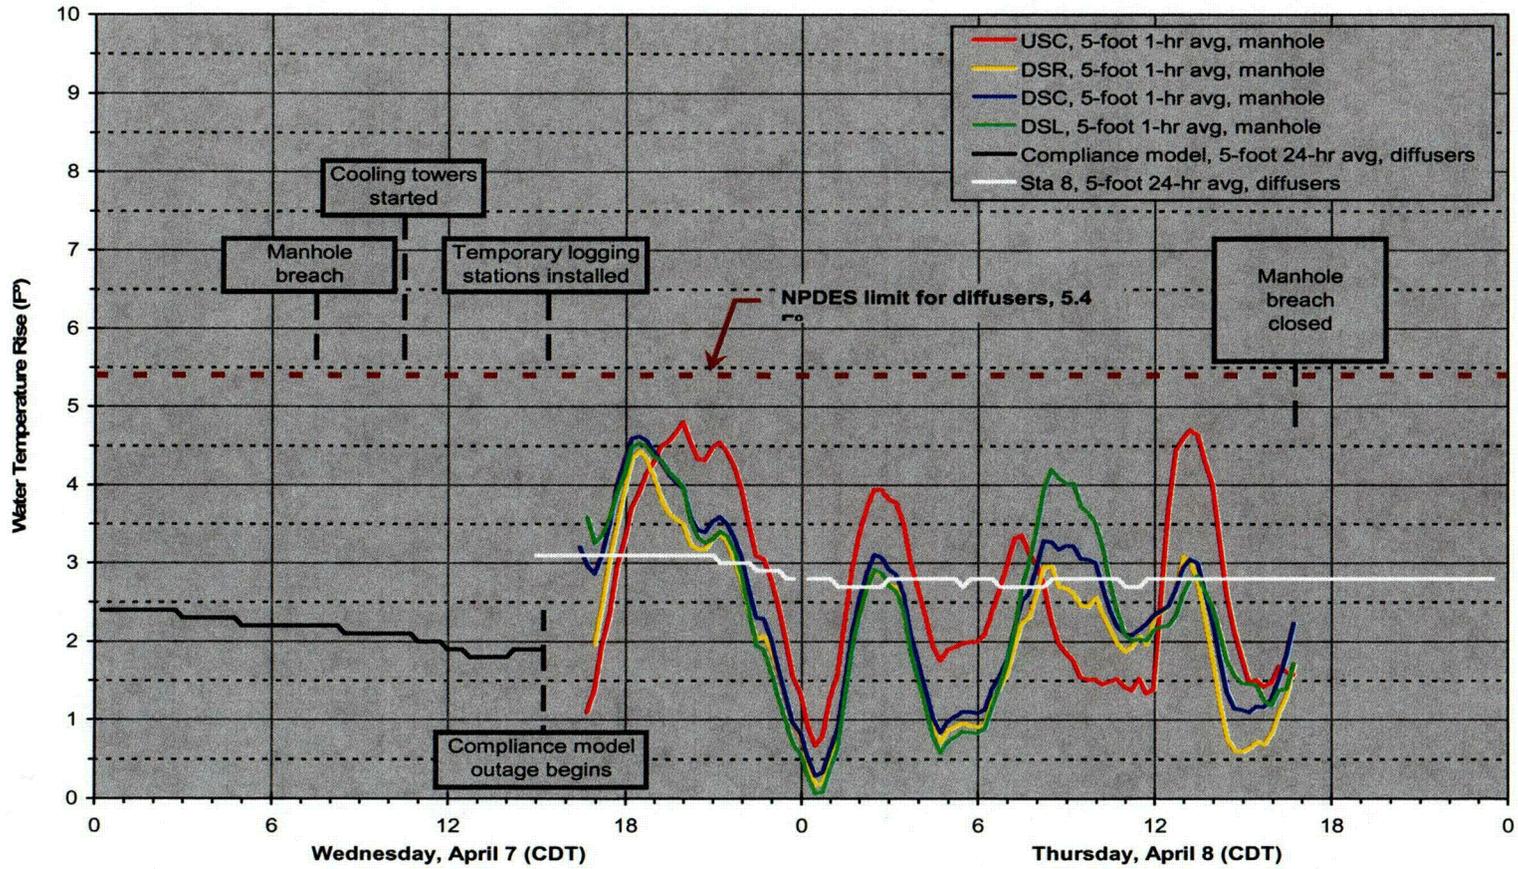
Figure 3. Variation of Temperature Rise Above Ambient

- Although the NPDES thermal criteria call for 24-hour averaging for the downstream temperature and temperature rise, the manhole jet breach was not long enough to enable computation of meaningful 24-hour averages for the temporary logging stations. In lieu of 24-hour averages, the temporary logging station data are plotted as 1-hour averages, with the assumption that if 1-hour average data fall within NPDES criteria, the 24-hour averages may be assumed to fall within the criteria also.

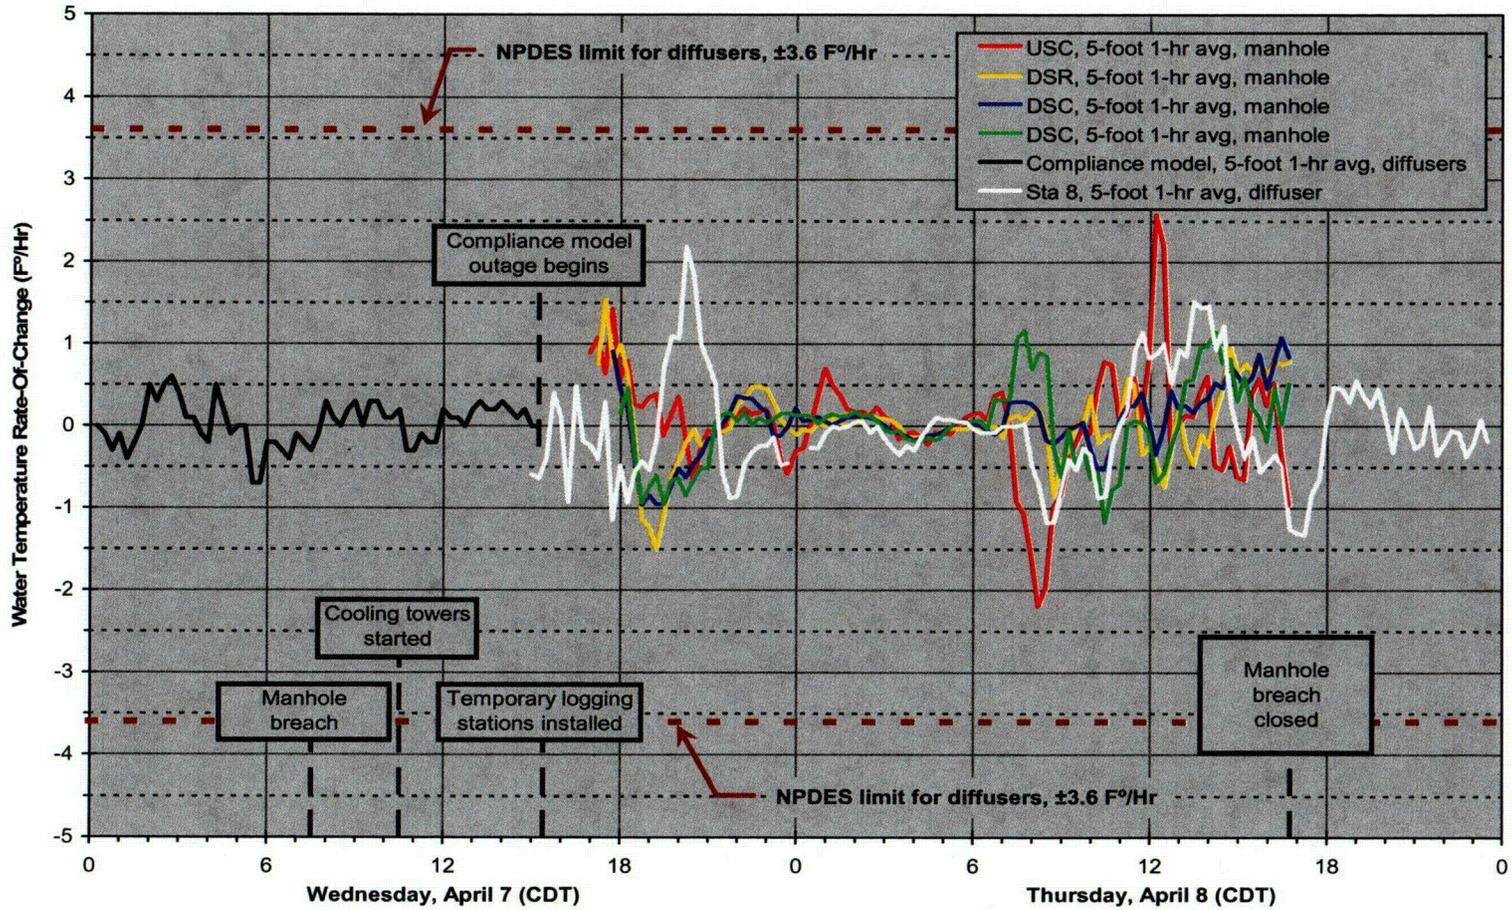
Figure 4. Variation of Rate of Temperature Change.

- Station 8, located at the downstream corner of the diffuser mixing zone, is shown as the alternate source of data for demonstrating compliance with the downstream temperature, temperature rise, and rate of change limitations.
