LICENSEE EVENT REPORT (LER)

| FACILITY NAME (1)<br><b>JAMES A. FITZPATRICK NUCLEAR POWER PLANT</b> | DOCKET NUMBER (2)<br><b>0 5 0 0 0 3 3 3</b> | PAGE (3)<br><b>1 OF 1 1</b> |

TITLE (4) **Residual Heat Removal, Emergency Diesel Generators, and Fire Pumps Potentially Made Inoperable Due to Inadequate Modification Installation Activities**

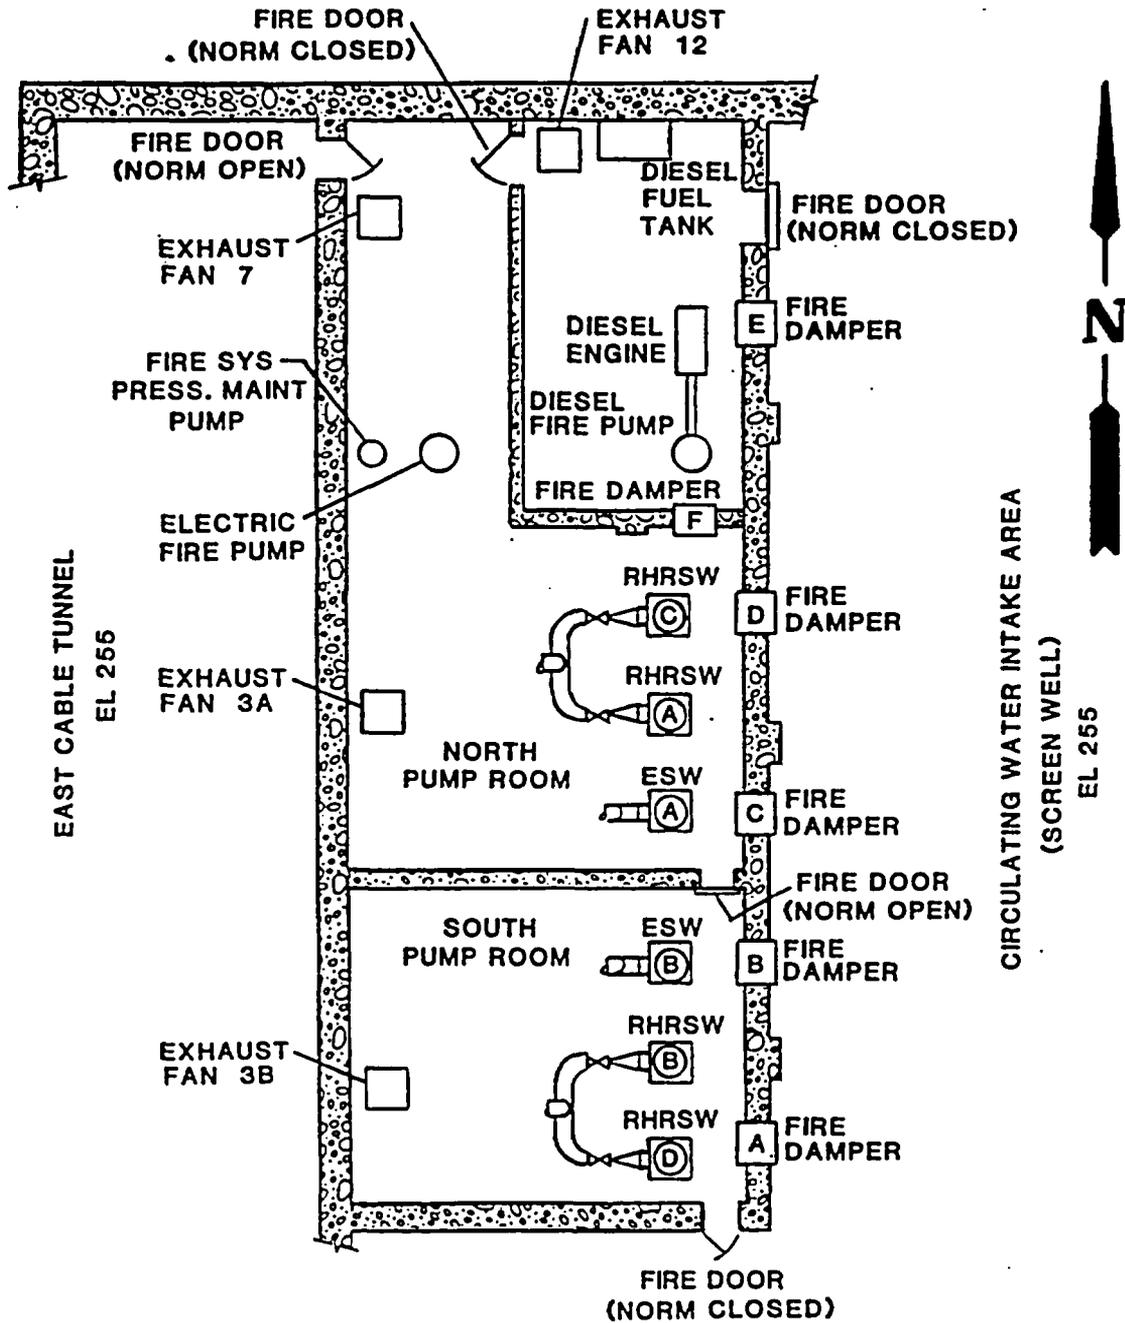
RHRSW / ESW & FIRE PUMP ROOMS

The electric motor driven fire pump is located in the north safety-related pump room as indicated on the sketch on the last page of the LER. This room is supplied with an additional exhaust fan designated as Fan 7 on the sketch. This room has the advantage of direct access to air intake from the east cable tunnel. However, because the cable tunnel supply fan is designed to supply on the order of 4,000 CFM total flow (some of which is diverted to the EDG switchgear rooms) while the safety-related pump room exhaust fans 73FN-3A&B are rated on the order of 12,000 CFM. Accordingly, fire damper closure in the north safety-related pump room has the potential to render the electric fire pump inoperable.

The diesel fire pump is located in a separate room which shares two walls in common with the north pump room as shown on the sketch. The dampers supplying the diesel fire pump room from the north safety-related pump room and the screenwell were also closed during this event and would also be closed by the postulated fire in the intake structure (screenwell) scenario. This room is cooled by a separate fan designated as Fan 12 on the sketch. Although the engine has a water jacket cooling system, the engine combustion air intake comes from within the room. Accordingly, the dampers must be open for proper operation.
