FACILITY NAME (1) JAMES A. FITZPATRICK NUCLEAR POWER PLANT	DOCKET NUMBER (2) 0 5 0 0 0 3 3 3	PAGE (3) 1 OF 1 1
--	---	-------------------------------

TITLE (4) **Residual Heat Removal, Emergency Diesel Generators, and Fire Pumps Potentially Made Inoperable Due to Inadequate Modification Installation Activities**

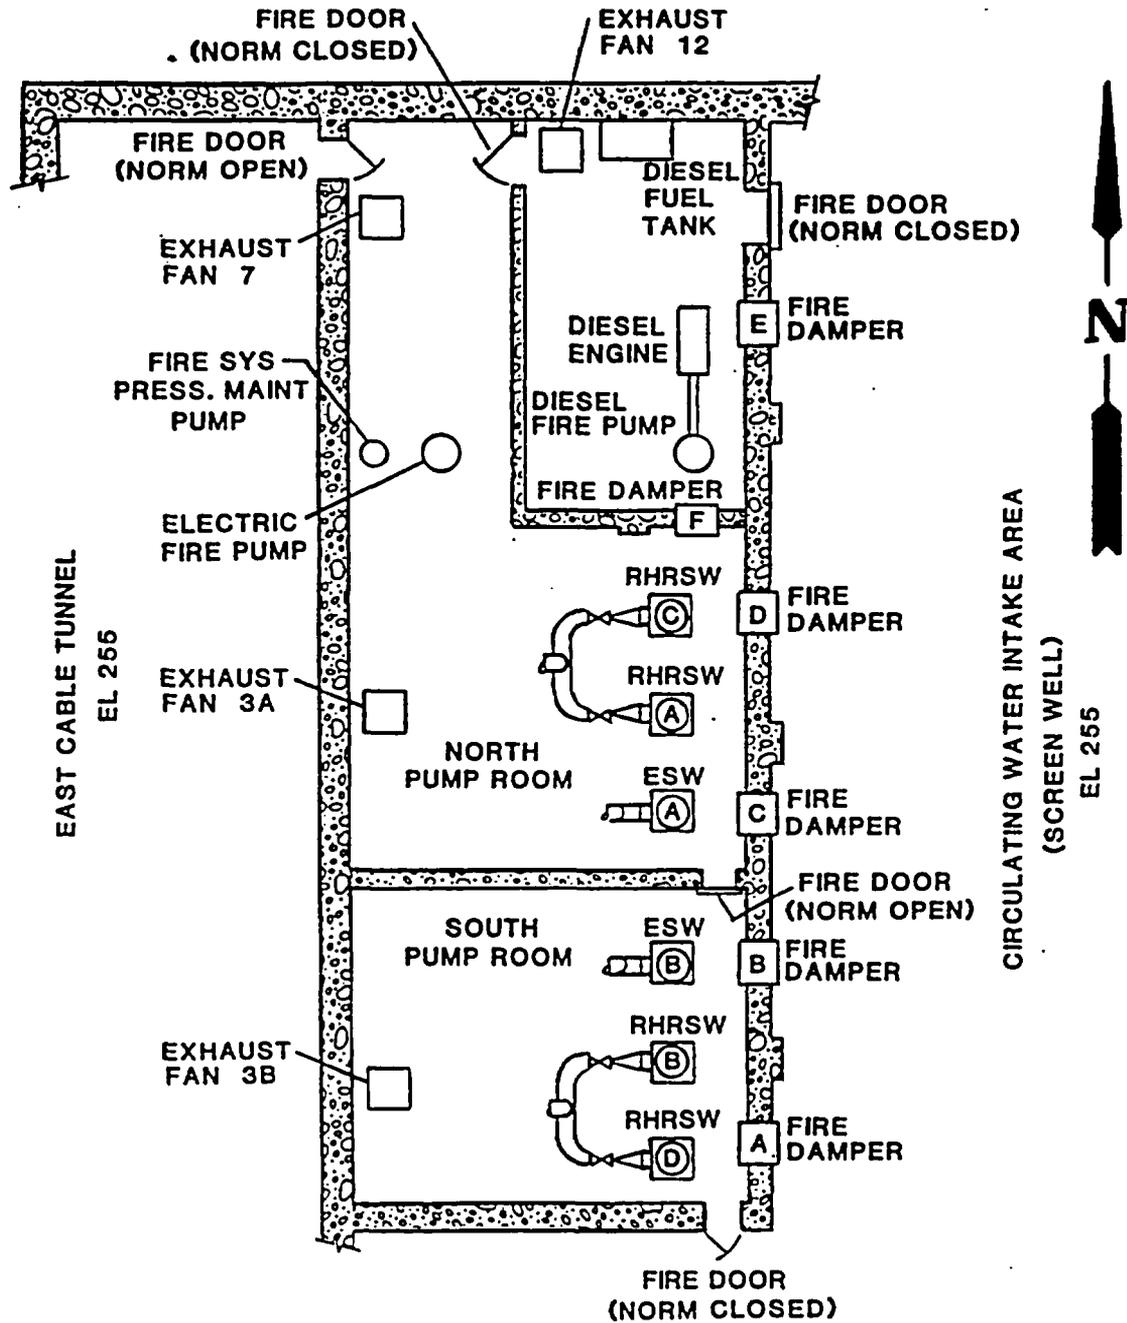
DOCKET NO. 50-333
LER 91-021-00
RHRSW / ESW & FIRE PUMP ROOMS

The electric motor driven fire pump is located in the north safety-related pump room as indicated on the sketch on the last page of the LER. This room is supplied with an additional exhaust fan designated as Fan 7 on the sketch. This room has the advantage of direct access to air intake from the east cable tunnel. However, because the cable tunnel supply fan is designed to supply on the order of 4,000 CFM total flow (some of which is diverted to the EDG switchgear rooms) while the safety-related pump room exhaust fans 73FN-3A&B are rated on the order of 12,000 CFM. Accordingly, fire damper closure in the north safety-related pump room has the potential to render the electric fire pump inoperable.

The diesel fire pump is located in a separate room which shares two walls in common with the north pump room as shown on the sketch. The dampers supplying the diesel fire pump room from the north safety-related pump room and the screenwell were also closed during this event and would also be closed by the postulated fire in the intake structure (screenwell) scenario. This room is cooled by a separate fan designated as Fan 12 on the sketch. Although the engine has a water jacket cooling system, the engine combustion air intake comes from within the room. Accordingly, the dampers must be open for proper operation.
