Report on the Televiwer Log of the Boreholes PB-1 and PB-3 and Well PB-4 in Nopal, Municipality of Aldama, Chihuahua (includes original Spanish Version and English Translation), MOL.20040108.0362

**REPORT ON THE TELEVIEWER LOG OF THE BOREHOLES PB-1 AND PB-3
AND WELL PB-4 IN NOPAL, MUNICIPALITY OF ALDAMA, CHIHUAHUA**

**FEDERAL COMMISSION OF ELECTRICITY
TECHNICAL SUBMANAGEMENT**

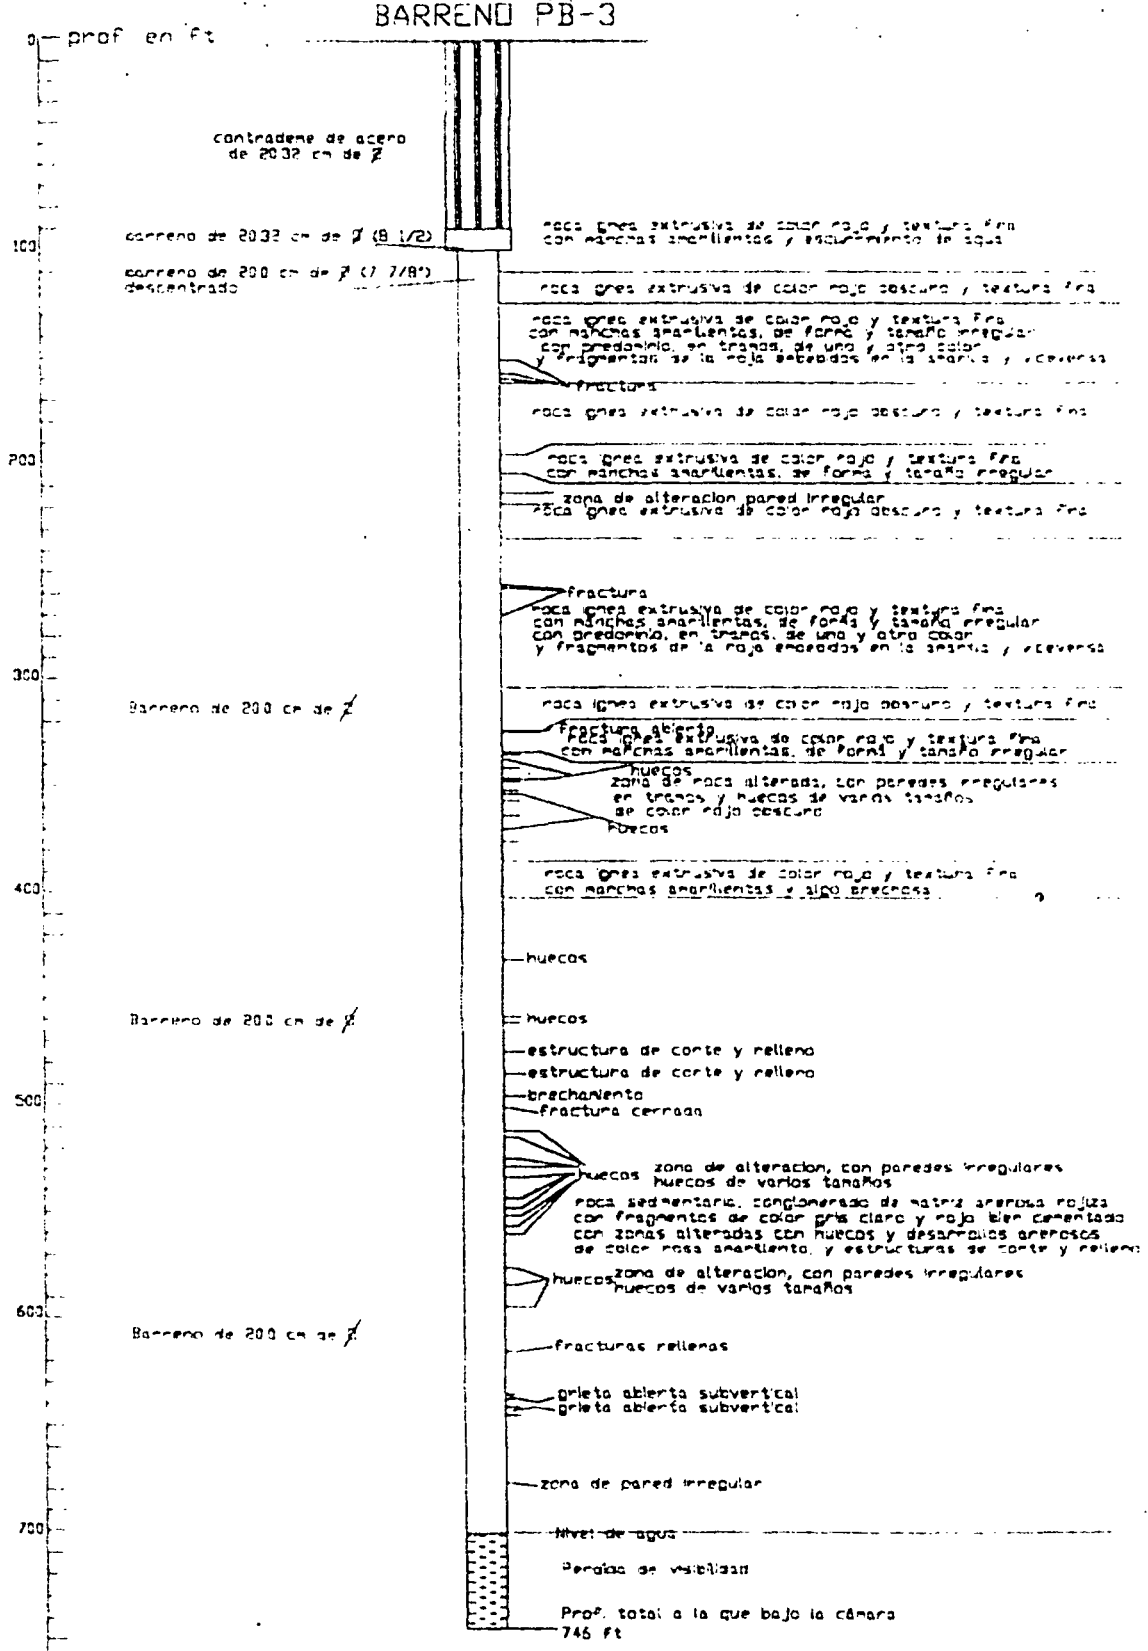
BARRENO PB-3

27.43-227.38 m	<p>Barreno de 7 7/8" de diámetro (21.59 cm) perforado en roca</p> <p>La perforación esta descentrada del brocal y presenta varias desviaciones de la vertical en su desarrollo.</p> <p>Al inicio del barreno libre la roca corresponde a una ignea extrusiva, con varias unidades, unas de color rojo oscuro y otras de color rojo amarillento, estas ultimas con abundantes huecos se encuentran desde los 100 ft hasta los 335 ft. Presenta algunas fracturas y una zona de alteración con pared irregular entre los 215 y 220 ft.</p> <p>De los 335 ft a los 387, la roca ignea es de color rojo oscuro y se presenta muy alterada con abundantes huecos en la pared del barreno</p> <p>De los 387 a los 404 ft reaparece la roca extrusiva de color rojo y amarillo con huecos.</p> <p>De los 404 ft en adelante se observa un conglomerado con fragmentos de color gris, rojo y amarillo con algunos huecos mayores y probables estructuras de corte y relleno (o fracturas rellenas) a los 478 y a los 489 ft. También presenta zonas de alteración con abundantes huecos entre los 512 y los 560 ft. A los 636 se inicia una grieta subvertical abierta que se observa hasta los 645 ft. A los 700 ft se llegó al nivel del agua e inmediatamente se tuvo perdida de visibilidad. Se penetro hasta los 746 ft de profundidad sin visibilidad.</p>

Se observaron zonas de fracturas cerradas y abiertas en ambos barrenos. En el PB-1 se tiene una grieta importante entre los 636 y los 645 ft que puede corresponder a una zona de falla, y en el PB-3 se tienen probables rasgos de corte y relleno entre los 478 y 489 ft

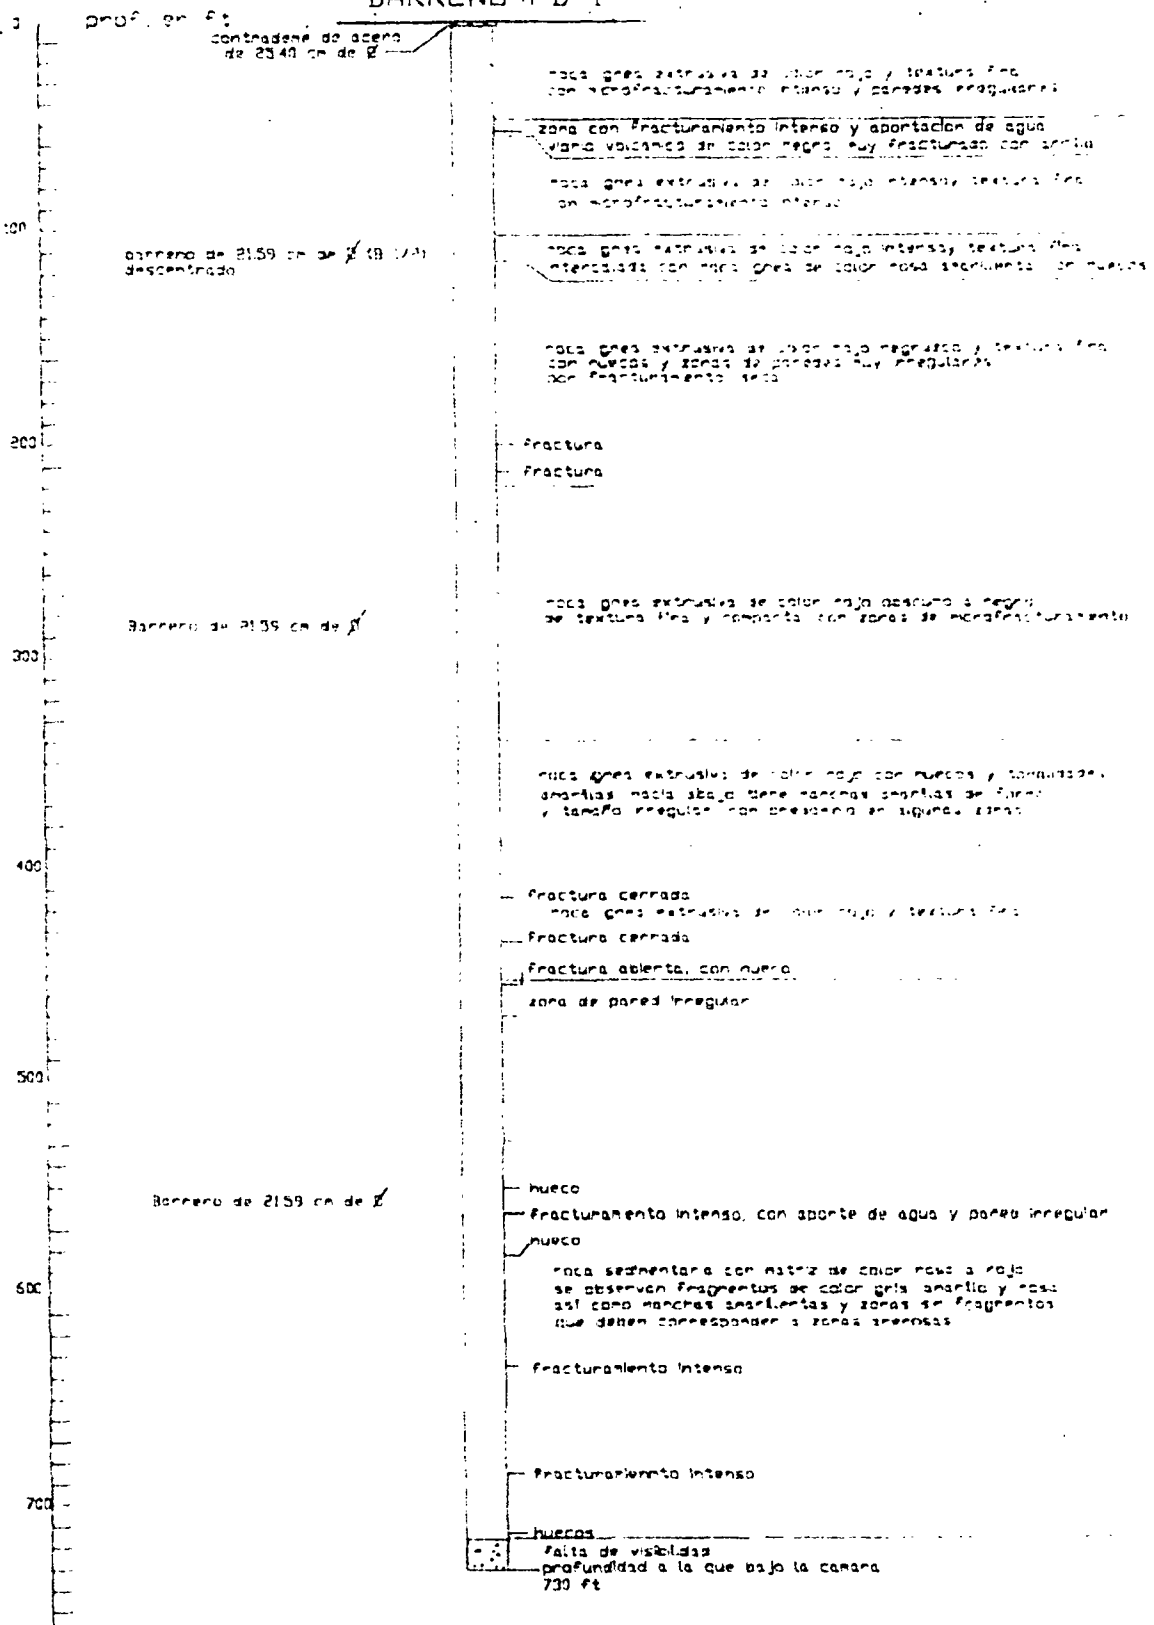
BARRENO PB-1

2.13 - 222.50	Barreno de 8 ½" de diámetro (21.59 cm) perforado en roca. La perforación esta descentrada del brocal y presenta varias desviaciones de la vertical, muy ligeras, en su desarrollo. Al inicio del barreno libre la roca corresponde a roca ígnea extrusiva, de color rojo, a rojo amarillento, no se observa la textura, tiene abundante microfracturamiento, algunas fracturas cerradas y zonas con bandas y manchas amarillentas de forma y tamaño irregular. A los 52 ft hay una zona de fracturamiento con aportación de agua., en una zona de vidrio volcánico, que se observa claramente únicamente por 10 o 12 ft. A los 222 ft se inicia una roca ígnea masiva de color rojo oscuro a negro y continua hasta los 340 ft. De 340 a 370 ft nuevamente aparece la roca ígnea de color rojo y zonas de color amarillo con huecos constantes De 370 a 458 nuevamente aparece una roca ígnea compacta de color rojo que hacia abajo tiene tonalidades amarillas, con fracturas cerradas. A los 460 se tiene un hueco desarrollado en una fractura y se inicia un conglomerado

<p>con fragmentos de color gris, amarillo y rosa, con algunas zonas en que no se observan los fragmentos que deben corresponder a desarrollos arenosos, esta litología continua hasta el nivel de agua localizado a los 717 ft. Tiene zonas de fracturamiento intenso y a los 562 hay escurrimiento de agua. A los 715 ft se tienen huecos mayores con ensanchamiento de la perforación.</p> <p>A los 717 ft se determino un nivel de agua e inmediatamente hay perdida de visibilidad por el sedimento contenido en el ella. En estas condiciones se bajaron 13 ft, más hasta 730 ft.</p>
222.50	Profundidad a la que bajo la cámara. La profundidad de perforación reportada es de 252.5 m por lo que no se registraron 30 m.

En el barreno PB-1 se tiene dos entradas de agua, a los 52 ft y a los 562 ft. En el pozo PB-3 únicamente se tiene el escurrimiento entre el contra-ademe y la pared del barreno que entra al barreno al termino del contra-ademe.
