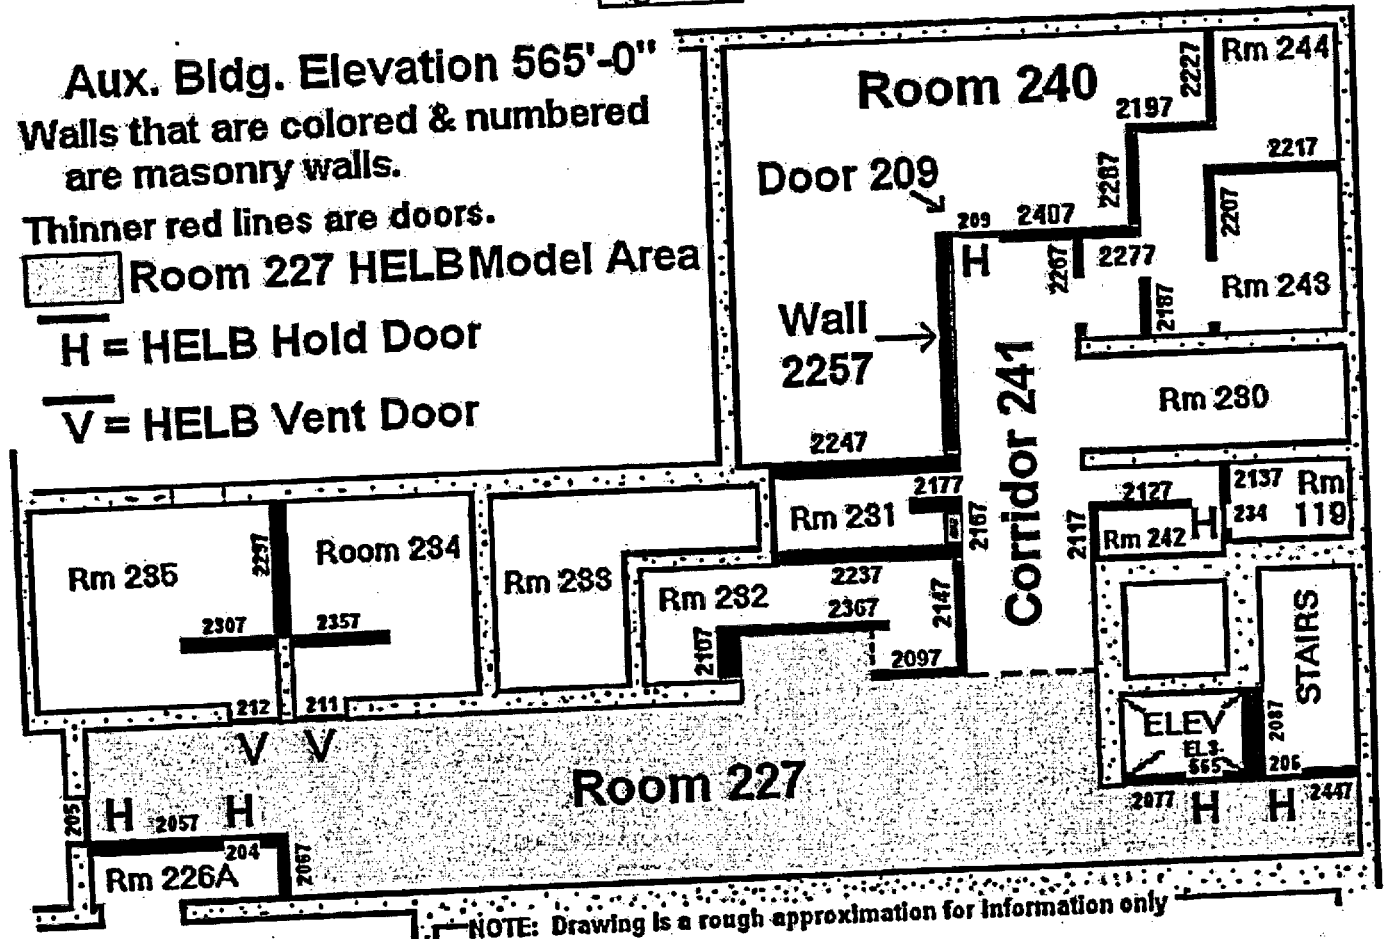
Figure 5

As noted above, wall 2257, which forms one boundary between the Boric Acid Addition Tanks room 240 and corridor 241, would be subjected to compartment pressurization upon a HELB within adjoining room 227. According to C-NSA-000.02-004, corridor 241 is not included with the HELB model for room 227. An artificial "barrier" is indicated by a dotted line in the representation of the HELB area on page 15 of the calculation. The area that C-NSA-000.02-004 modeled as the Room 227 HELB area is represented by the yellow area in Fig. 5 below.

The drawing in Calculation C-NSA-000.02-004 of the Room 227 HELB area shows the border of the area with a solid line, not distinguishing between concrete walls, masonry walls and solid doors.¹⁷ As noted above, the opening to Corridor 241 and the doorway to Room 232 were shown as dotted lines indicating borders without barriers.
