16 OTHER LICENSE CONSIDERATIONS

16.1 Prior Use Of Reactor Components

16.1.1 Reactor Vessel and Core Components

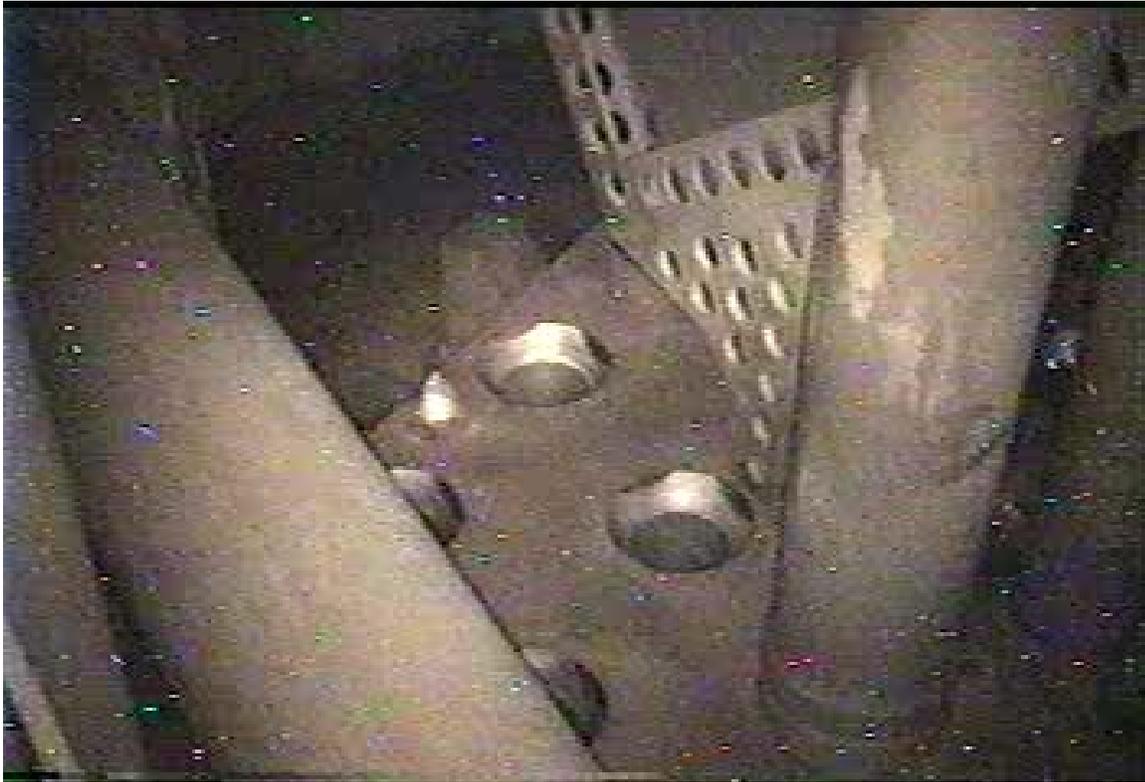
Figure 16.1: Lower Grid Plate

The inspection revealed no flaws that indicated a decrease in the integrity of the welds. The tip welds were in excellent condition. The other items examined also appeared to have no defects that would affect their design function.
