SHEARON HARRIS NUCLEAR POWER PLANT, UNIT NO. 1
DOCKET NO. 50-400/LICENSE NO. NPF-63

RESPONSE TO THE REQUEST FOR ADDITIONAL INFORMATION CONCERNING
THE LICENSE AMENDMENT REQUEST FOR A ONE-TIME INCREASE IN STEAM
GENERATOR INSPECTION INTERVAL (TAC NO. MC1633)

SHEARON HARRIS NUCLEAR POWER PLANT, UNIT NO. 1
DOCKET NO. 50-400/LICENSE NO. NPF-63
RESPONSE TO THE REQUEST FOR ADDITIONAL INFORMATION CONCERNING THE
LICENSE AMENDMENT REQUEST FOR A ONE-TIME INCREASE IN STEAM
GENERATOR INSPECTION INTERVAL

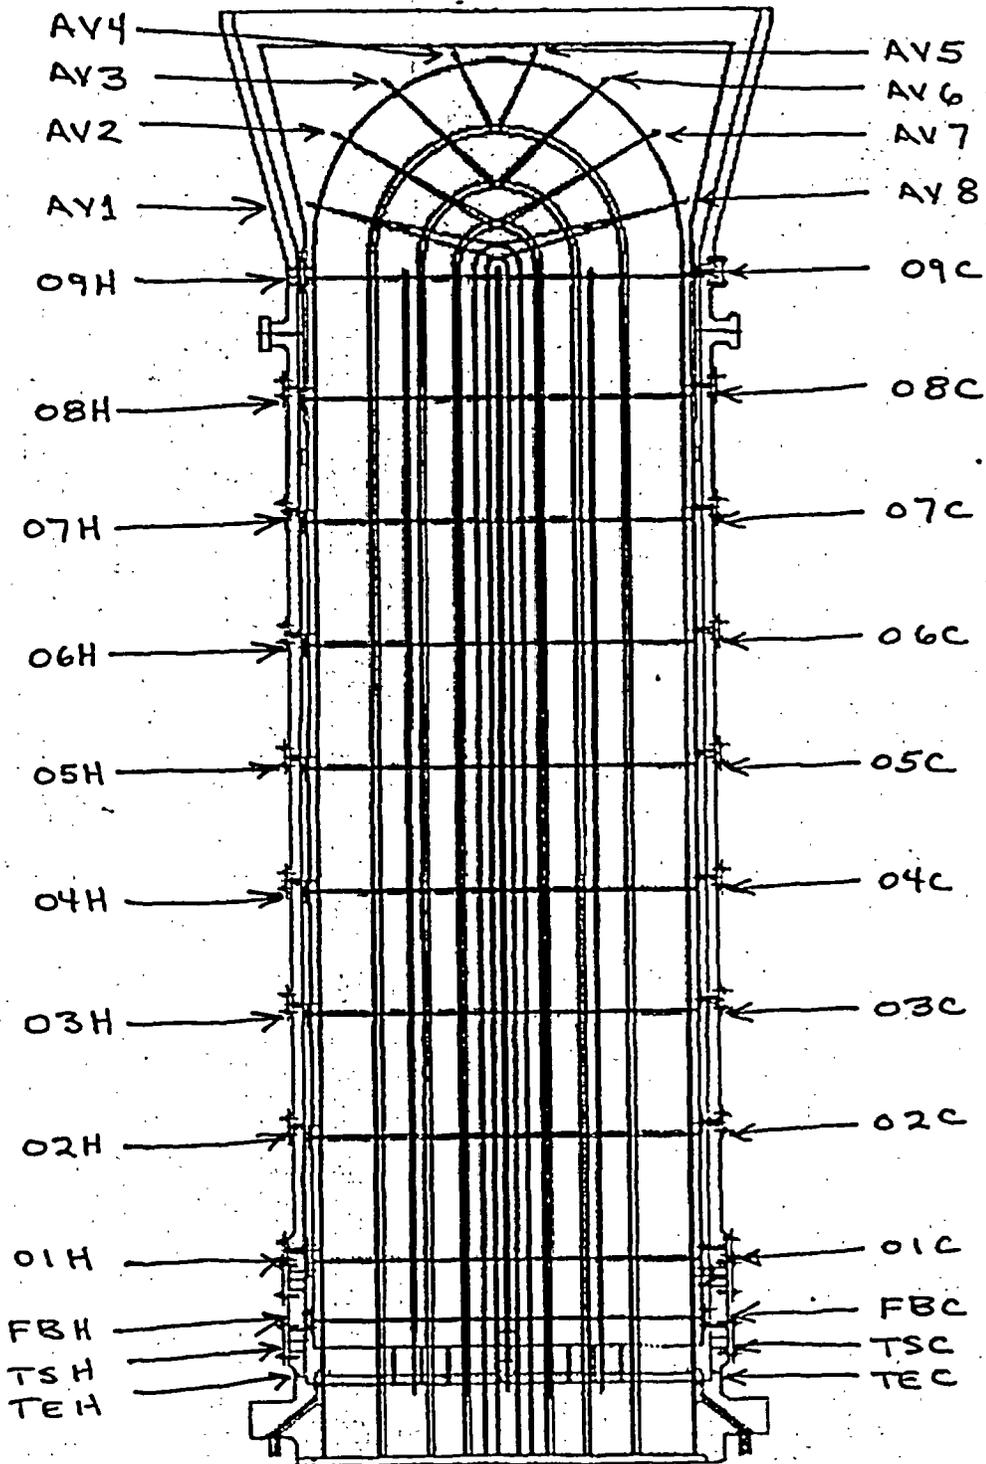
Figure 1 - W model D75 S/G

Response to Request 5.a
Schematic which depicts the tube supports and the tube support naming conventions

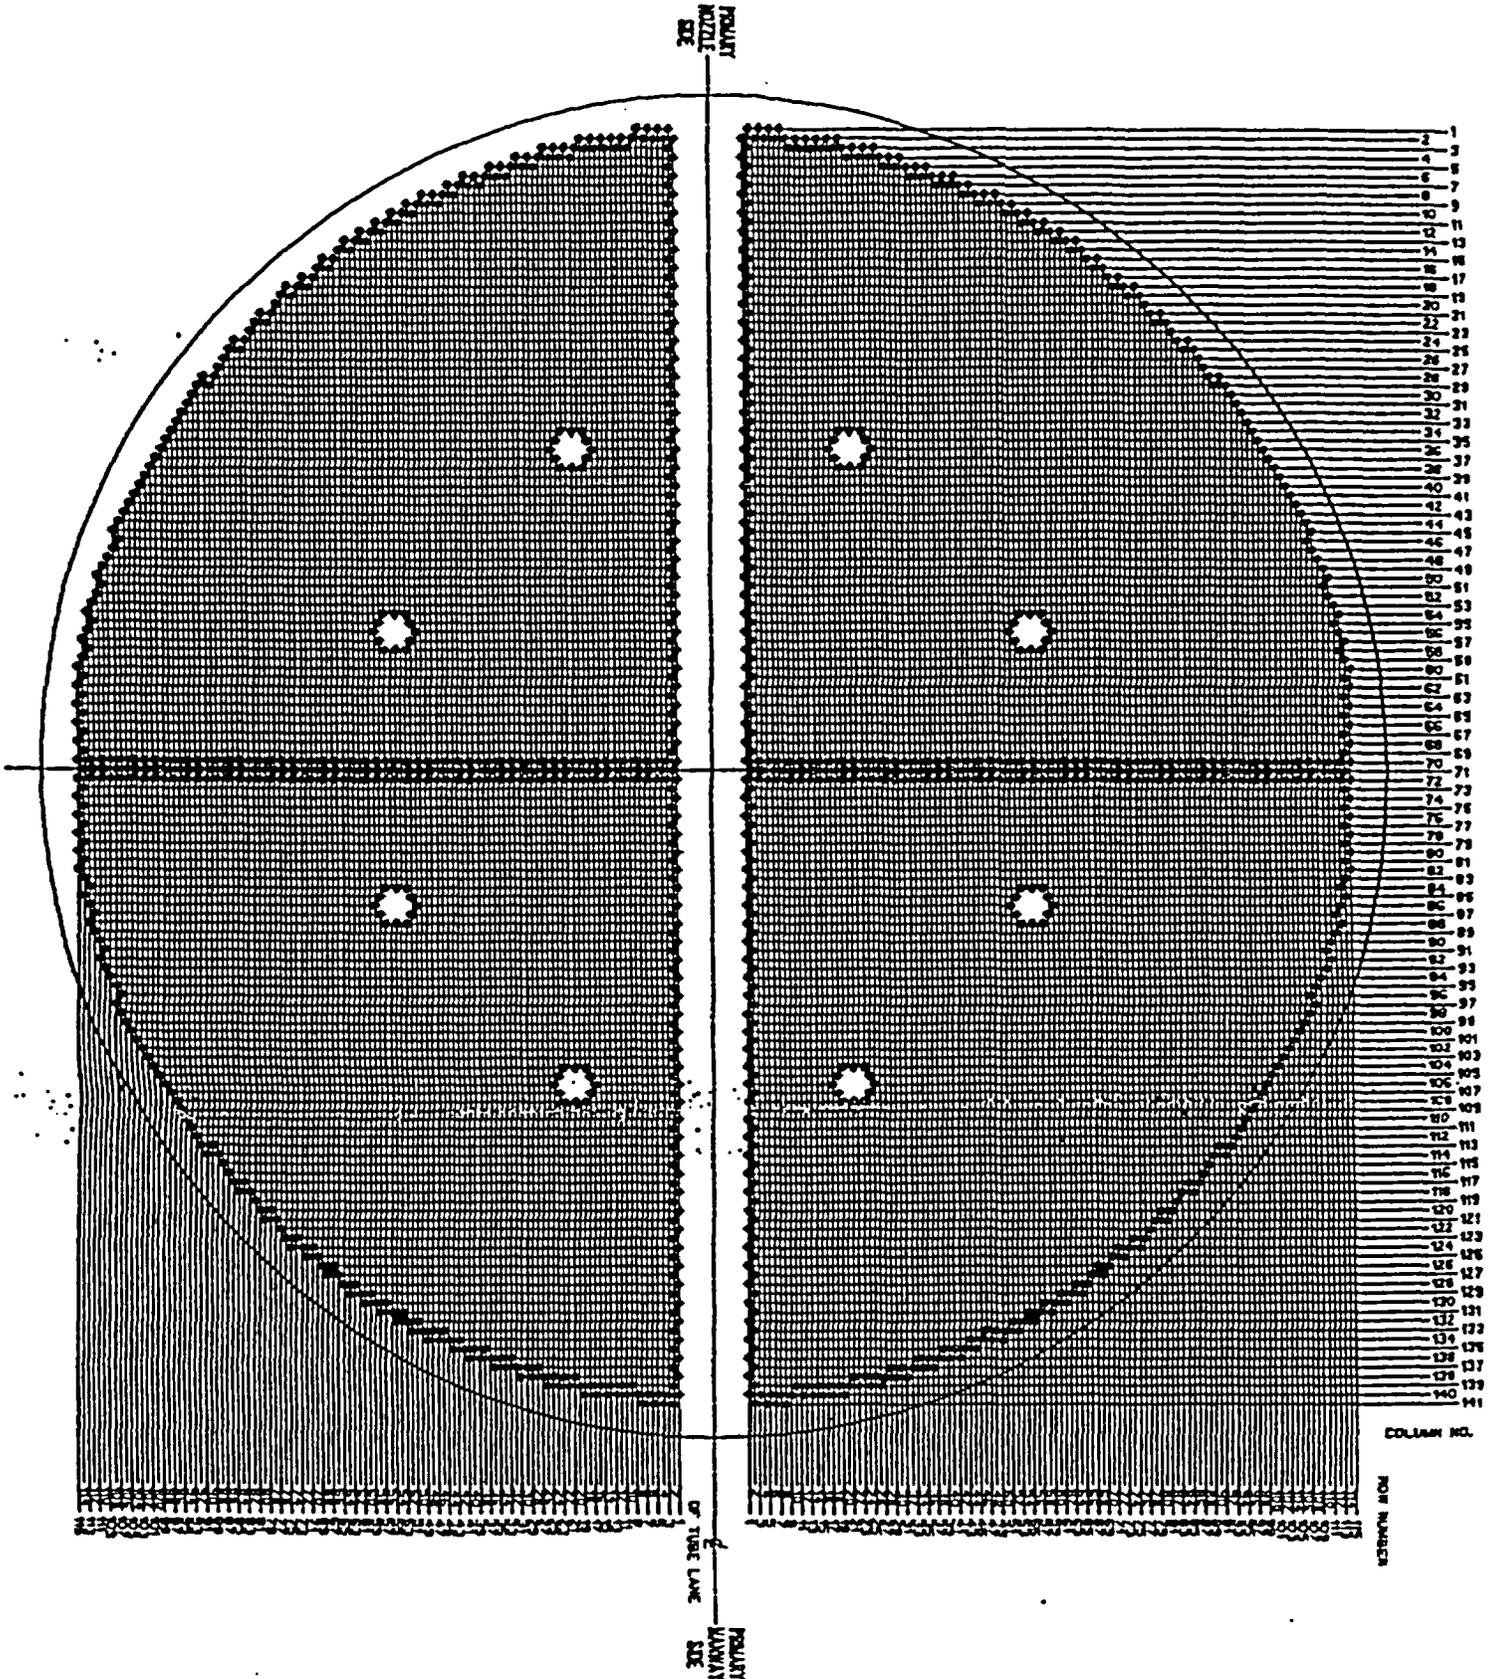
Response to Request 5.b
Tubesheet map which depicts the rows and columns of the tubes
